Follow up to Oral Question 503-18(2) Northern Frontier Visitors Centre

J.
Williams Engineering NFVC
Structural Assessment

File No. 35826.00

May 19, 2017

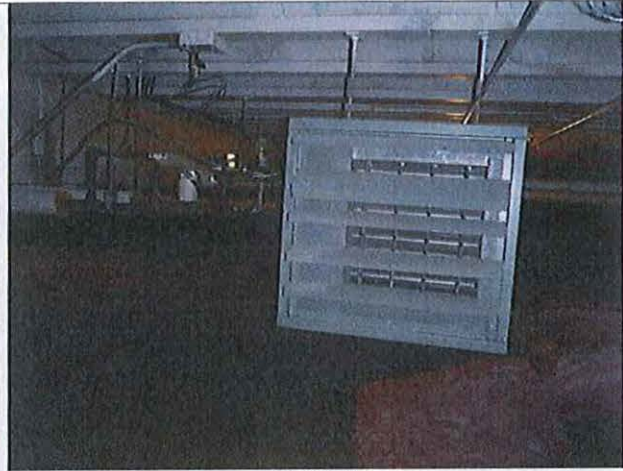
Photo 9

Condition:
Heating unit in the crawlspace.
Crawlspace was arm so it is assumed
that the heating units are operational.

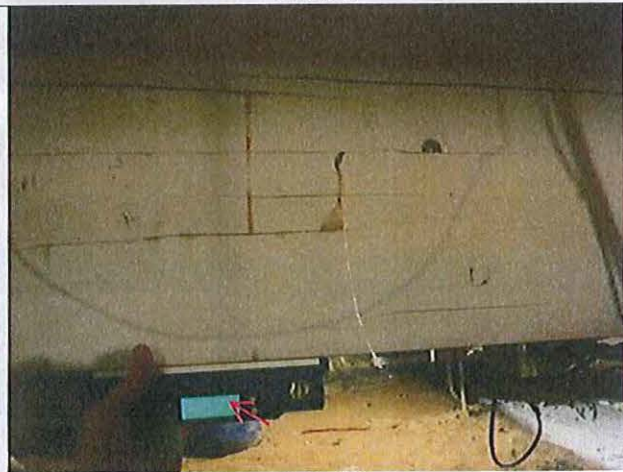
Photo 10

Condition:
Main floor beams that were observed
from the crawlspace were all level.
The beam in the picture reads 0.1°.

Some horizontal cracks were
observed in beams. Cracks were not
considered to be stress related, but
are probably due to drying out of the
wood.

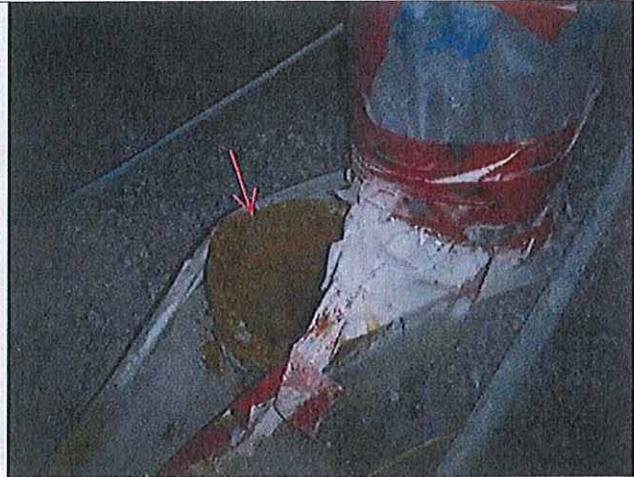
Photo 11

Condition:
We observed an abandoned pile located directly adjacent to pile located near Grid intersection 6B.

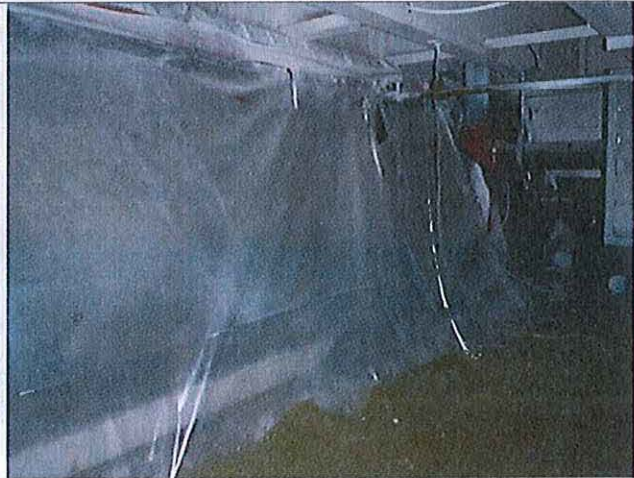
Photo 12

Condition:
We observed sandbags and draped poly around the crawlspace perimeter. It appears that the grade beneath the grade beams has settled away from the soffit of the voidform. This leaves a gap to the exterior in some locations. Sandbags and draped poly have been used to restrict airflow from the exterior.

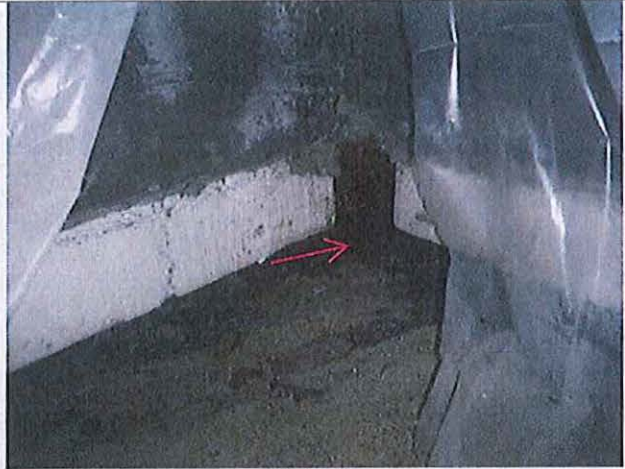
Photo 13

Condition:
 Pile at grid A8. You can also see the gap to the underside of the voidform.

Steel piles were observed to have surficial rust.

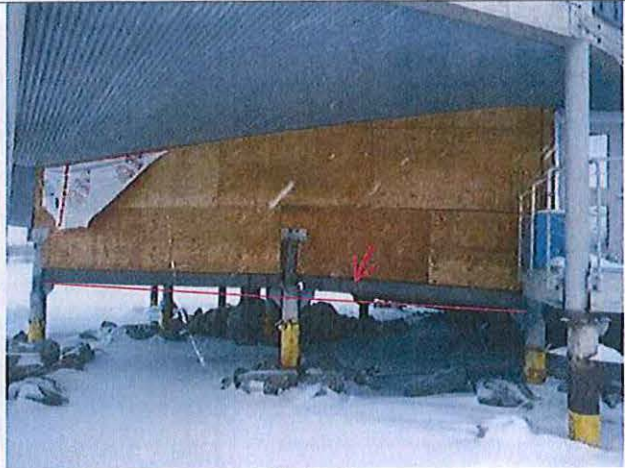
Photo 14

Condition:
 The beams highlighted in photo 14 were originally installed level back in 2015. At that time the beams were installed to help support a glulam beam that had experienced failures. The glulam beam is currently undergoing similar deformation to that reported in 2015.

Recommendations:
 We recommend that **immediate action** is taken to relevel the piles beneath the southern portion of the building.

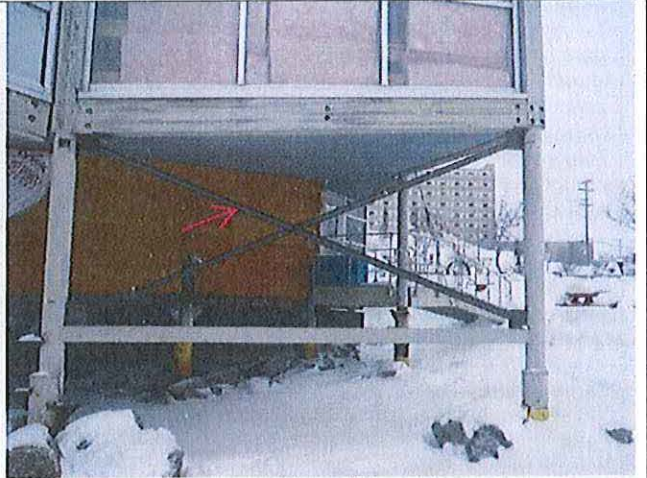
Photo 15

Condition:
Bracing that was reported to have been installed as part of the 2015 work.

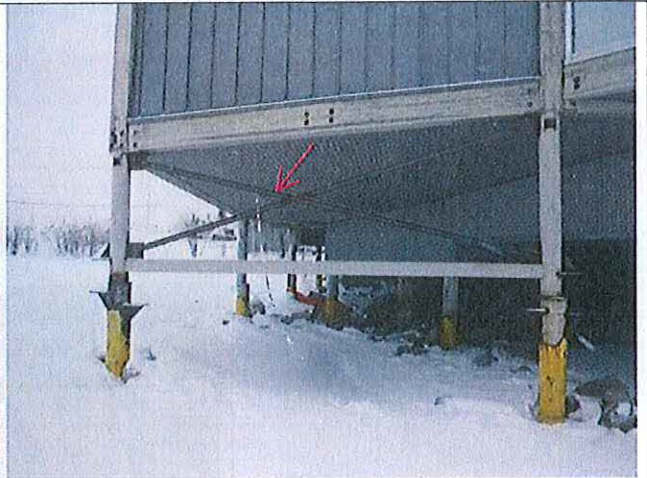
Photo 16

Condition:
Bracing that was reported to have been installed as part of the 2015 work.

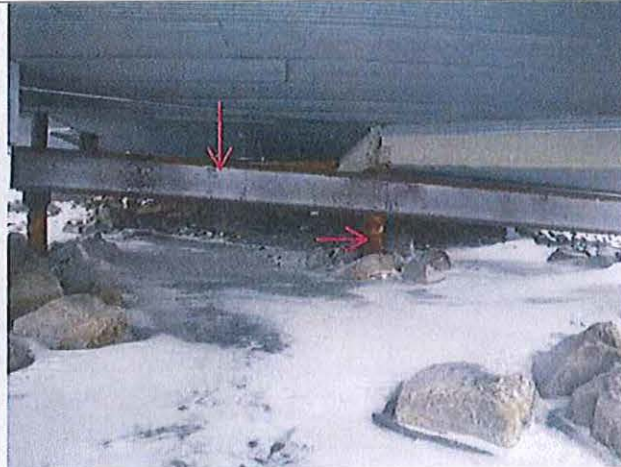
Photo 17

Condition:
 2 x W610 steel beam sections that were installed in an earlier foundation retrofit. These beams were installed to isolate the central pile that we have highlighted with the arrow. The isolated pile has frost jacked against the underside of the top flange. See photo 18.

Recommendations:
 We recommend that **immediate action** is taken to relevel the piles beneath the southern portion of the building. Also, the central pile needs to be cut away.

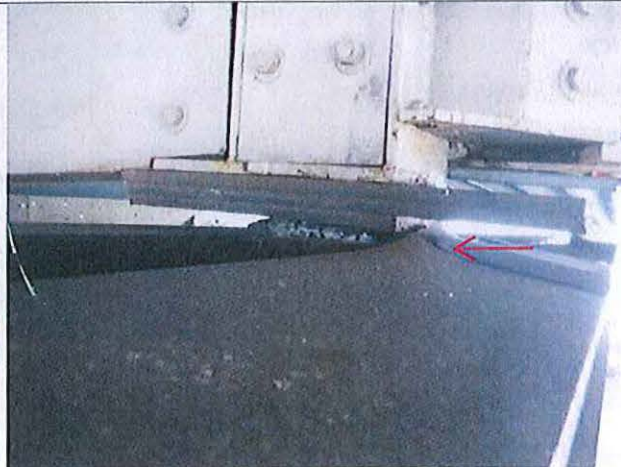
Condition:
 Photo 18 shows a close up of where the building framing bears onto the top flange of the beam. The detail has the framing supported on a series of plates that span the two beams. The isolated pile has jacked against the top flange of the beam and caused some local buckling.

Recommendations:
 Beam requires a repair detail to be designed by a structural engineer.

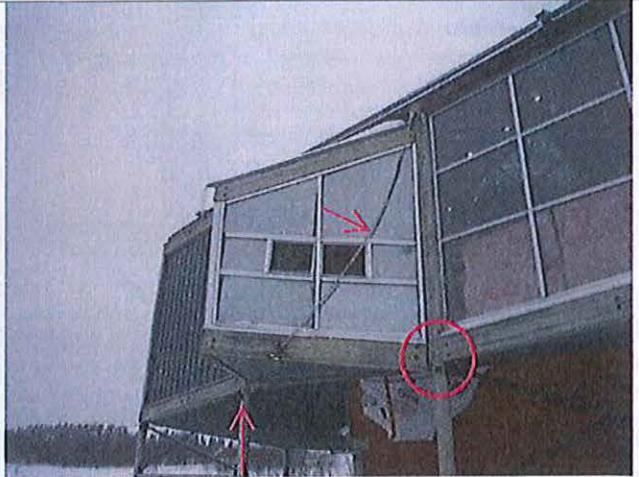
Photo 19

Condition:
 The pile at grid 1B has frost jacked causing deformations of the building framing along grid 1. The sagging support rod observed is due to this deformation.

Recommendations:
 We recommend that **immediate action** is taken to relevel the piles beneath the southern portion of the building.

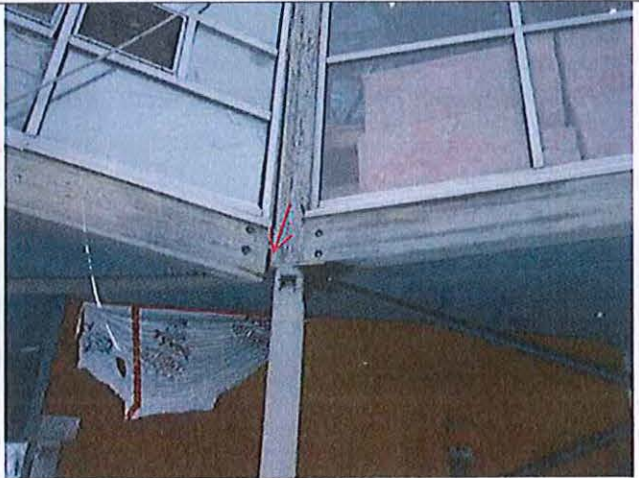
Photo 20

Condition:
 This connection is of concern. Currently the beam is bearing onto a steel plate that forms part of the connection. However the beam end has reduced bearing due to the rotation of the connection.

Recommendations:
 We recommend that **immediate action** is taken to relevel the piles beneath the southern portion of the building. As part of this work, this connection is to be assessed and repaired if necessary.

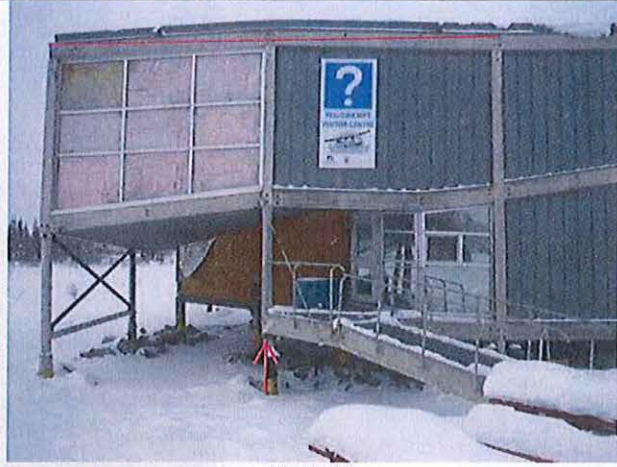
Photo 21

The pile at grid intersection 2D has frost jacked which has resulted in deformations in the framing along the southern portion of grid line D. The roof line was originally constructed level, see photo 21.

We recommend that immediate action is taken to relevel the piles beneath the southern portion of the building.

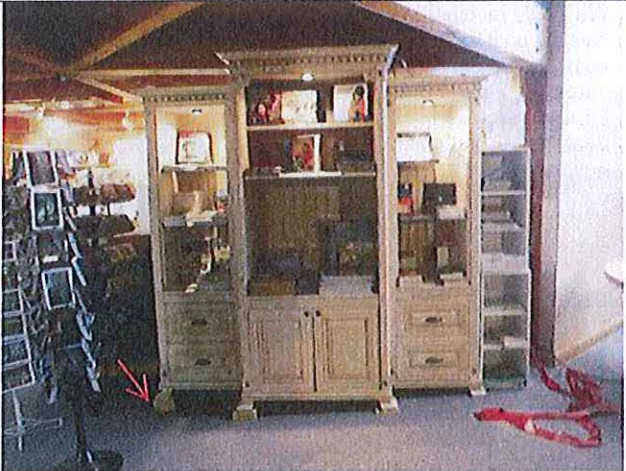
Condition and Recommendations	
Superstructure	
<p>Condition: This photo was taken between grids 3 & 4 in the interior of the main floor level. It is near the transition area from heated crawlspace to the area over the pond. In the photo you can get an idea of how sloped the floor has become. It was originally constructed level.</p> <p>Recommendations: For Information.</p>

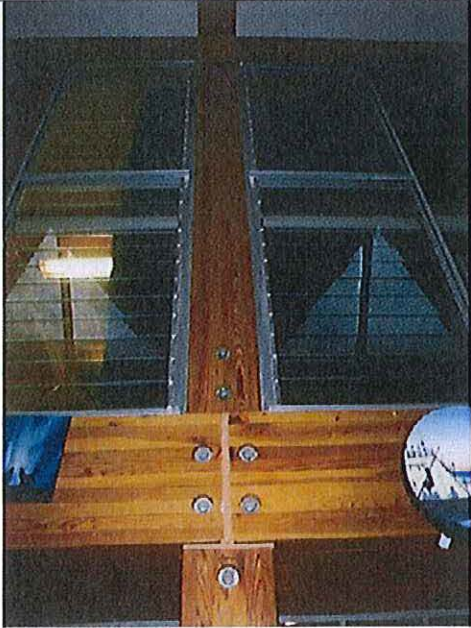
<p style="text-align: center;">Photo 23</p>

<p style="text-align: center;">Photo 22</p>
<p>Condition: Photo 23 gives an idea of the condition of the exposed post and beam framing in the northern portion of the building. Connections still appear tight, and framing is plumb. Operable louvered glazing is still fully functional.</p> <p>Recommendations: For Information.</p>

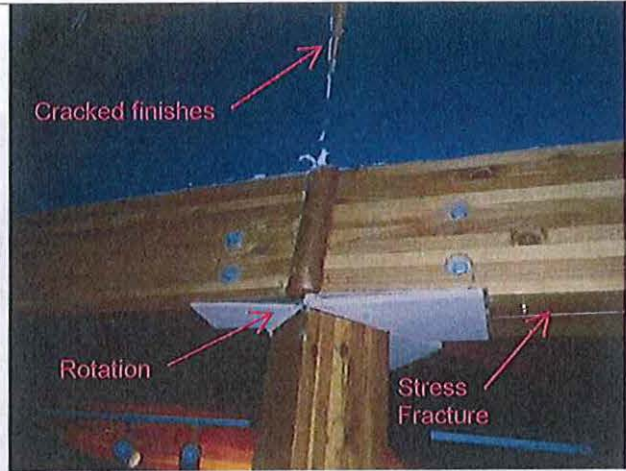
Condition:
 Photo 24 is a typical example of the condition of framing in the southern portion of the building. Drywall finishes cracking. Connections rotating. Stress fractures appearing in beams.

Recommendations:
 We would recommend not repairing finishes until leveling work has been completed on the foundation. At this stage beams and connections should be assessed and repaired. Repair design shall be done by a structural engineer.

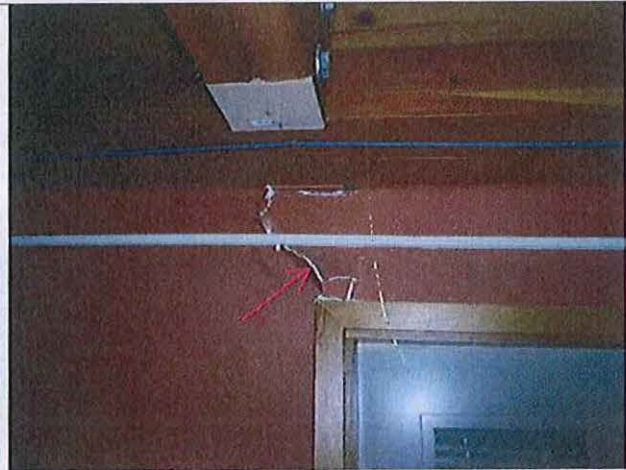
Photo 25

Condition:
 Typical example of cracks in finishes around racked door framing in southern portion of building.

Recommendations:
 We would recommend not repairing finishes until leveling work has been completed on the foundation. Please note that the building will continue to move even after releveilling work is completed. Finishes will crack again when the building moves.

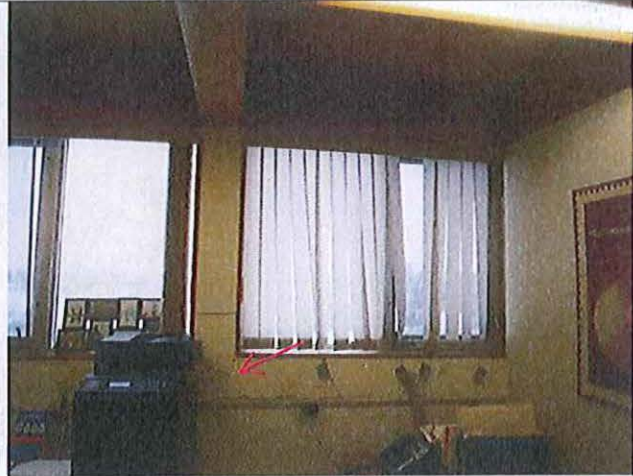
Photo 26

Condition:
Serious cracking in drywall finishes and racking of window framing at second floor level on the west of the building between grids 3 and 4.

Recommendations:
We would recommend not repairing finishes until leveling work has been completed on the foundation. Please note that the building will continue to move even after releveilling work is completed. Finishes will crack again when the building moves.

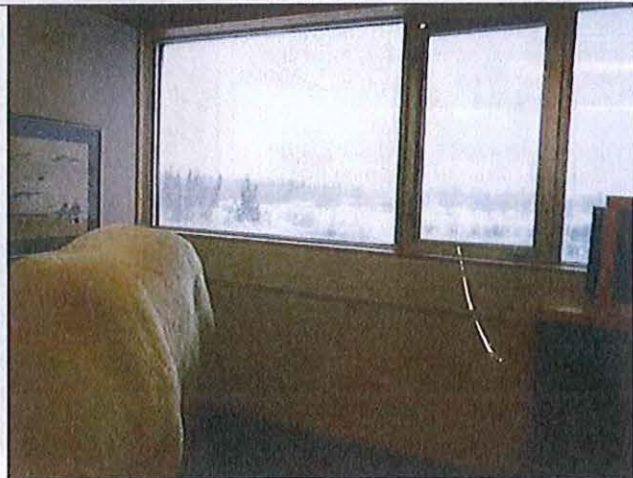
Condition:
Photo 27 was taken on the north side of the partition wall and photo 26 was taken on the south side.

On the north side some racking was noted in window framing, but drywall only exhibits minor cracks.

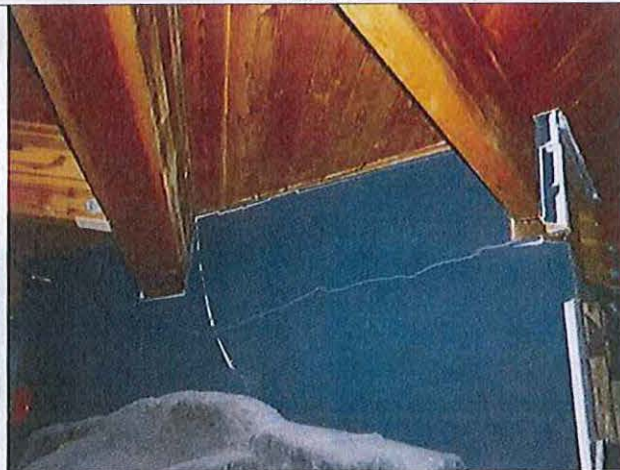
Photo 29

Severe uplift of beams at roof level around the elevator. This is most likely predominantly caused by frost jacking of the pile at grid 3B.

We recommend that **immediate action** is taken to relevel the piles beneath the southern portion of the building. Relevelling will relieve stresses on superstructure framing members.

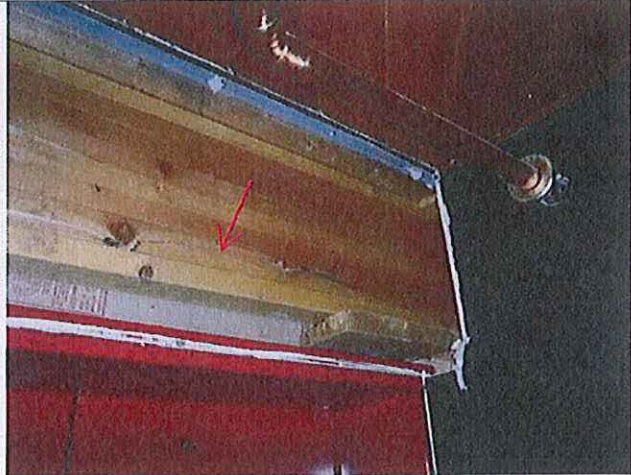
Photo 30

This failure is most likely caused by the jacking forces exerted by pile at grid 3B.

Recommendations:
 We recommend that **immediate action** is taken to relevel the piles beneath the southern portion of the building. Releveling will relieve stresses on superstructure framing members.

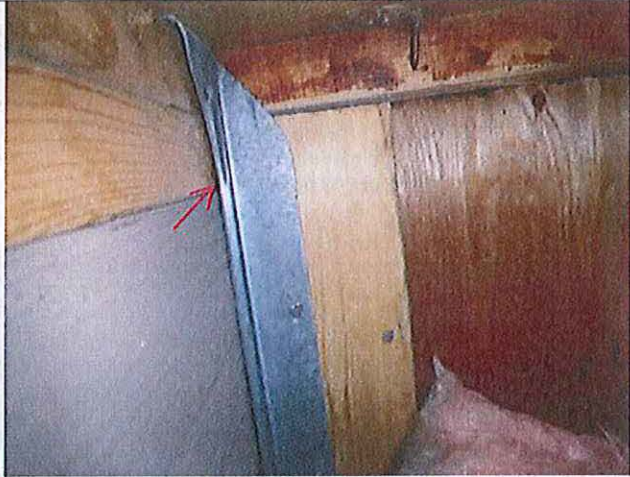
<p>Condition: Typical exterior beam supporting wood I-Joist floor.</p> <p>Recommendations: For information.</p>

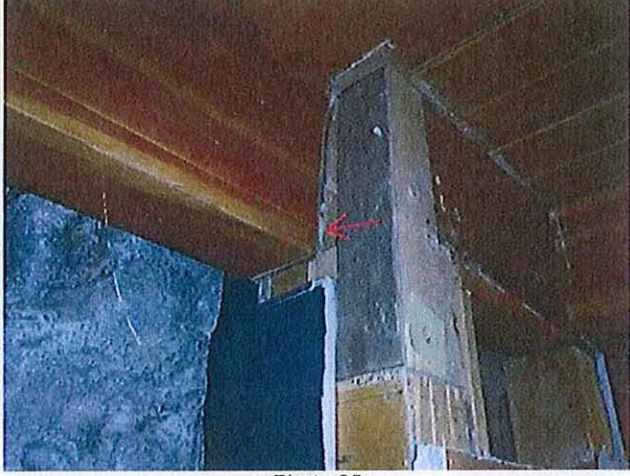
<p style="text-align: center;">Photo 35</p>

<p style="text-align: center;">Photo 34</p>
<p>Condition: It appears that there was a misalignment of framing at this location, during the original construction. The glulam beam has been roughly notched and bears onto a mass of timber stud members. The beam off cut seems to have been used as a filler piece. This is not acting as per its original design intent.</p> <p>See photo 36 below for close up.</p> <p>Recommendations: Once the piles have been relevelled, connections should be assessed and repaired. Repair design shall be done by a structural engineer.</p>

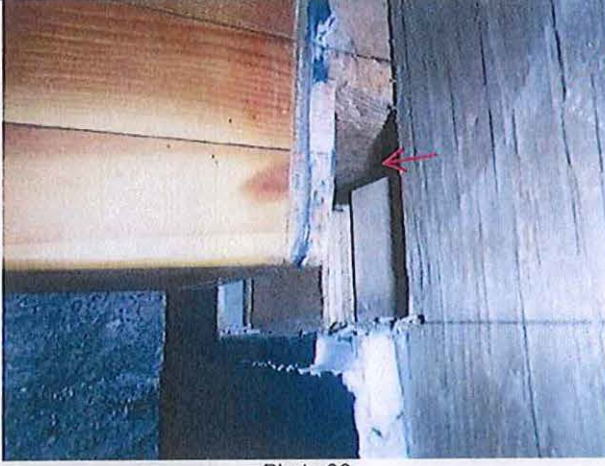
<p>Condition: Close up of notched beam bearing surface.</p> <p>Recommendations: The timber code allows a maximum notch depth of 25% of the member depth. This should be checked against this requirement.</p>

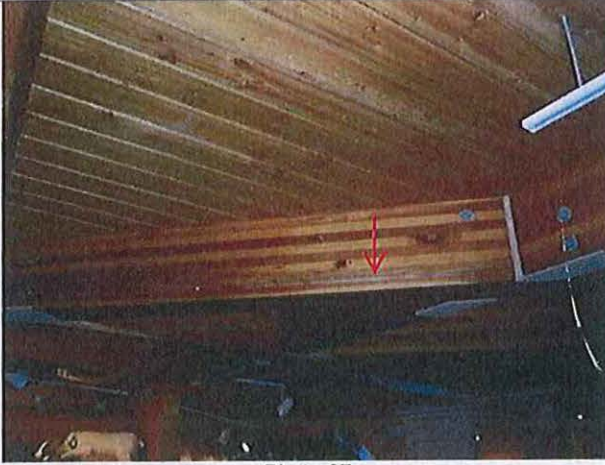
<p style="text-align: center;">Photo 37</p>

<p style="text-align: center;">Photo 36</p>
<p>Condition: Photo 37 shows the early stages of a stress fracture in a mezzanine framing primary beam located at the bottom of the ramp. This fracture is a result of the upward frost jacking forces exerted by the pile at grid 3B. The upward force effectively causes a load reversal on the beam resulting in a fracture at through bolt penetrations.</p> <p>Recommendations: Beam to be repaired after relevening work has been completed. Repair design is to be done by a structural engineer.</p>

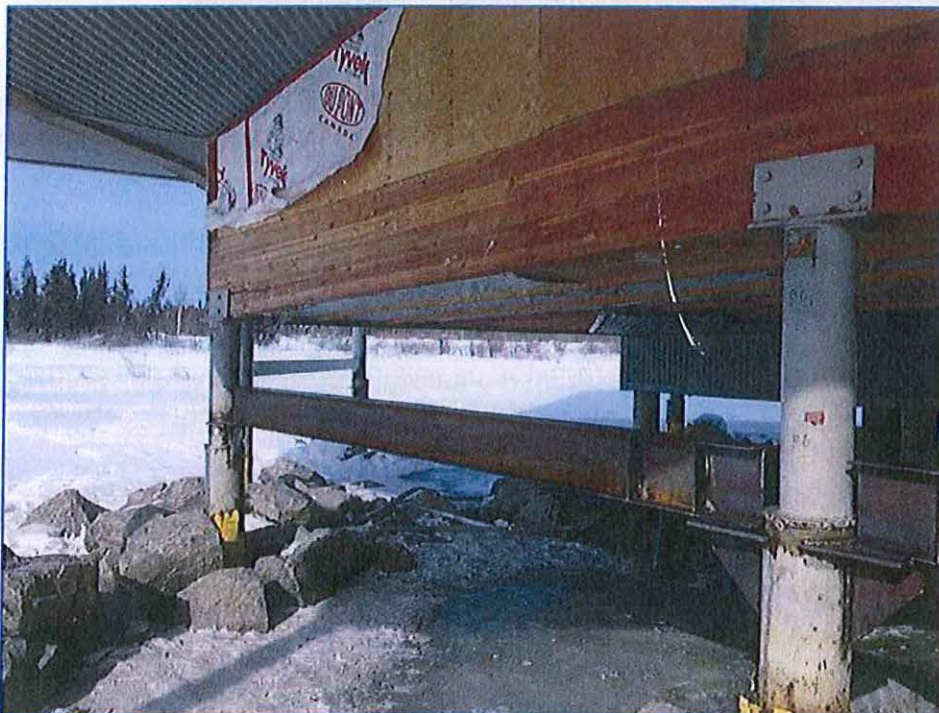
We initiated a site investigation and exposed areas of the wood framing we could see have been affected. This was particularly obvious along the ramp leading from the main floor to the second floor. We estimated the midpoint of the ramp to have jacked 6-8". When we exposed the face of the underlying framing, we discovered the glulam beam had failed.

Figure 1: Failed Glulam Beam supporting ramp, installation of substitute wide flange steel beam at lower elevation. This scheme permitted us to remove sections of the original steel pipe pile. Having removed approximately 7" of the intermediate pile, the gap between the broken glulam beam and the steel beam was filled in with a load bearing wall assembly. The surface was sheeted with plywood and covered with galvanized cladding consistent with the original design.
