Government of the Northwest Territories

Bridge Inspection Form

Struct. ID	03B004
-------------------	--------

Structure Name	Frank Channel Bridge		
Structure Location	HWY003-KM00243.8		
Road Number	3	On <input checked="" type="checkbox"/>	Under <input type="checkbox"/>
Road Name	Yellowknife Highway		
Watercourse Name	Frank Channel		
Crossing Type:	Road <input type="checkbox"/>	Rail <input type="checkbox"/>	Water <input checked="" type="checkbox"/> Navigable waterway <input type="checkbox"/>
	River <input type="checkbox"/>	Other <input type="checkbox"/>	Creek <input type="checkbox"/> Pedestrian <input type="checkbox"/>
Hwy Direction	3-SOUTH/NORTH		
Owner Category			
Maint.Resp.		Northing	62.7841667
Region	North Slave	Easting	-115.94639
District		National Highway System	
Municipality		Highway Designation	
Township		Hwy Functional Classification	
Structure Category	Bridge	AADT	890
Main Struct. Subcateg.	Truss	Trucks (%)	3
Main Struct. Type	Through Truss	District Bridge Engineer	002
Deck Length (Total)	207.15 (m)	Road Authority

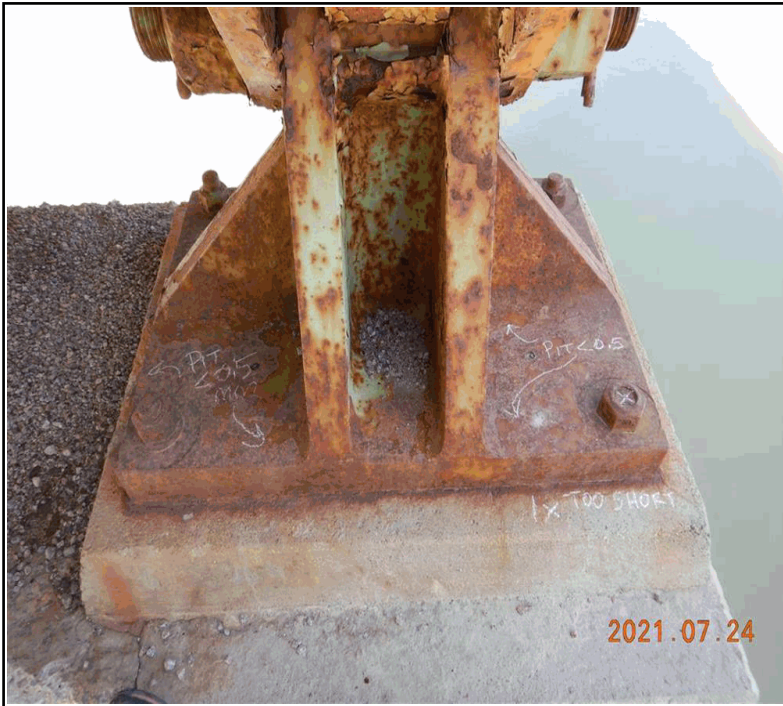
Description Rock Bearing at Pier 3, pit on the steel	
Elem Grp/Class	Piers/Bearings
Elem Type	Hinge
Sub Element	
Material Type	
Locator	Above
Defect Descript1	Light
Defect Descript2	
Defect	Corrosion
Other

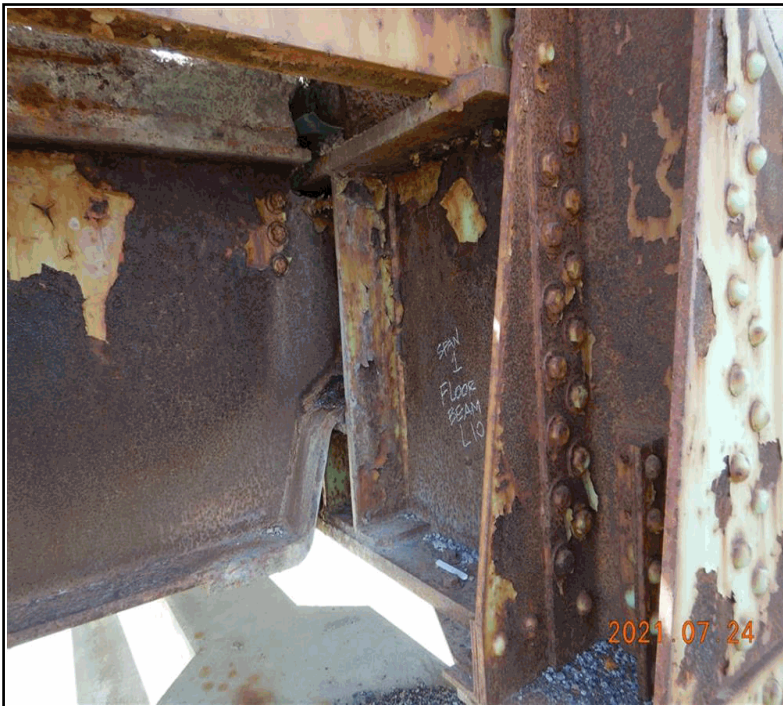
Description Floor beam at Span 1, pier 1, light corrosion	
Elem Grp/Class	Beams/ML'E's/Floor Beams
Elem Type	I type
Sub Element	Intermediate
Material Type	Steel
Locator	
Defect Descript1	
Defect Descript2	
Defect	
Other

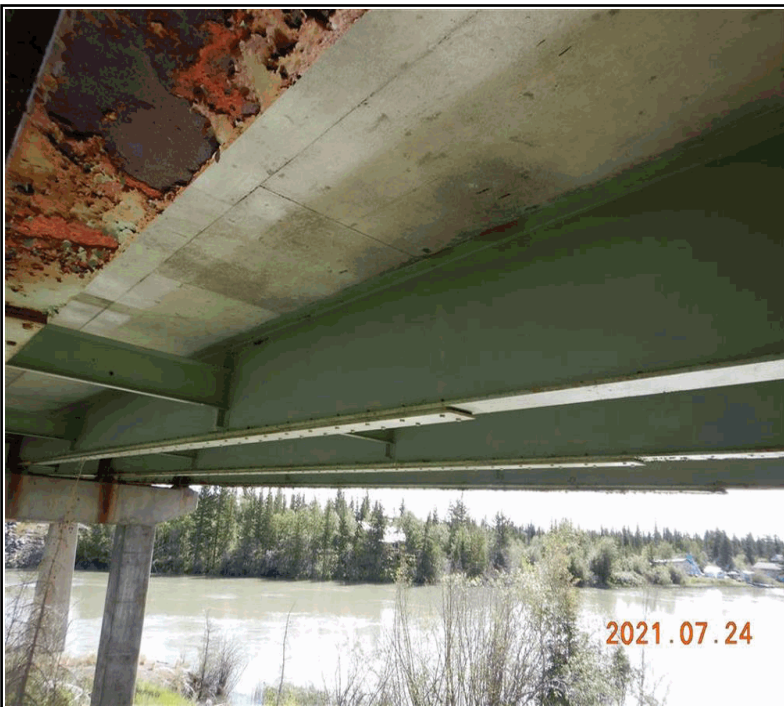
Description Exterior girder and intermediate diaphragm are in good condition	
Elem Grp/Class	Beams/MLE's/Girders
Elem Type	I type
Sub Element	Middle
Material Type	Steel
Locator	
Defect Descript1	
Defect Descript2	
Defect	
Other

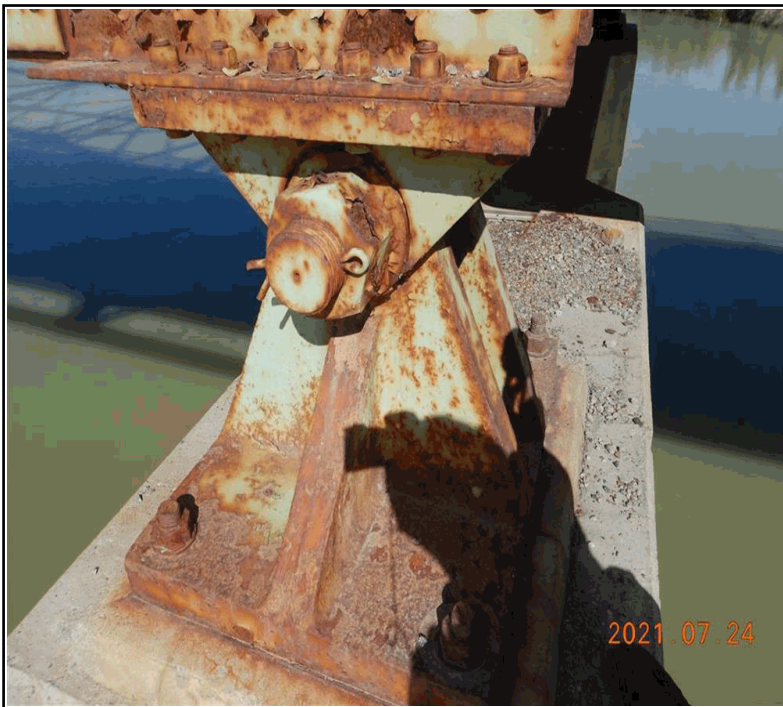
Description Rock bearing at Pier1, U/S, functioning as intended	
Elem Grp/Class	Piers/Bearings
Elem Type	Hinge
Sub Element	
Material Type	
Locator	
Defect Descript1	
Defect Descript2	
Defect	
Other

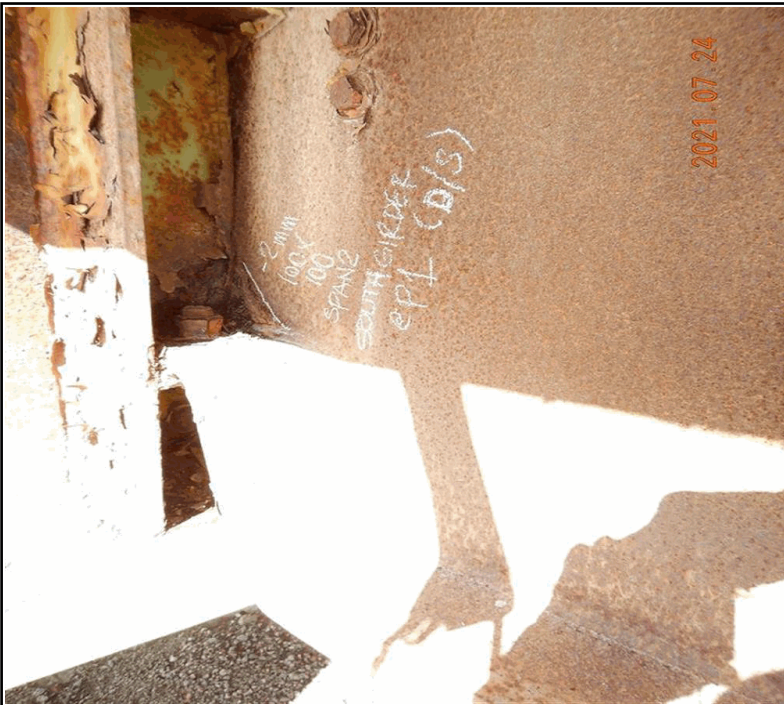
Description Exterior girder at Span1, Pier 1 D/S, section loss 2mm area 100x100mm	
Elem Grp/Class	Beams/ML'E's/Girders
Elem Type	I type
Sub Element	End
Material Type	Steel
Locator	
Defect Descript1	
Defect Descript2	
Defect	
Other

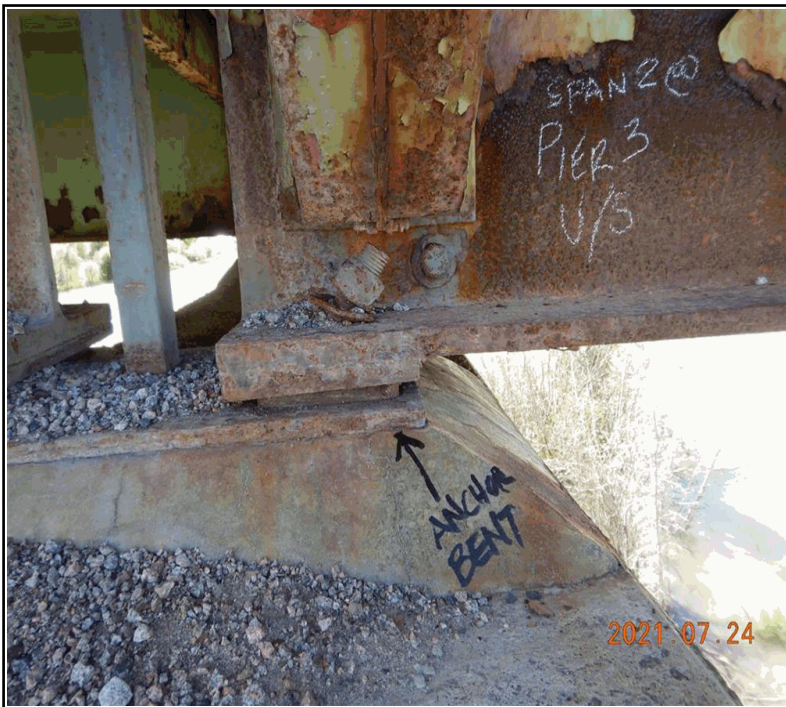
Description
Anchor bolt bent at Span1, Pier 3, exterior girder 1(U/S)

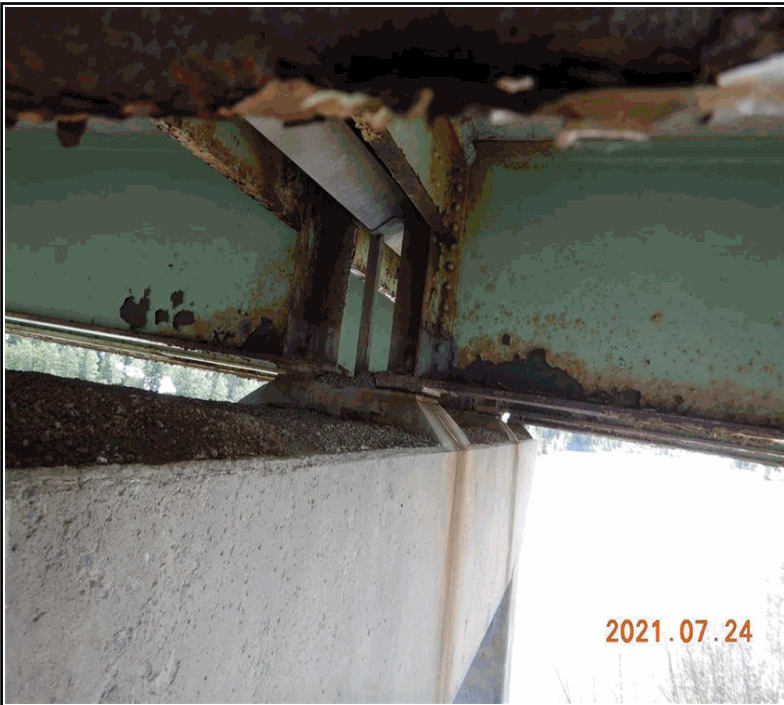
Description Floor beam, have severe corrosion on the bottom of the web directly above the bottom flange. Section loss is 2-4 mm and is approx.. 10 mm high. Typical.	
Elem Grp/Class	Beams/MLE's/Floor Beams
Elem Type	I type
Sub Element	Intermediate
Material Type	Steel
Locator	
Defect Descript1	
Defect Descript2	
Defect	
Other

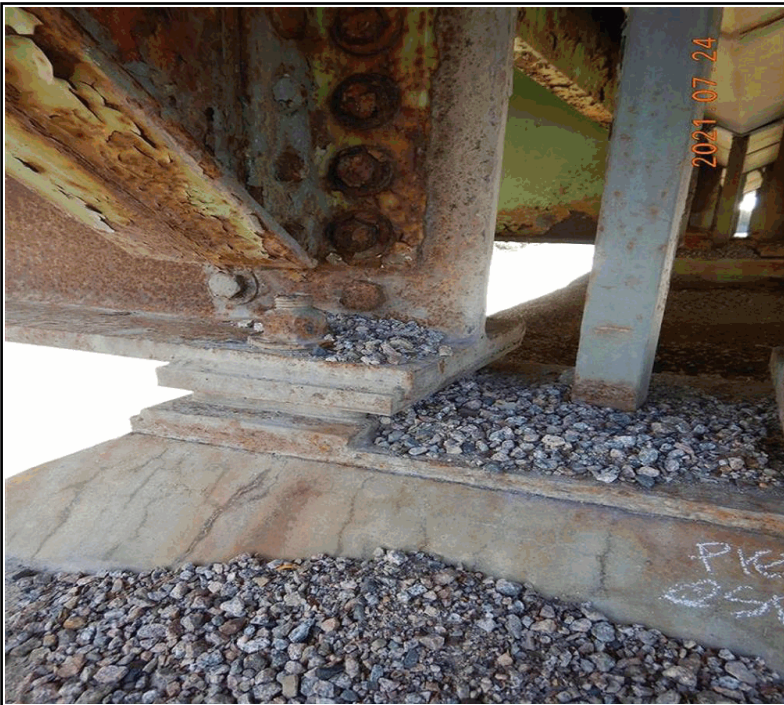
Description Gravel on the pier cap, Pier 2, D/S	
Elem Grp/Class	Piers/Caps
Elem Type	
Sub Element	
Material Type	Cast-in-place concrete
Locator	
Defect Descript1	
Defect Descript2	
Defect	
Other

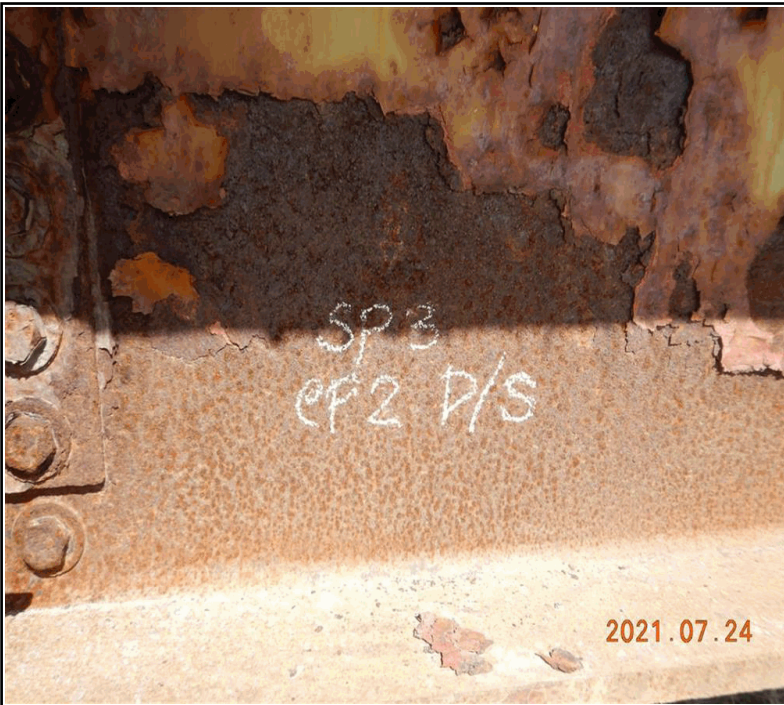
Description Exterior girder at Pier2, Span3, D/S, coat peeled, minor section loss	
Elem Grp/Class	Beams/ML'E's/Girders
Elem Type	I type
Sub Element	End
Material Type	Steel
Locator	
Defect Descript1	
Defect Descript2	
Defect	
Other

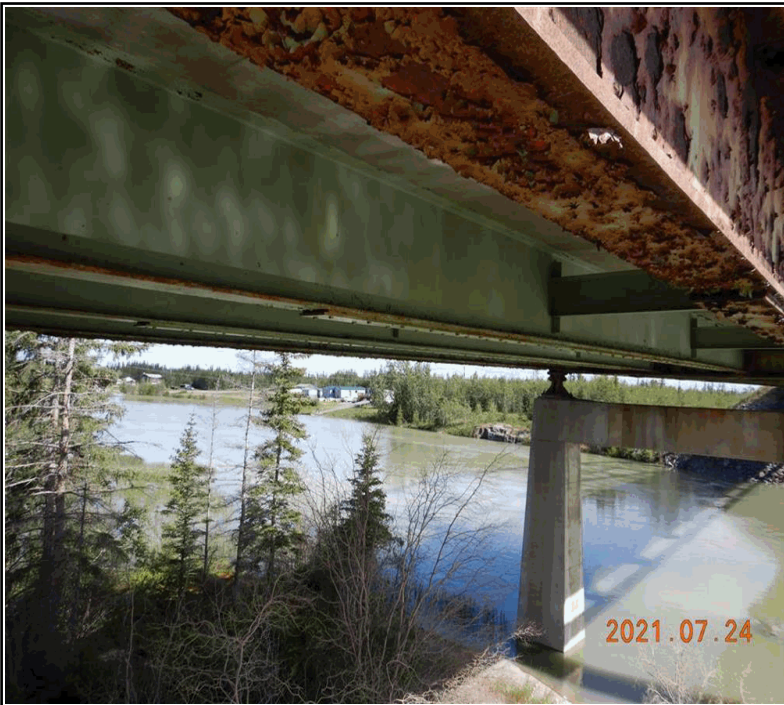
Description Coat peeled and light corrosion at bottom chord without section loss	
Elem Grp/Class	Coatings/Structural Steel
Elem Type	Unknown
Sub Element	
Material Type	
Locator	
Defect Descript1	
Defect Descript2	
Defect	
Other

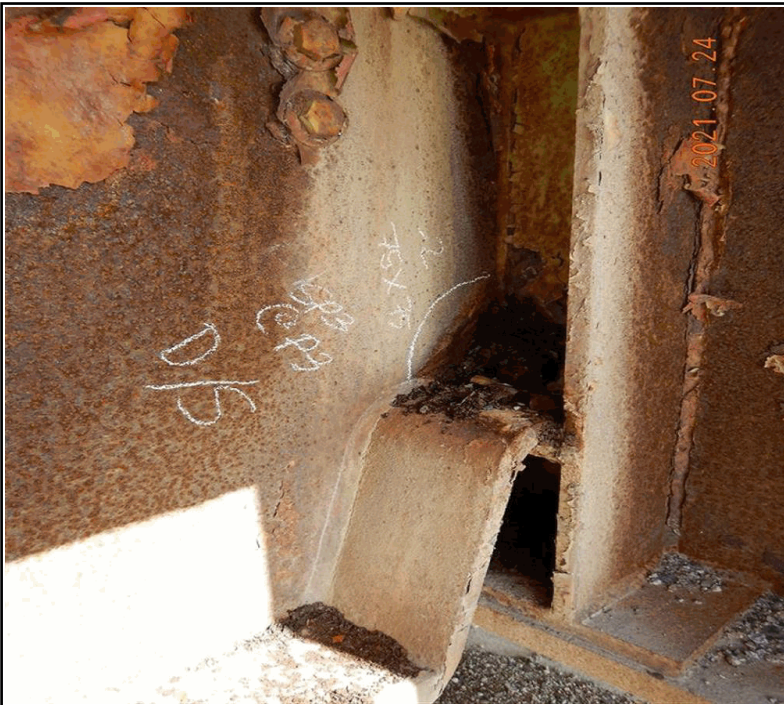
Description
Light steel corrosion of the steel girder #4 (D/S) at end, Span 3, at Pier 3

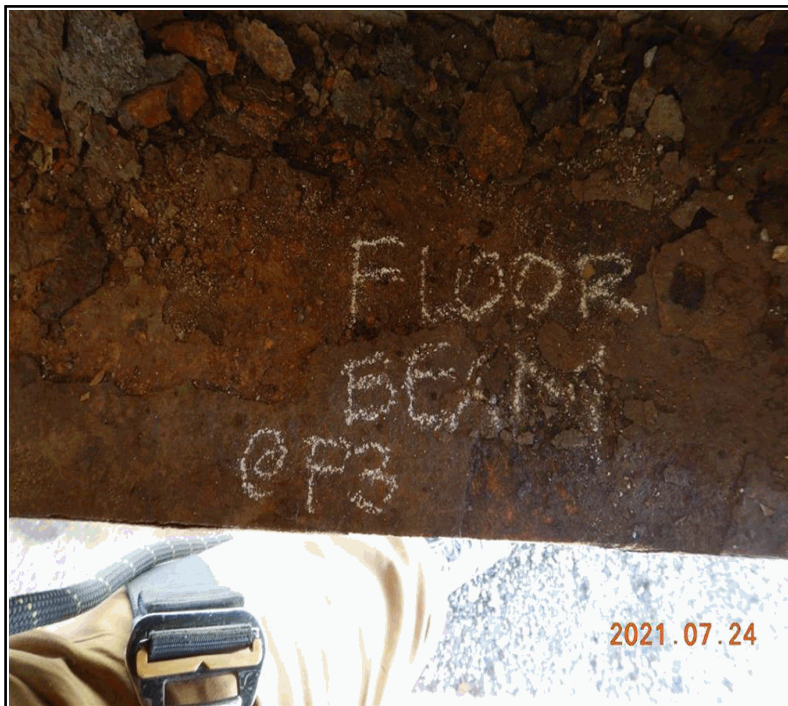
Description End floor beams at P3 has section loss of up to 1 mm on the web	
Elem Grp/Class	Beams/MLE's/Floor Beams
Elem Type	I type
Sub Element	Intermediate
Material Type	Steel
Locator	
Defect Descript1	
Defect Descript2	
Defect	
Other

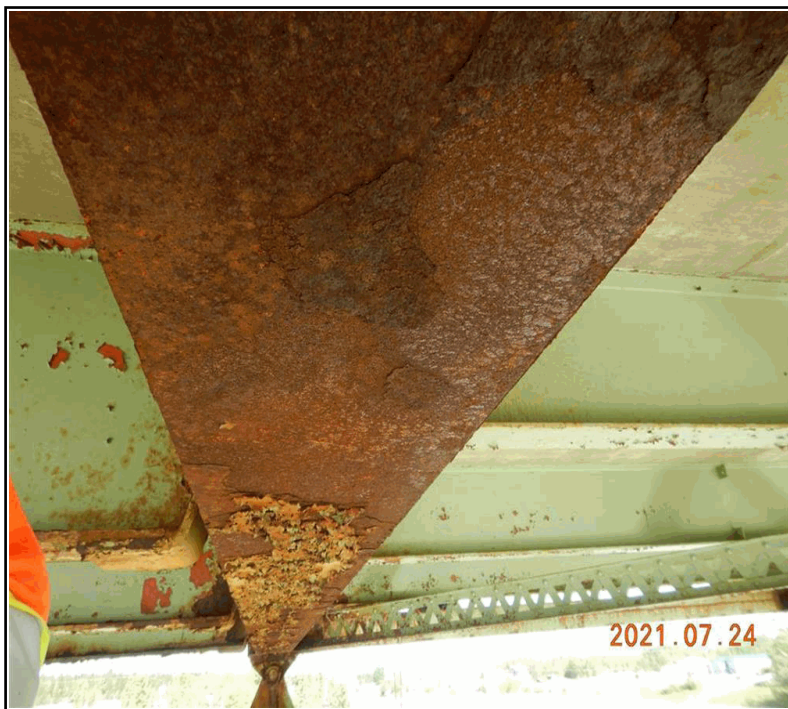
Description Coat peeled, light to medium section loss at floor beams at P3	
Elem Grp/Class	Beams/MLE's/Floor Beams
Elem Type	I type
Sub Element	Intermediate
Material Type	Steel
Locator	
Defect Descript1	
Defect Descript2	
Defect	
Other

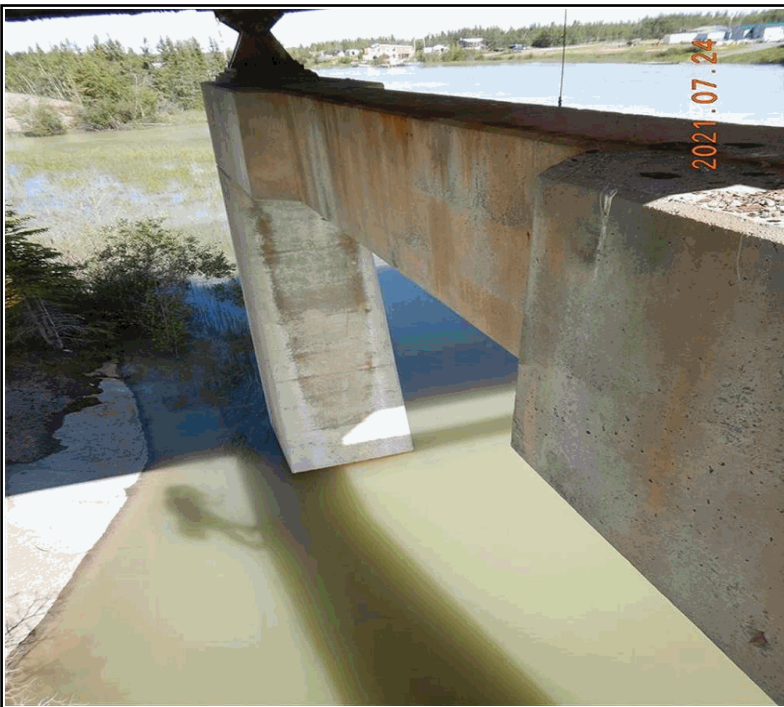
Description Concrete pier cap at P3 is in fair condition	
Elem Grp/Class	Piers/Caps
Elem Type	
Sub Element	
Material Type	Cast-in-place concrete
Locator	
Defect Descript1	
Defect Descript2	
Defect	
Other

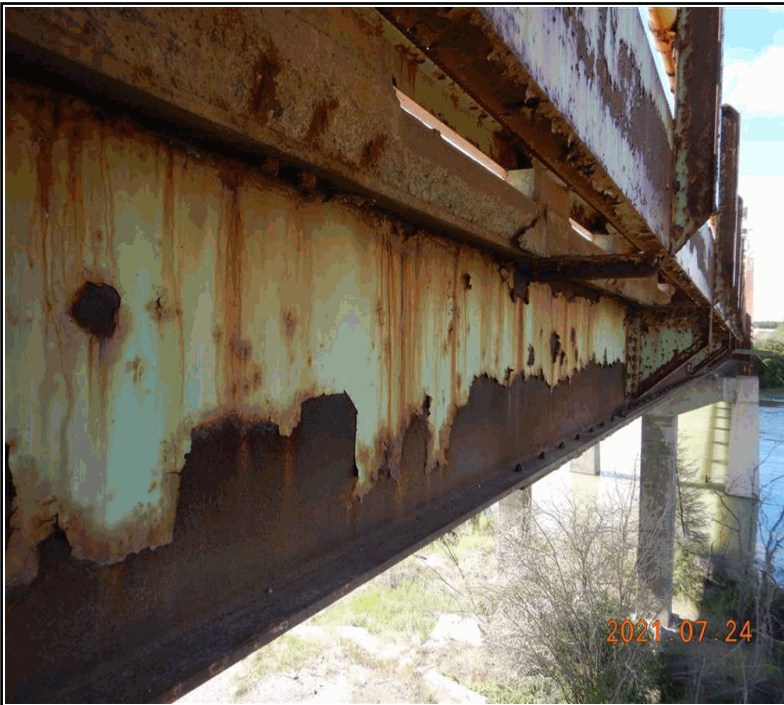
Description Coat peeling at exterior girder. Concrete spalled at deck fascia	
Elem Grp/Class	Beams/MLE's/Girders
Elem Type	I type
Sub Element	Middle
Material Type	Steel
Locator	
Defect Descript1	
Defect Descript2	
Defect	
Other

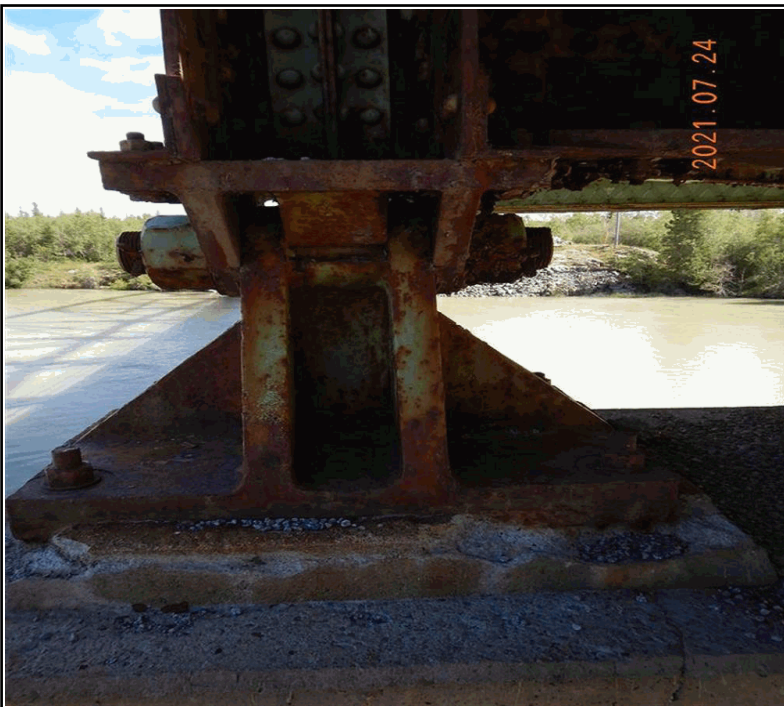
Description Rock earning at pier 3, U/S, light concrete spall of the grout pad.	
Elem Grp/Class	Piers/Bearings
Elem Type	Rocker
Sub Element	
Material Type	
Locator	
Defect Descript1	
Defect Descript2	
Defect	
Other

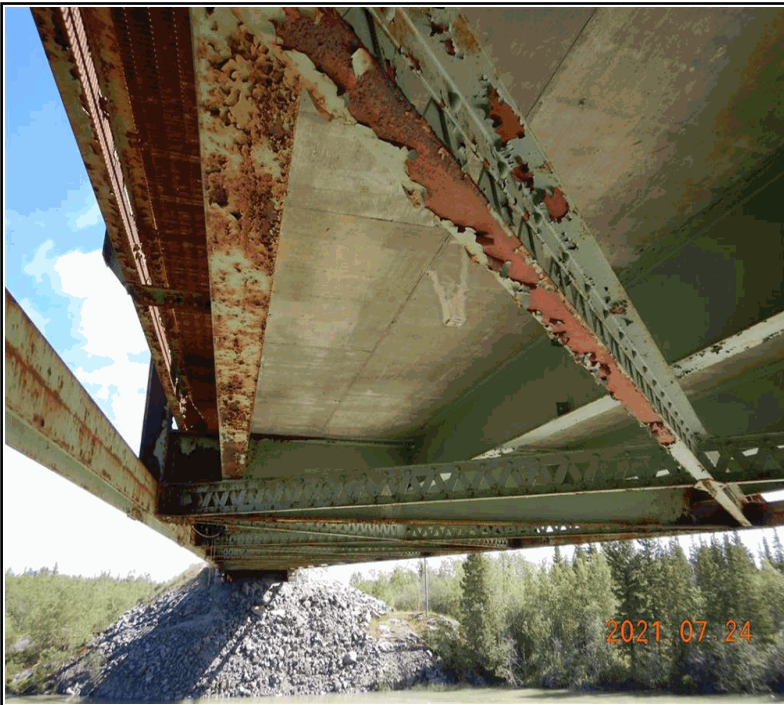
Description Sway bracing at span4 and deck soffit, typical in fair condition	
Elem Grp/Class	Bracing/Bracing
Elem Type	
Sub Element	Intermediate
Material Type	Steel
Locator	
Defect Descript1	
Defect Descript2	
Defect	
Other

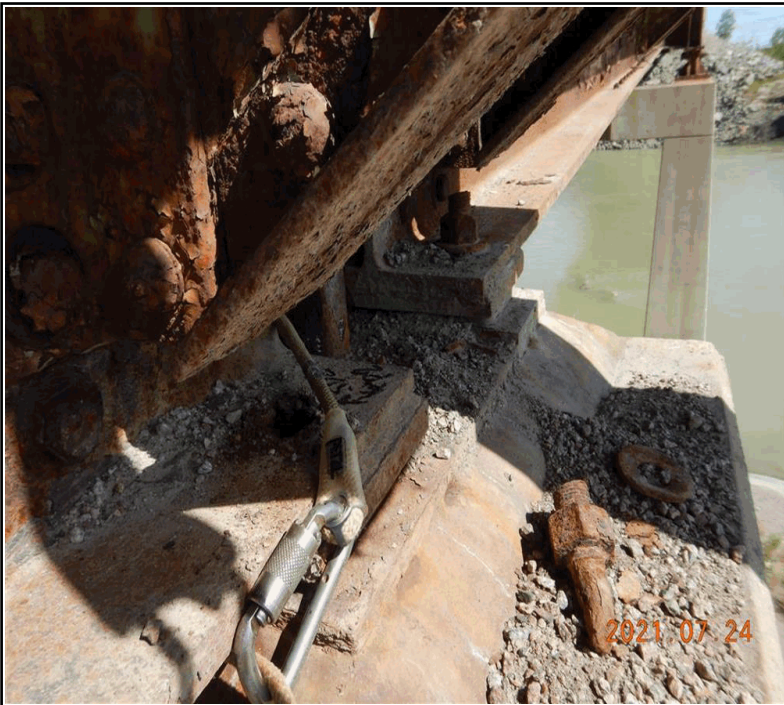
Description Steel girder anchor bolt sheared off , typical	
Elem Grp/Class	Piers/Bearings
Elem Type	Hinge
Sub Element	
Material Type	
Locator	
Defect Descript1	
Defect Descript2	
Defect	
Other

Work Category	None <input type="checkbox"/>	Minor Rehab <input type="checkbox"/>	Major Rehab <input type="checkbox"/>	Replacement <input checked="" type="checkbox"/>	
Timing	None <input type="checkbox"/>	Urgent <input type="checkbox"/>	< 1 year <input type="checkbox"/>	1 - 5 year <input checked="" type="checkbox"/>	6 - 10 year <input type="checkbox"/>
Est. Total Cost	\$30,000,000				
Comments	The existing bridge is to be replaced within 5 years. The existing bridge will be opened to traffic during construction. The bearings at Pier 2 should be monitored due to sheared anchor bolts.

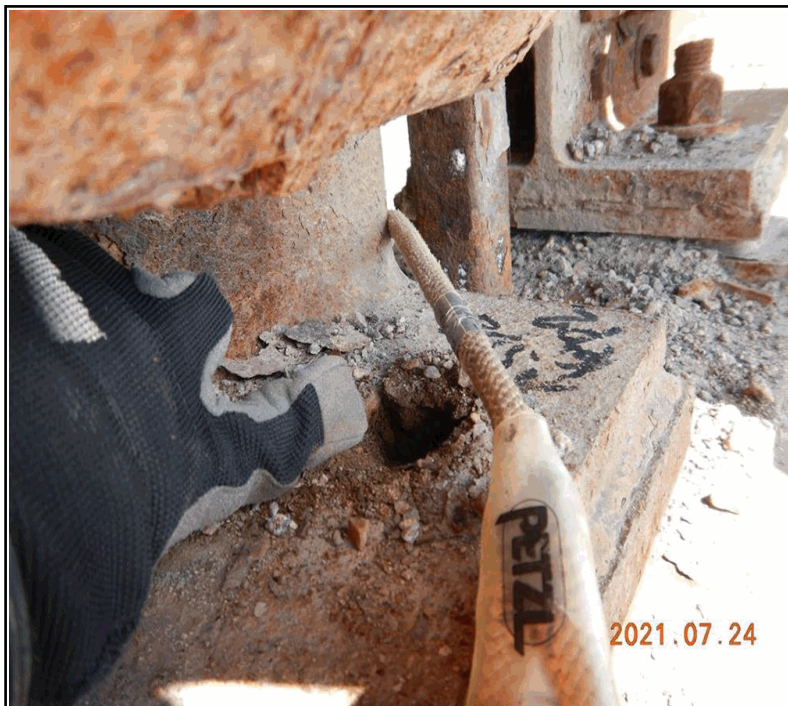
Description Anchor bolts of the steel girder bearing at Pier 2 sheared off	
Elem Grp/Class	Piers/Bearings
Elem Type	Plate
Sub Element	
Material Type	
Locator	
Defect Descript1	
Defect Descript2	
Defect	
Other

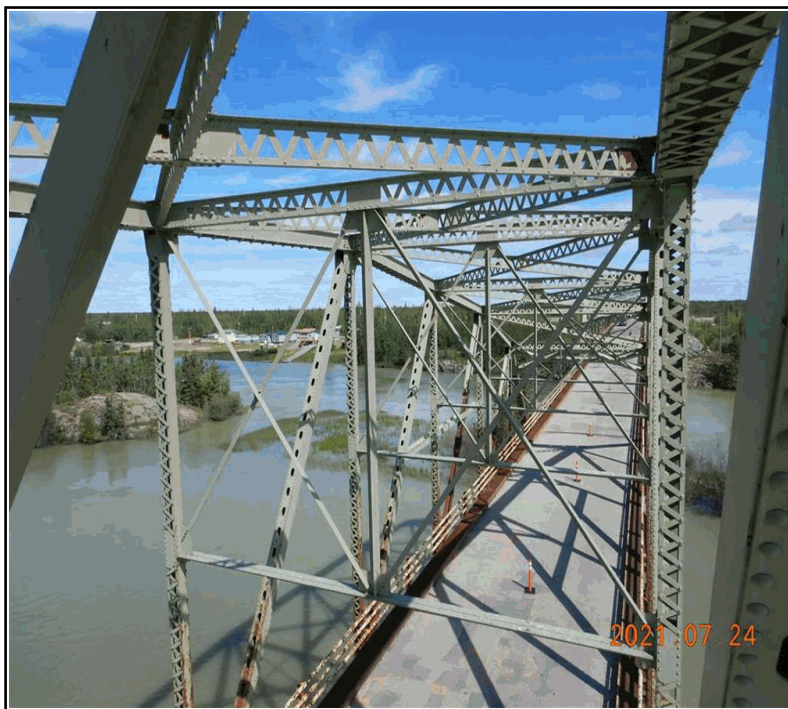
Description Looking from top, the truss elements are in good condition	
Elem Grp/Class	Trusses/Arches/Top chords
Elem Type	
Sub Element	
Material Type	Steel
Locator	
Defect Descript1	
Defect Descript2	
Defect	
Other

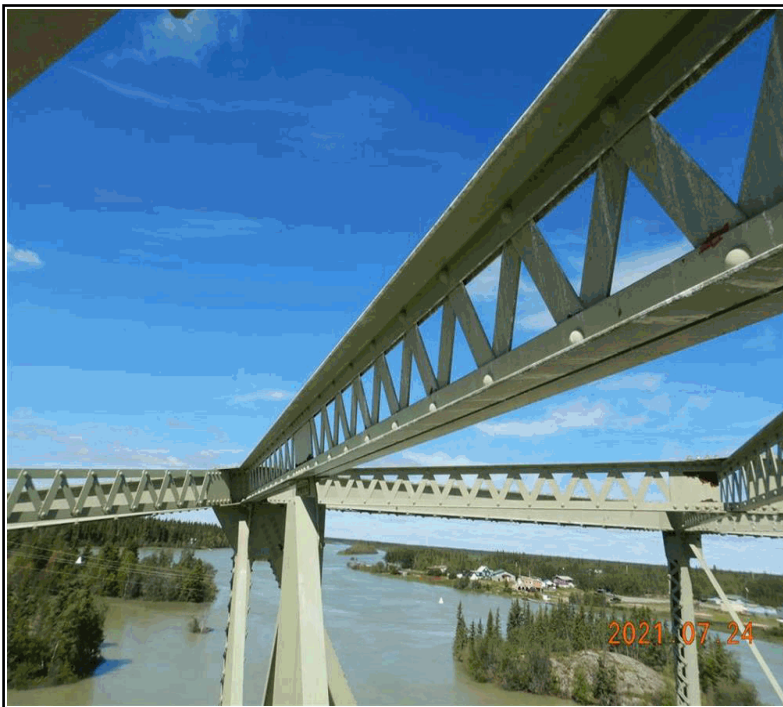
Description Braces are in excellent condition	
Elem Grp/Class	Bracing/Bracing
Elem Type	
Sub Element	Intermediate
Material Type	Steel
Locator	
Defect Descript1	
Defect Descript2	
Defect	
Other

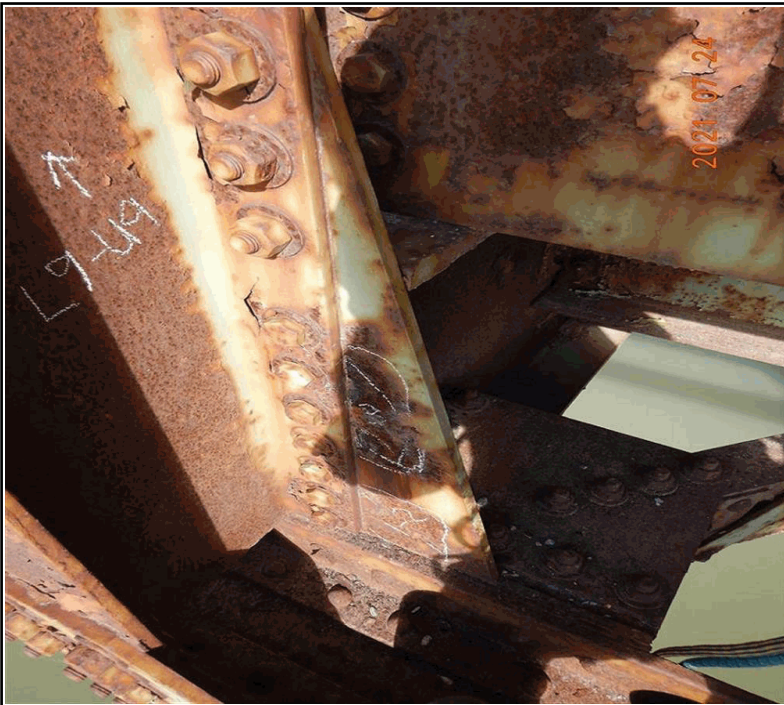
Description	
Vertical L9U9 at span1, U/S, minor section loss 1-2 mm at small area,	
Elem Grp/Class	Trusses/Arches/Verticals/diagonal:
Elem Type	
Sub Element	
Material Type	Steel
Locator	
Defect Descript1	
Defect Descript2	
Defect	
Other

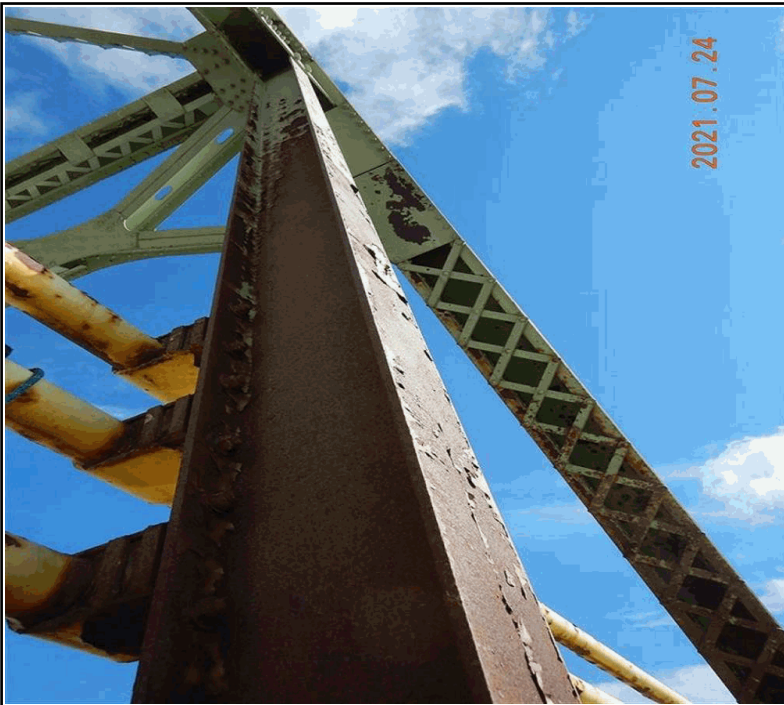
Description Typical verticals, coating fail at splash zone, minor section loss	
Elem Grp/Class	Trusses/Arches/Verticals/diagonal:
Elem Type	
Sub Element	
Material Type	Steel
Locator	
Defect Descript1	
Defect Descript2	
Defect	
Other

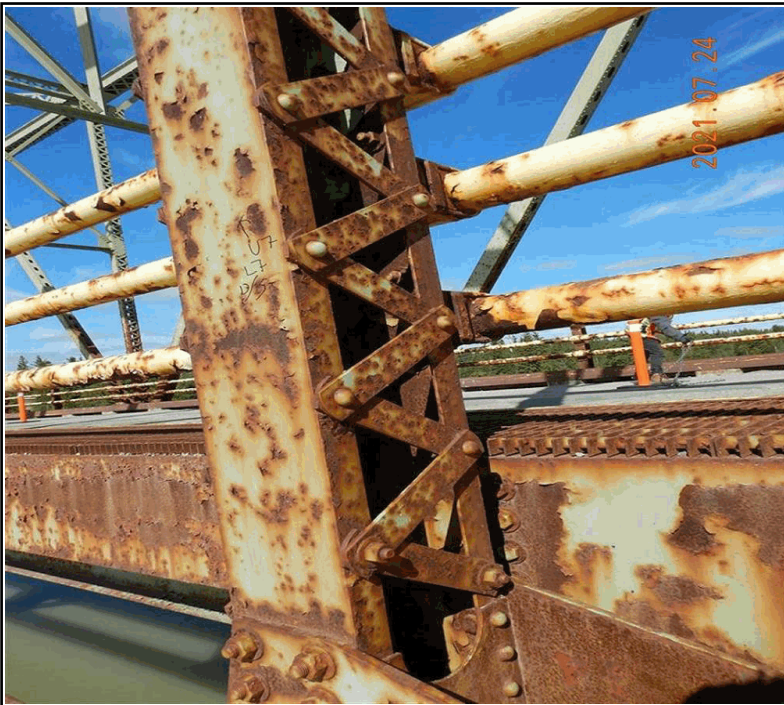
Description
Vertical U7L7, Span 1 , D/S, coating fail at splash zone, no section loss

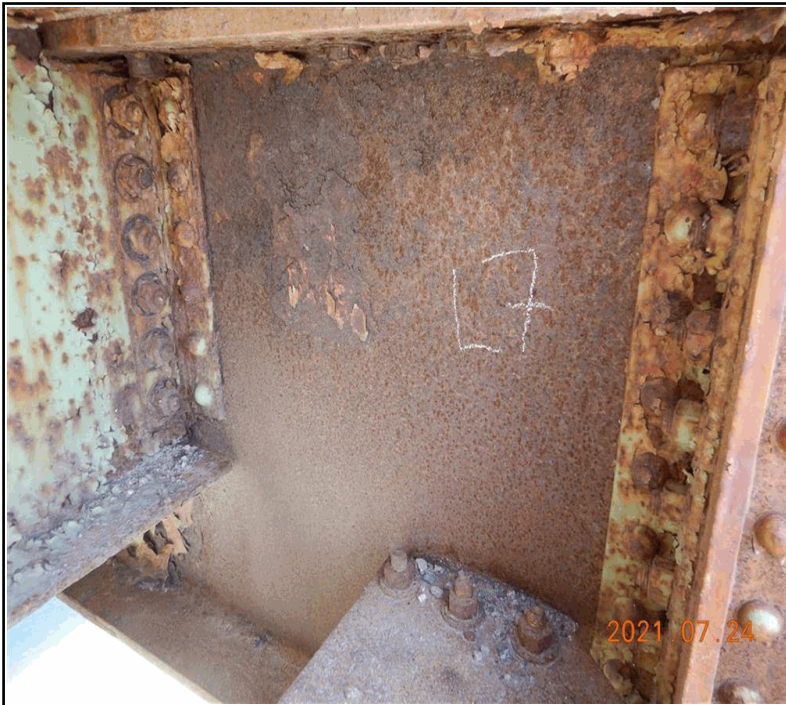
Description
Floor beam, at Span 1, L7, coating failed, minor section loss

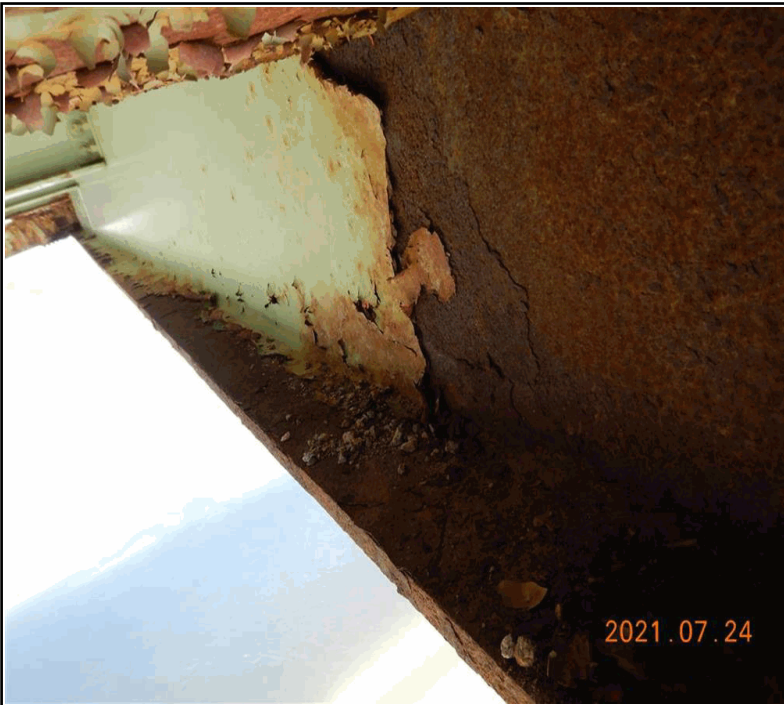
Description Intermediate Floor Beams, on one face, have severe corrosion on the bottom of the web directly above the bottom flange. Section loss is 2-4 mm	
Elem Grp/Class	Beams/ML'E's/Floor Beams
Elem Type	I type
Sub Element	Intermediate
Material Type	Steel
Locator	
Defect Descript1	
Defect Descript2	
Defect	
Other

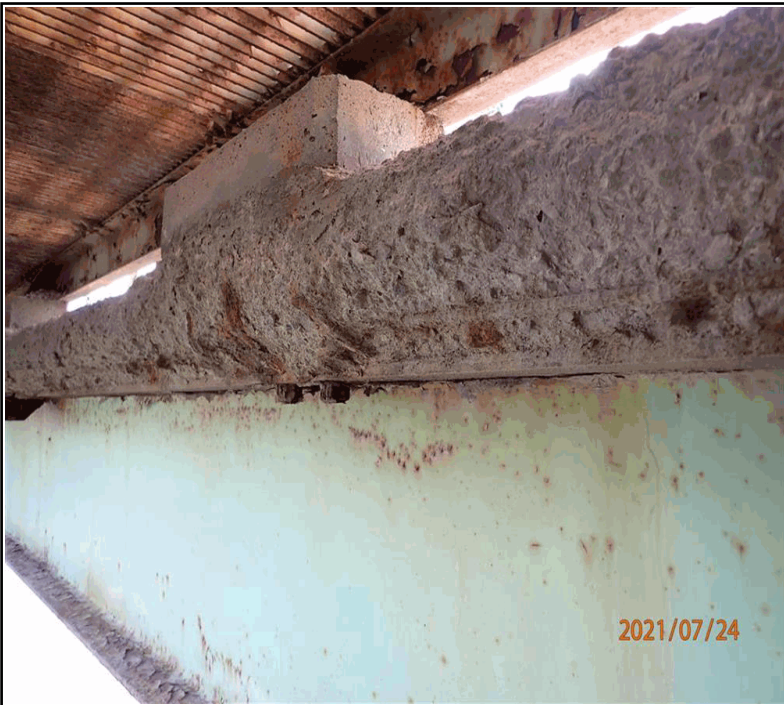
Description Concrete in the exterior soffit had severe spalls and scaling with exposed corroded reinforcement throughout	
Elem Grp/Class	Decks/Soffit - Thin Slab
Elem Type	
Sub Element	Exterior
Material Type	Cast-in-place concrete
Locator	
Defect Descript1	
Defect Descript2	
Defect	
Other

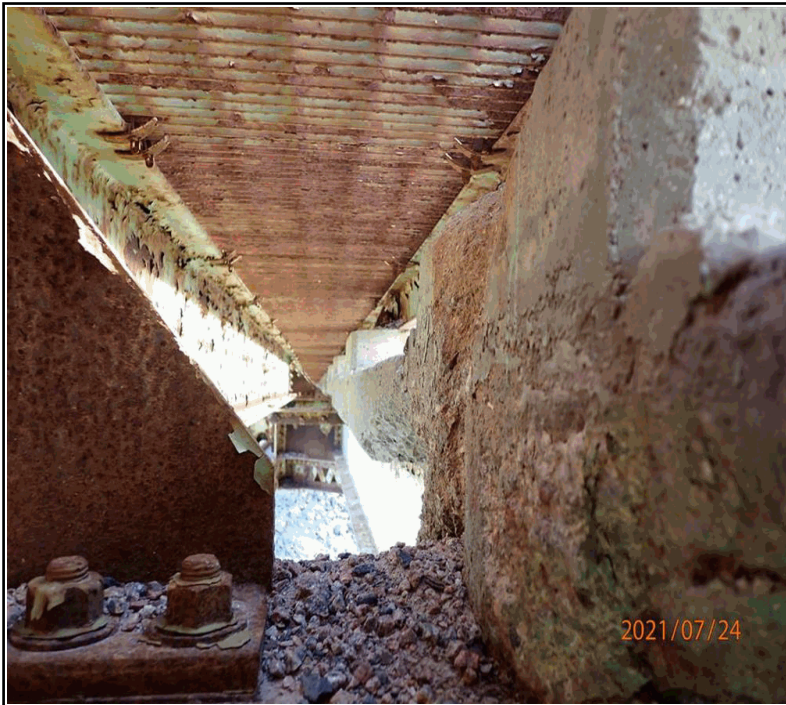
Description underside of sidewalk, steel grating, typical	
Elem Grp/Class	Sidewalks/curbs/Curbs
Elem Type	
Sub Element	
Material Type	Other
Locator	
Defect Descript1	
Defect Descript2	
Defect	
Other

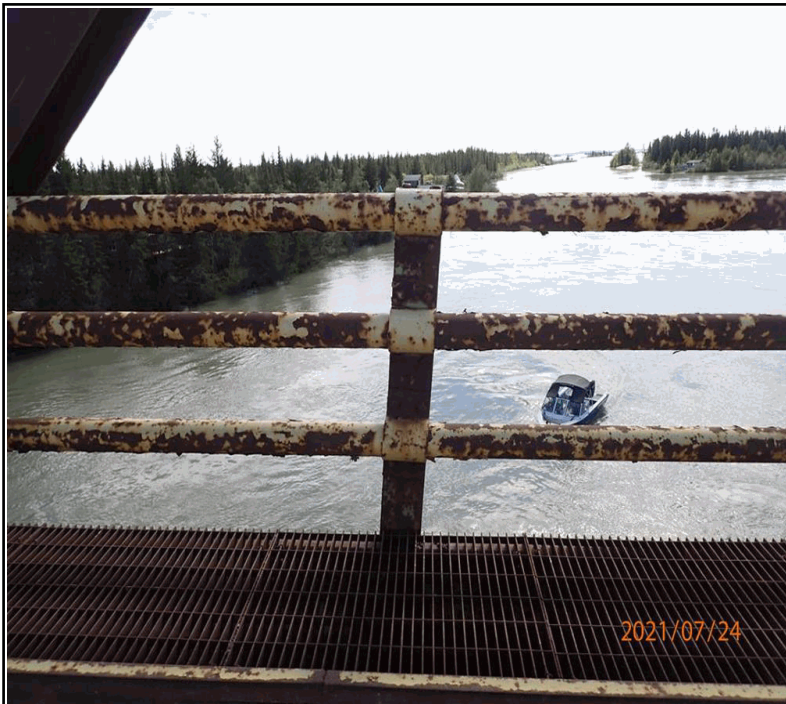
DS:100% Fair. Dent on one section @ T2 (span 4). US: 100% Fair. Paint peeling and rust, light corrosion with 0-5% section loss. Post 4 on south side of span 4 is bent to west.

Description coat peeled on the railing system and posts, typical. 8. Barrier post 4 on south side of bridge in span 4 is bent to the west.	
Elem Grp/Class	Barriers/Railing Systems
Elem Type	3 Rail Metal Railing - Steel
Sub Element	
Material Type	Steel
Locator	
Defect Descript1	
Defect Descript2	
Defect	
Other

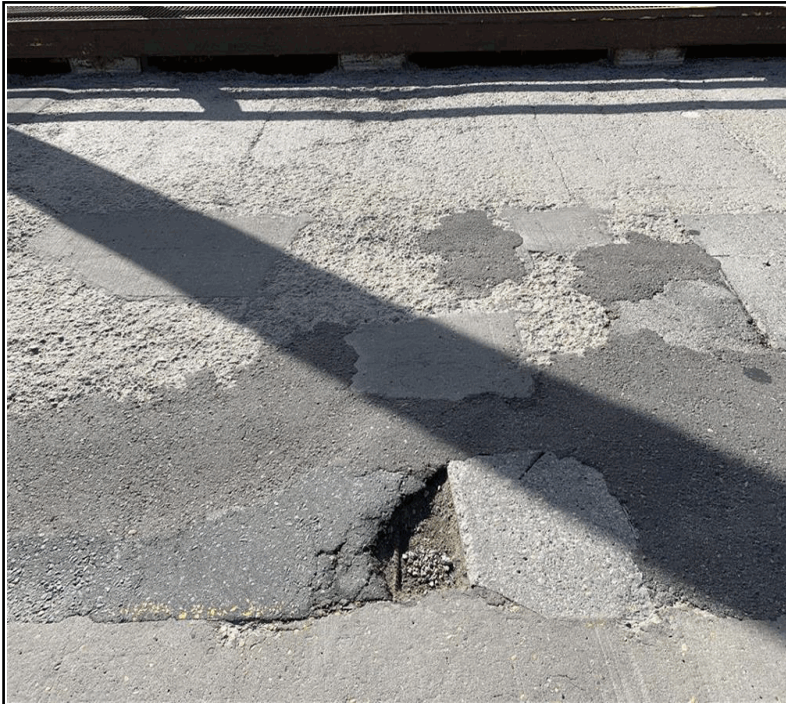
Description Concrete spalled with rebar exposed, Span 1	
Elem Grp/Class	Decks/Deck top
Elem Type	Cast-in-place concrete on supports
Sub Element	End
Material Type	Cast-in-place concrete
Locator	
Defect Descript1	
Defect Descript2	
Defect	
Other

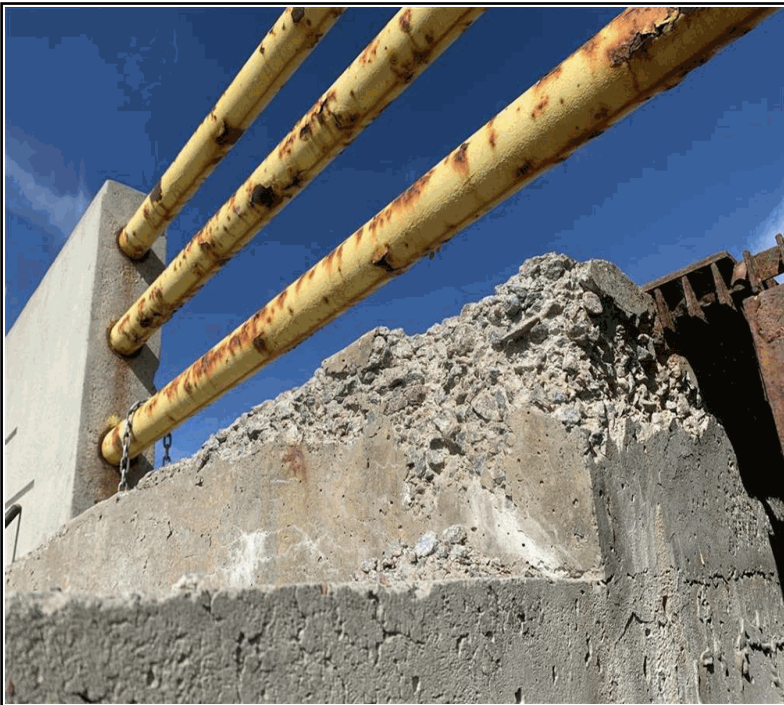
Description
Concrete spall at abutment wall

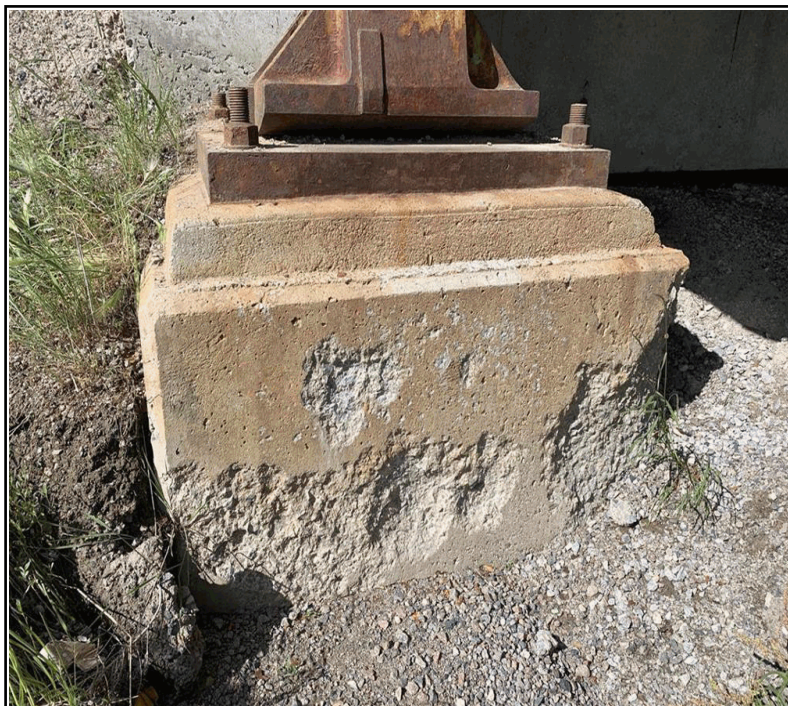
Description Concrete spall at bearing seat, Abut 1 U/S	
Elem Grp/Class	Abutments/Bearings
Elem Type	Rocker
Sub Element	
Material Type	
Locator	
Defect Descript1	
Defect Descript2	
Defect	
Other

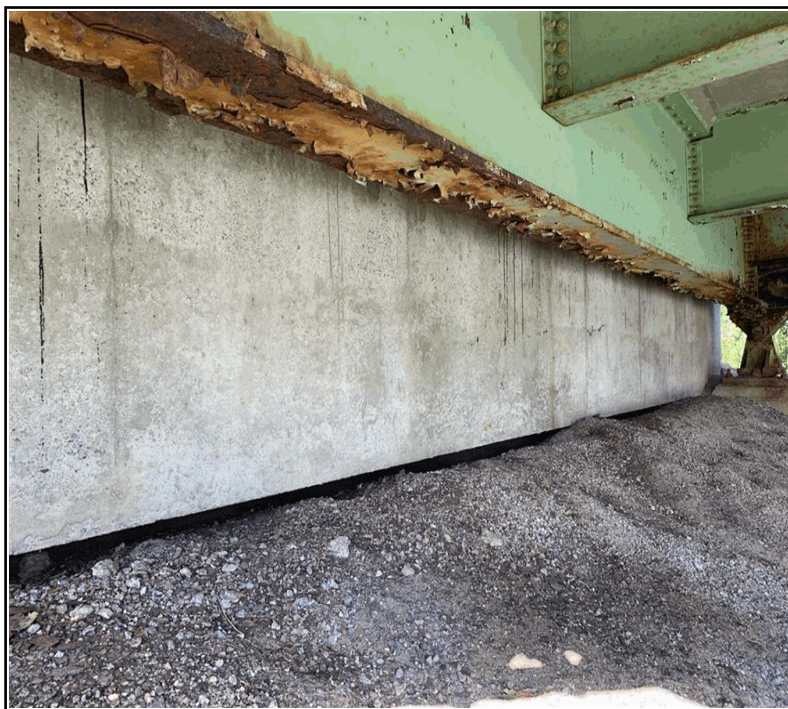
Description Abutment wall at Abut 1 is in good condition, heaslope slightly setteled	
Elem Grp/Class	Abutments/Abutment walls
Elem Type	Conventional closed
Sub Element	
Material Type	Cast-in-place concrete
Locator	
Defect Descript1	
Defect Descript2	
Defect	
Other

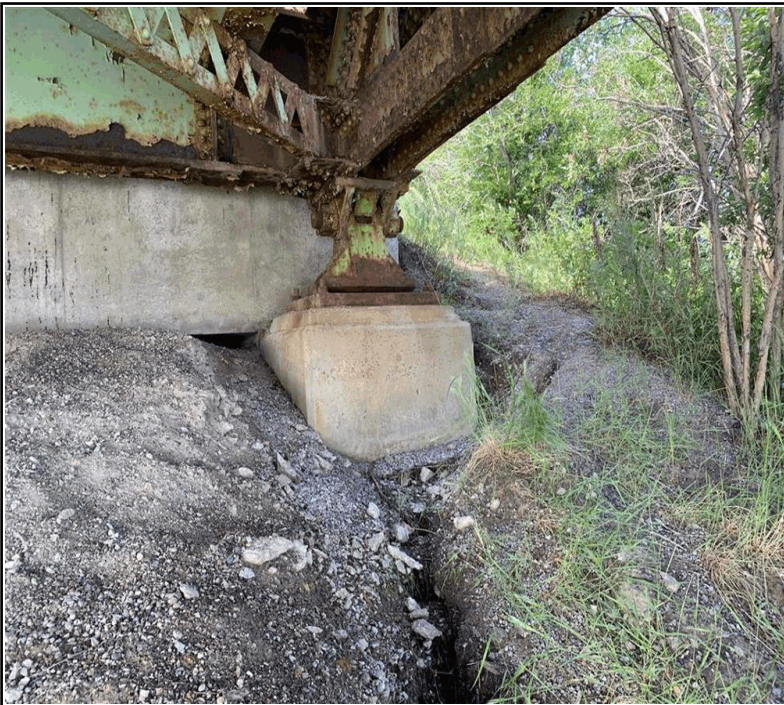
Description Gully at Abutment 1, D/S , bearing seat	
Elem Grp/Class	Abutments/Bearings
Elem Type	Rocker
Sub Element	
Material Type	
Locator	
Defect Descript1	
Defect Descript2	
Defect	
Other

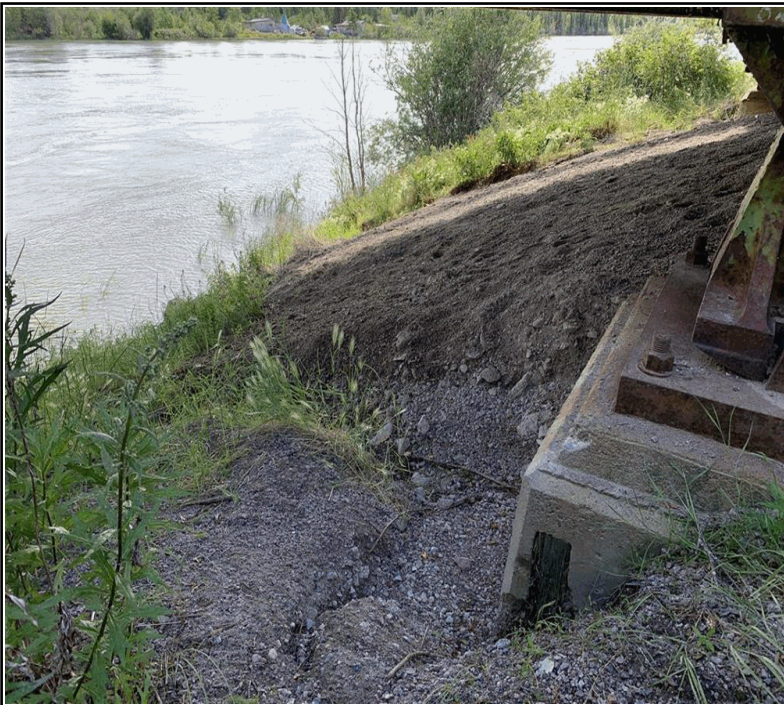
Description Headslope without slope protection at Abutment1	
Elem Grp/Class	Embankments & Streams/Slope pr
Elem Type	
Sub Element	
Material Type	
Locator	
Defect Descript1	
Defect Descript2	
Defect	
Other

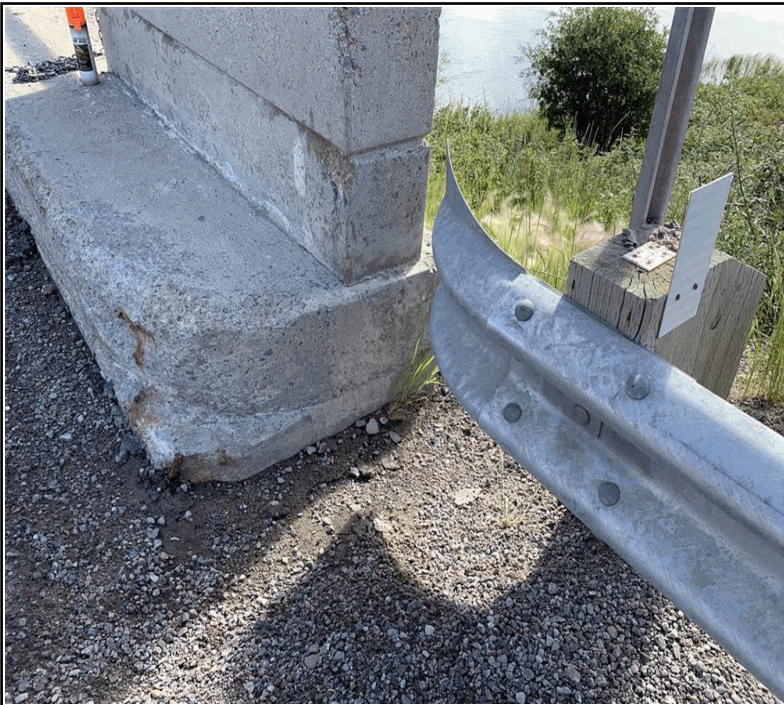
Description No connection and transition between bridge rail /parapet and W-beam guardrail at approach	
Elem Grp/Class	Barriers/Railing Systems
Elem Type	Steel Flex Beam on wood post
Sub Element	
Material Type	Steel
Locator	
Defect Descript1	
Defect Descript2	
Defect	
Other
