Government of the Northwest Territories

Bridge Inspection Form

Struct. ID	03B004
-------------------	--------

Structure Name	Frank Channel Bridge		
Structure Location	HWY003-KM00243.8		
Road Number	3	On <input checked="" type="checkbox"/>	Under <input type="checkbox"/>
Road Name	Yellowknife Highway		
Watercourse Name	Frank Channel		
Crossing Type:	Road <input type="checkbox"/>	Rail <input type="checkbox"/>	Water <input checked="" type="checkbox"/> Navigable waterway <input type="checkbox"/>
	River <input type="checkbox"/>	Other <input type="checkbox"/>	Creek <input type="checkbox"/> Pedestrian <input type="checkbox"/>
Hwy Direction	3-SOUTH/NORTH		
Owner Category			
Maint.Resp.		Northing	62.7841667
Region	North Slave	Easting	-115.94639
District		National Highway System	
Municipality		Highway Designation	
Township		Hwy Functional Classification	
Structure Category	Bridge	AADT	890
Main Struct. Subcateg.	Truss	Trucks (%)	3
Main Struct. Type	Through Truss	District Bridge Engineer	002
Deck Length (Total)	207.15 (m)	Road Authority

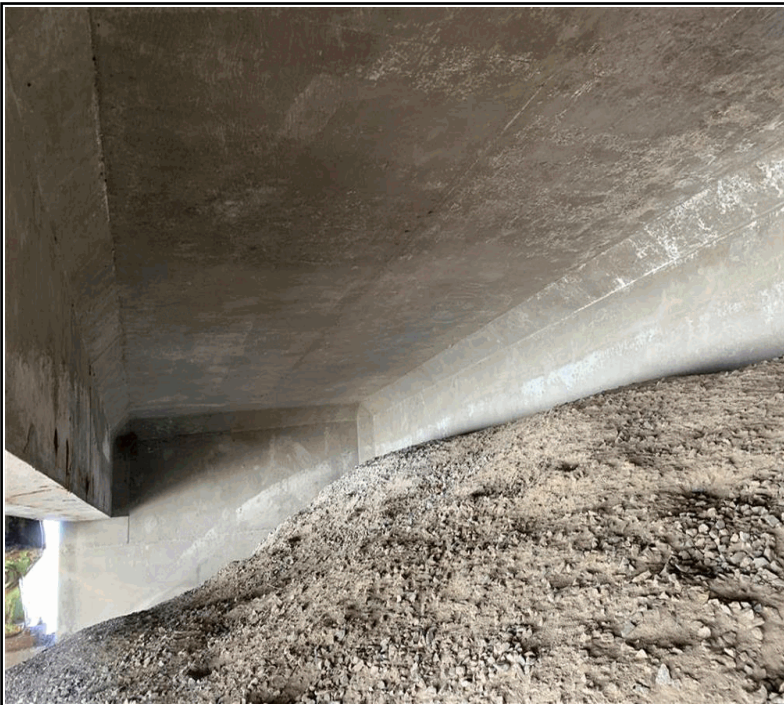
Description Abutment 2 roof slab, concrete in good condition	
Elem Grp/Class	Approaches/Approach slabs
Elem Type	
Sub Element	
Material Type	Cast-in-place concrete
Locator	
Defect Descript1	
Defect Descript2	
Defect	
Other

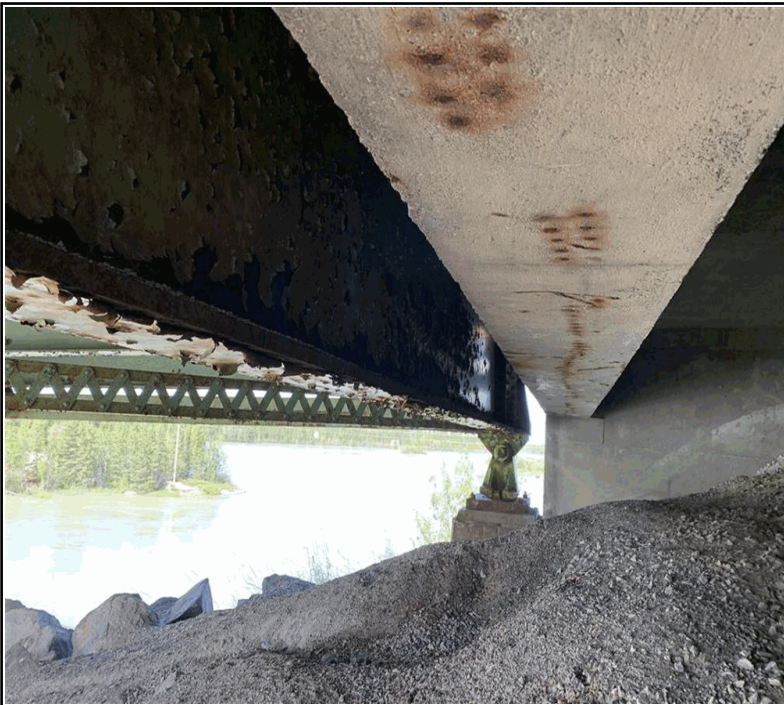
Description Stain of the rust rebar on the backwall	
Elem Grp/Class	Abutments/Abutment walls
Elem Type	Conventional closed
Sub Element	
Material Type	Cast-in-place concrete
Locator	
Defect Descript1	
Defect Descript2	
Defect	
Other

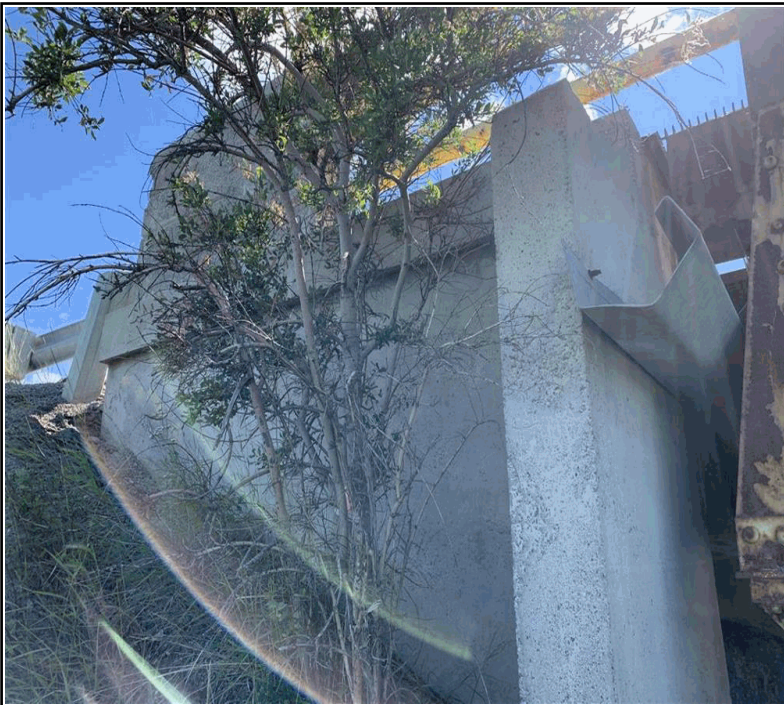
Description Wingwall at Northeast	
Elem Grp/Class	Abutments/Wingwalls
Elem Type	Reinforced concrete
Sub Element	
Material Type	Cast-in-place concrete
Locator	
Defect Descript1	
Defect Descript2	
Defect	
Other

Light scaling typical throughout, rust stains visible. few narrow horizontal cracks observed. Minor spall at South west corner.

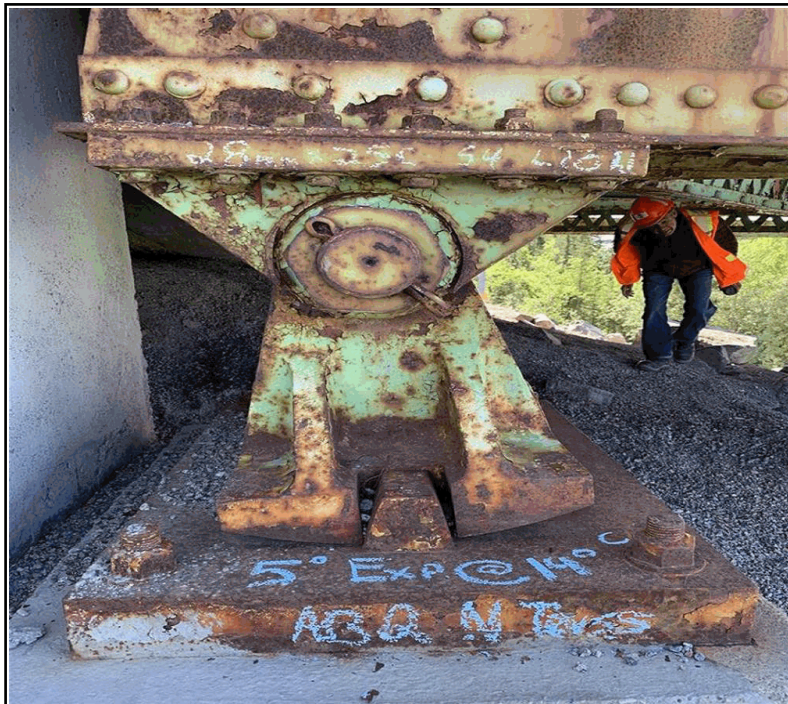
Description Bearing at Abutment 2, U/S, light corrosion	
Elem Grp/Class	Abutments/Bearings
Elem Type	Rocker
Sub Element	
Material Type	
Locator	
Defect Descript1	
Defect Descript2	
Defect	
Other

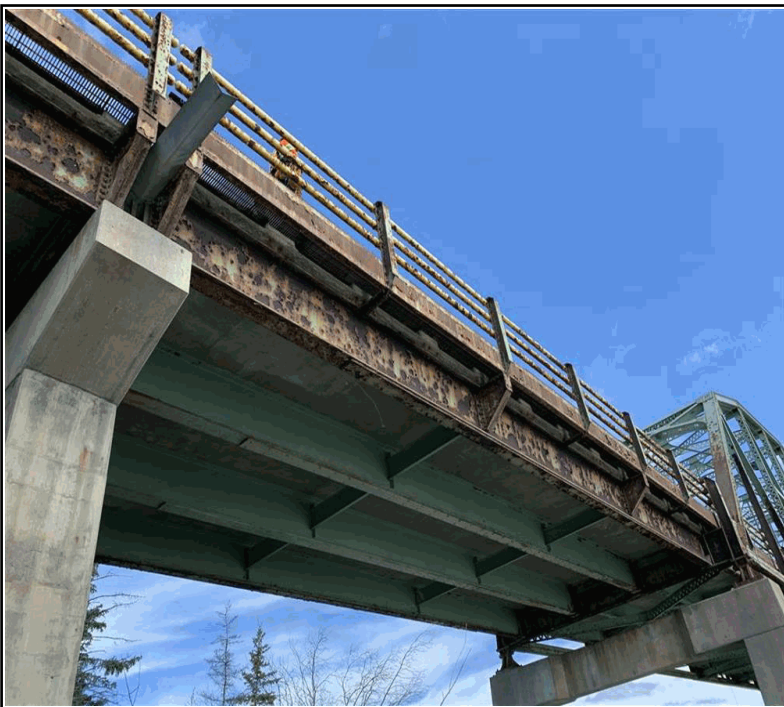
Description Span 2, typical girders and deck soffit	
Elem Grp/Class Elem Type Sub Element Material Type Locator Defect Descript1 Defect Descript2 Defect Other	Decks/Soffit - Thin Slab Interior Cast-in-place concrete

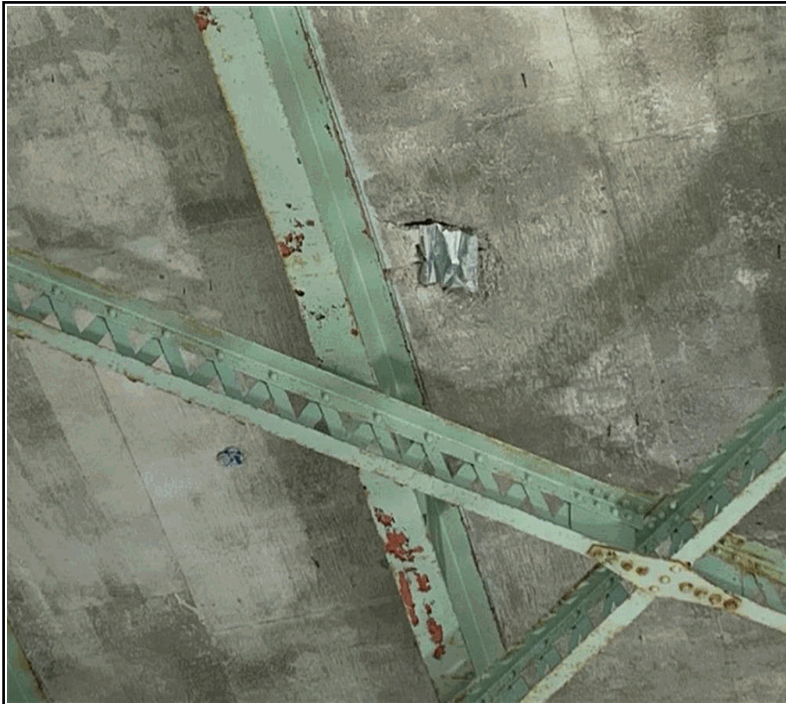
Description
Punch through hole at the span 1, 200mmx200mm, repaired

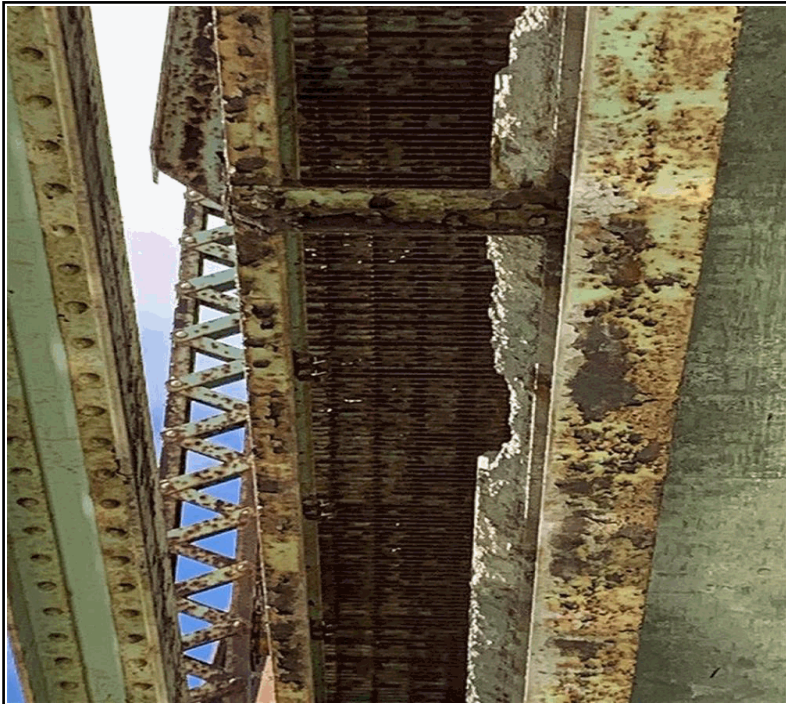
Description
Concrete in the exterior soffits had severe spalls and scaling with exposed corroded reinforcement throughout.

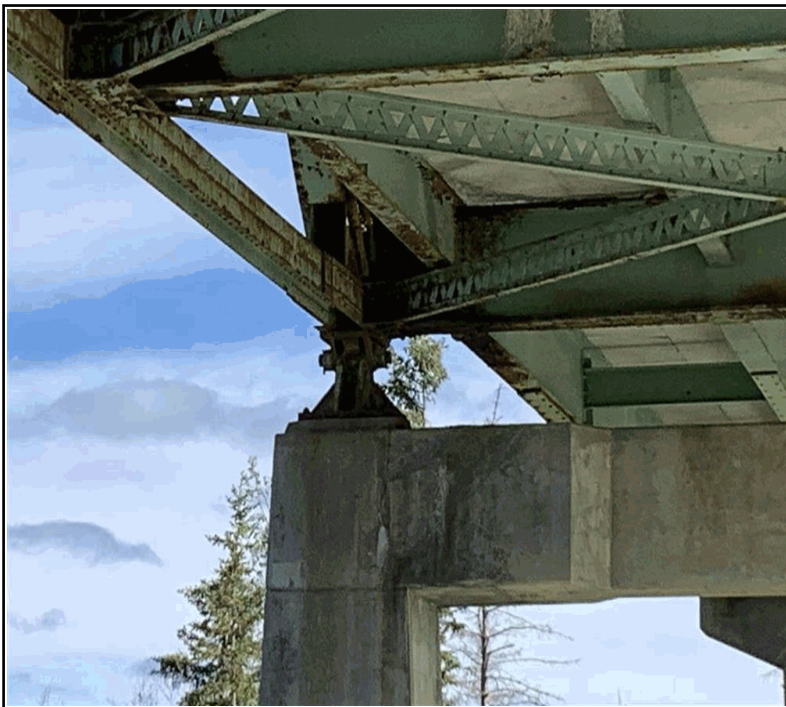
Description
Pier cap at Pier 3, concrete spalls at D/S

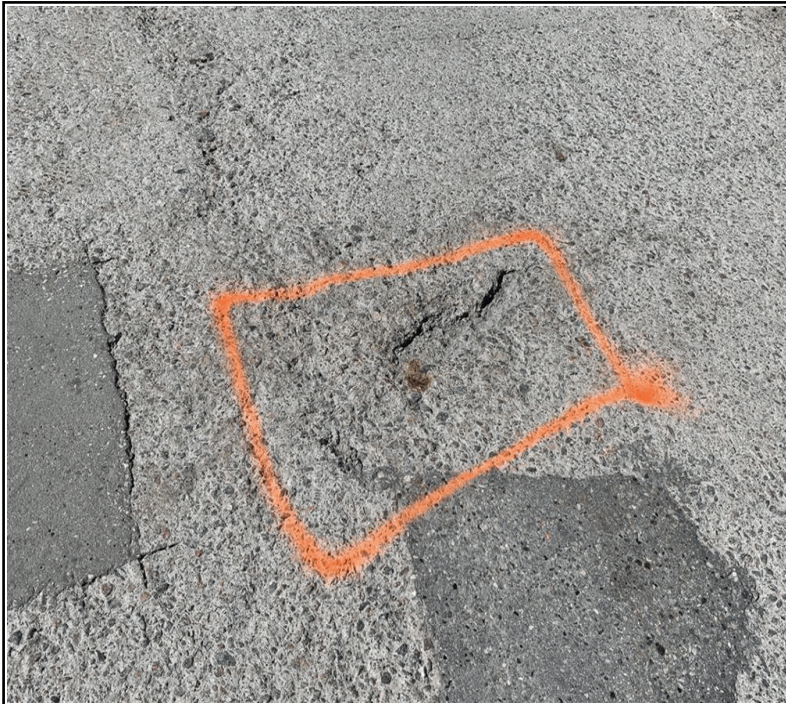
Description
Concrete spall are 300x 500mm
