Joe Greenland Centre

Aklavik, NT

TECHNICAL STATUS EVALUATION REPORT

November 2002

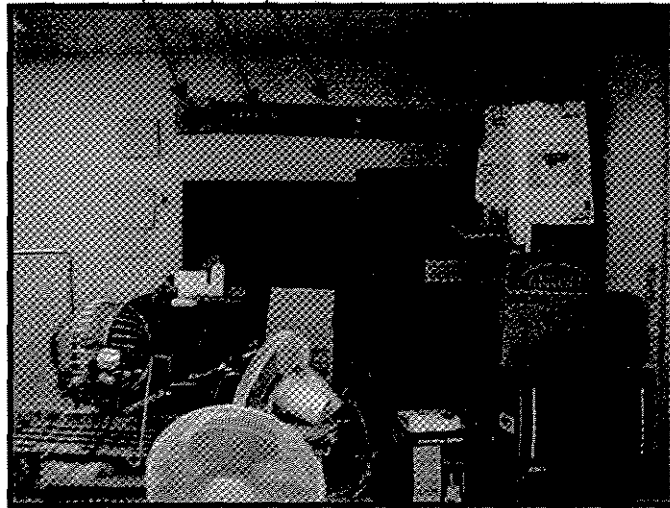
- Most room thermostats are set to the maximum temperature.
- Piping on fill line for domestic water tank is a combination of copper, galvanized iron and ABS.

Photo 1: Potable water tank fill piping.

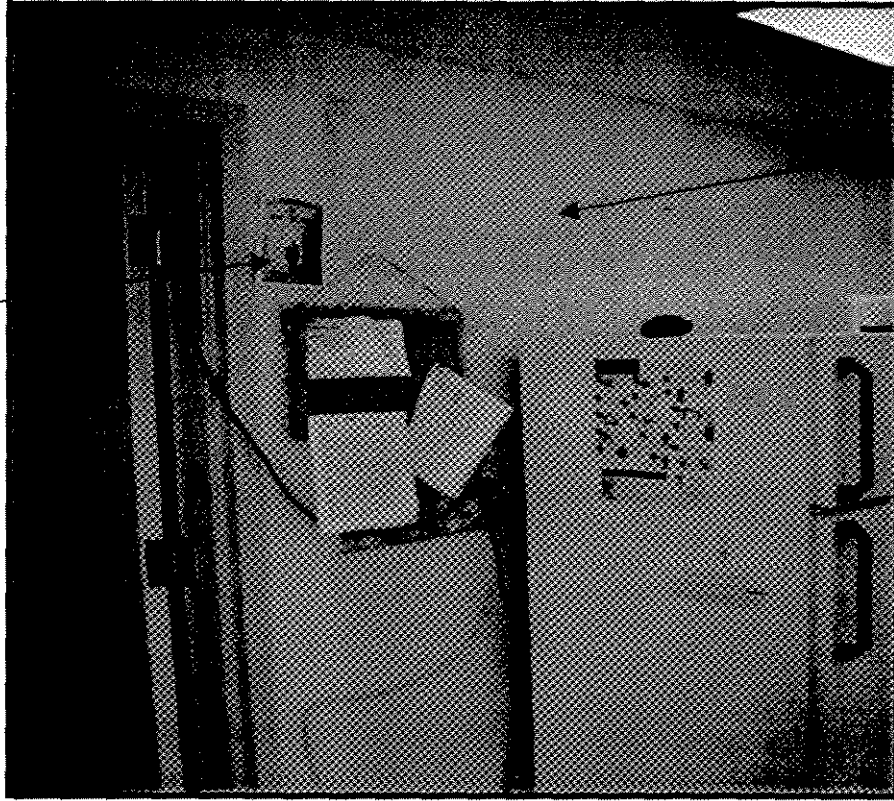
- Door is not fire rated.
- No fire extinguisher in cooking area of kitchen.
- Kitchen is very warm with no cooking taking place. Staff indicated that temperature become unbearable in the summer.
- No exhaust fan has been installed except range hood that cannot move sufficient air to ventilate this area.
- Lights in range hood do not work.
- Dishwasher has not worked for years.
- Movement cracking above door to storeroom.
- Ceiling tiles are damaged.
- Wall areas were left unpainted during renovations carried out in 1996(?).

Photo 2: Wall not painted during renovation and cord for freezer

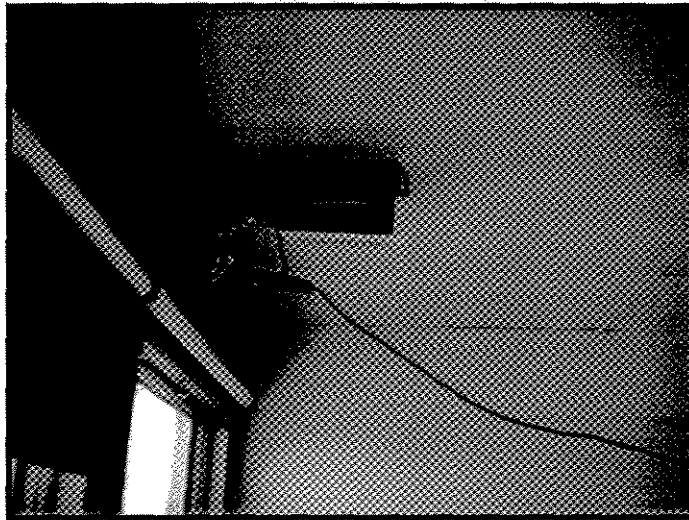
- Cable from satellite dish is running through window.
- Room is not connected to building heating system.
- Smoke exhaust is provided by a recess type bathroom fan surface mounted on the ceiling and powered by an extension cord through sliding doors.

Photo 3: Exhaust fan in smoking room

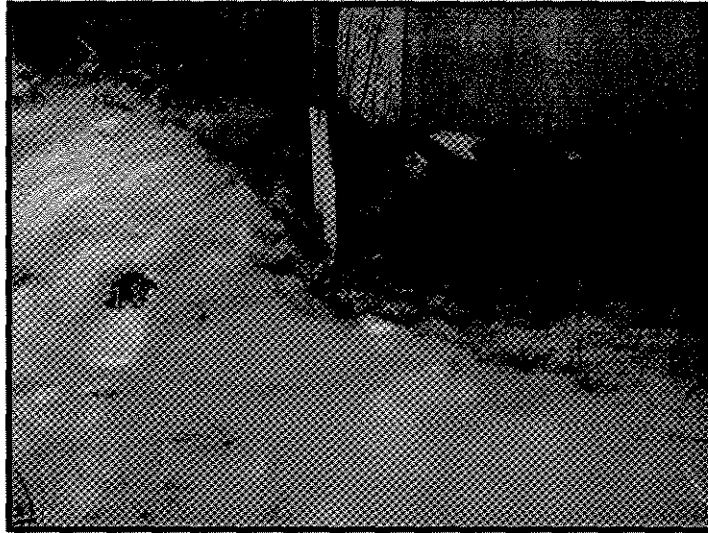
Hollows in the ground surface in the open crawl space indicate water is retained there, in some locations around piles. The crawl space is not graded to allow surface water to drain away from the building, and the finished grade of the site around the building perimeter appears insufficient to allow surface water to drain away from the building perimeter. Retained water will aid rotting of the wood piles, and reduce their service life. Once rotting piles are stabilized, replaced or remediated, better drainage will conserve their service life.

- Soffit is loose at the eave on the end wall (over water fill point).
- Access port in skirting by sewage pump-out is missing.
- Visible depression at base of exposed piles.

Photo 5: Depression at base of pile.

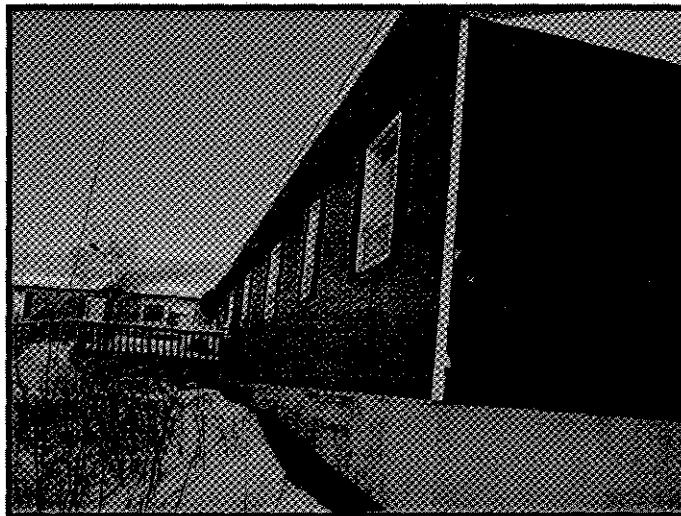
Original prefinished composition siding (Canfor "CanExel" siding visible inside the smoker's room) has been replaced at other locations of the exterior with a "Masonite" or ABTCO/ABITIBI style interlocking composition board siding. The siding is bowing and coming loose at numerous locations. Corrosion is visible on some fasteners and metal splice plates. Problems with this type of siding are the subject of current litigation in the USA. A photo from the web site

(<http://www.sidingclaims.com/abtco/damage.shtml>) tracking the litigation shows a photo typical of the condition of the product. The looseness of the siding on this building may be due to structural flexing of the wall from building movement, and inadequate initial fastening. In addition, the siding appears to have been installed without back venting (not rain screen method). Where the siding is loose, snow and rain will be able to enter behind the siding, where the moisture will corrode fasteners and cause deterioration of the wood fibres in the material.

Photo 6: Loose siding.

As part of routine building repair and maintenance, re-nail the siding where it has come loose from the wall. As part of any major renovation of the building, include for replacement of the siding with a more durable product mounted on the wall with the rainscreen method so it can dry by natural ventilation.
