**EMD PLANT DAY TANK FILL SYSTEM
OVERFILL INCIDENT INVESTIGATION**

Tim Farrell, P.Eng.
October 26, 2004

Jackfish Lake EMD Plant Fuel Overfill

Jackfish Lake EMD Plant Day Tank Fill System
Overfill Incident September 22, 2004

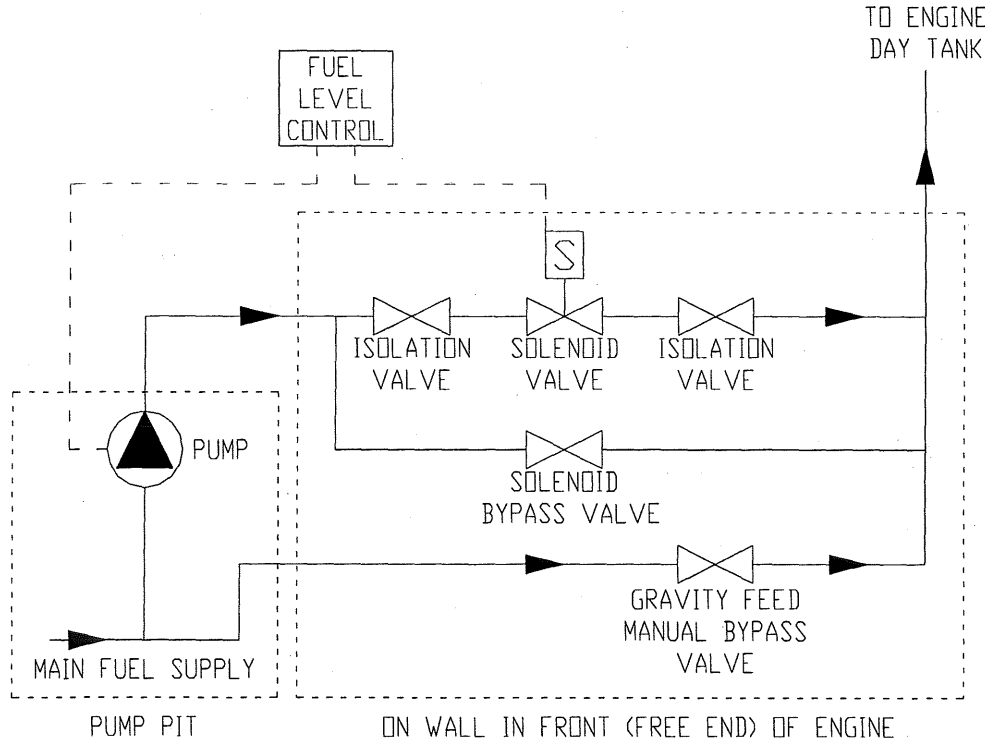
Figure 1 - Day Tank Pump and Bypass System

The main supply tank, when full, can provide sufficient head to gravity fill day tanks in the EMD Plant. Available head is sufficient to cause complete filling of vent stack, and subsequent spilling of fuel. Each engine fuel delivery system is fitted with a solenoid valve which opens on call for fuel, allowing the pump to fill the day tank, and then closing to prevent siphoning from the main supply tank. The solenoid valve also provides protection from overfill in the event that the pump motor starter contacts do not open when pump control stops the pump. A solenoid bypass valve allows manual bypass of the solenoid valve for maintenance purposes.

The plant is also equipped with a bypass manifold, allowing each individual fill system to be gravity fed from the main tank. Each bypass is operated by a single 1" gate valve. This valve is

unlocked, and no procedures are apparent for the manual fill operation. See Figure 1 above. Also see photos 1 and 2 in Appendix A.

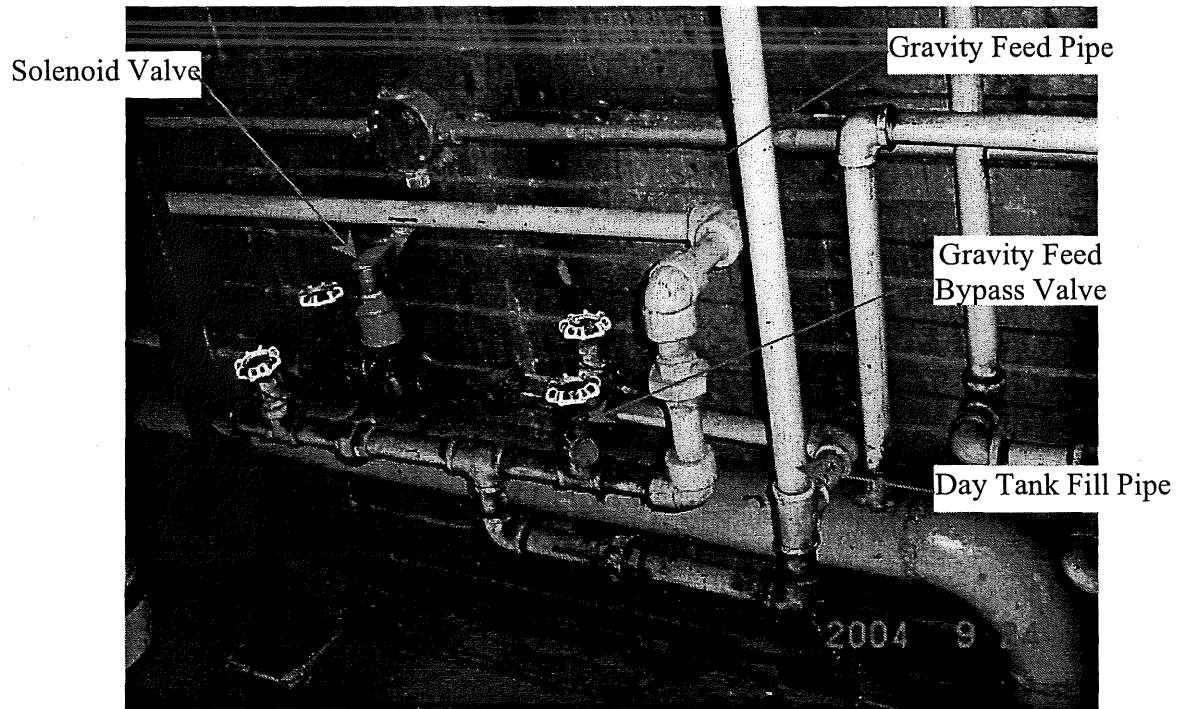
Figure 1 - Unit G8 Fill System Solenoid and Bypass Group

Unit G8 was out of service during the entire period, with all power disconnected or locked out. Therefore, the fuel transfer system for Unit G8 is not considered to have contributed to the overfill incident. Unit G8 is directly beside Unit G5. The vent connection from G8 to the common horizontal vent manifold is also beside the connection from G5. It is thought at this time that the day tank on G8 filled through the vent line from the overfill of G5.

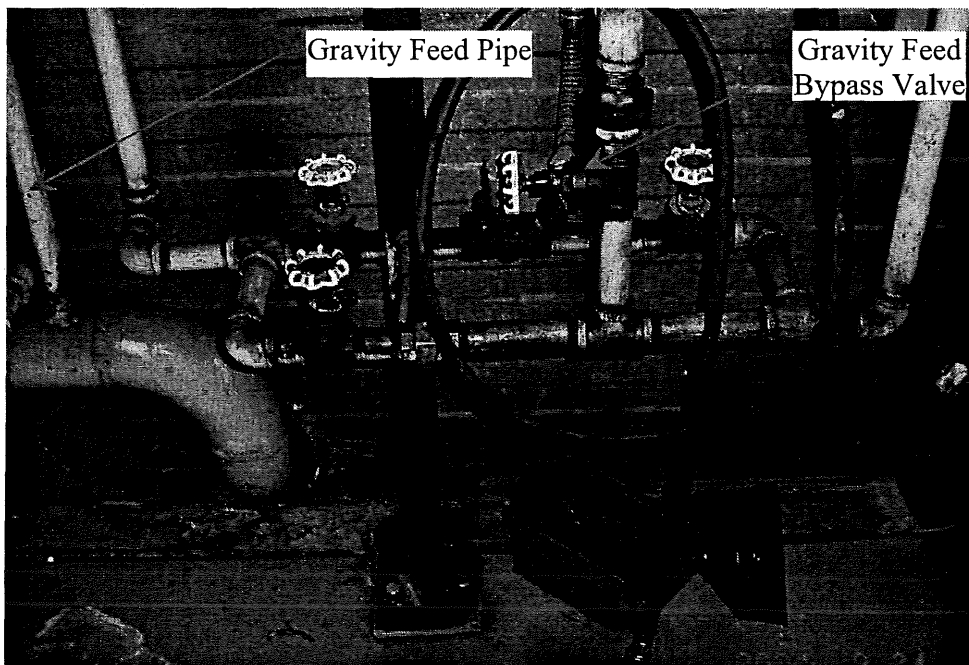
Figure 2 - Unit G5 Fill System Solenoid and Bypass Valve Group

Overfill by gravity feed may also result from leakage at one of the manual bypass valves, or failure of a manual bypass valve to be fully closed after a manual fill operation. There is evidence of a manual gravity feed operation being carried out shortly after the pump failure alarm on September 20. Had the valve been improperly closed at that time, a spill would have occurred overnight September 20/21. There is no evidence at this time of a manual fill being carried out after the September 21 pump fail alarm. However, with a substantial amount of activity in the area of the bypass valves on the evening of September 21, during the time personnel were investigating the second pump failure alarm, it is possible that one of the valves for G5 or G8 was accidentally cracked open by a passing body, tool box, or something similar. It appears by the estimated flow rates that this would have occurred shortly after September 21 pump failure alarm.

The present piping set-up allowing for manual bypass of the transfer pumps and gravity fill of individual tanks will be reinforced by the addition of a second bypass shut-off valve, in series with the original single valve. Recommendation is for a lockable ball valve, locked in the closed position. Proper fuel transfer procedures will be put in place for the operation of this valve, providing control over the use of the manual fill system, and instituting a system of checks for insuring the system is properly locked out after use. As an interim measure, lockable valve guards have been placed on all manual bypass valves.

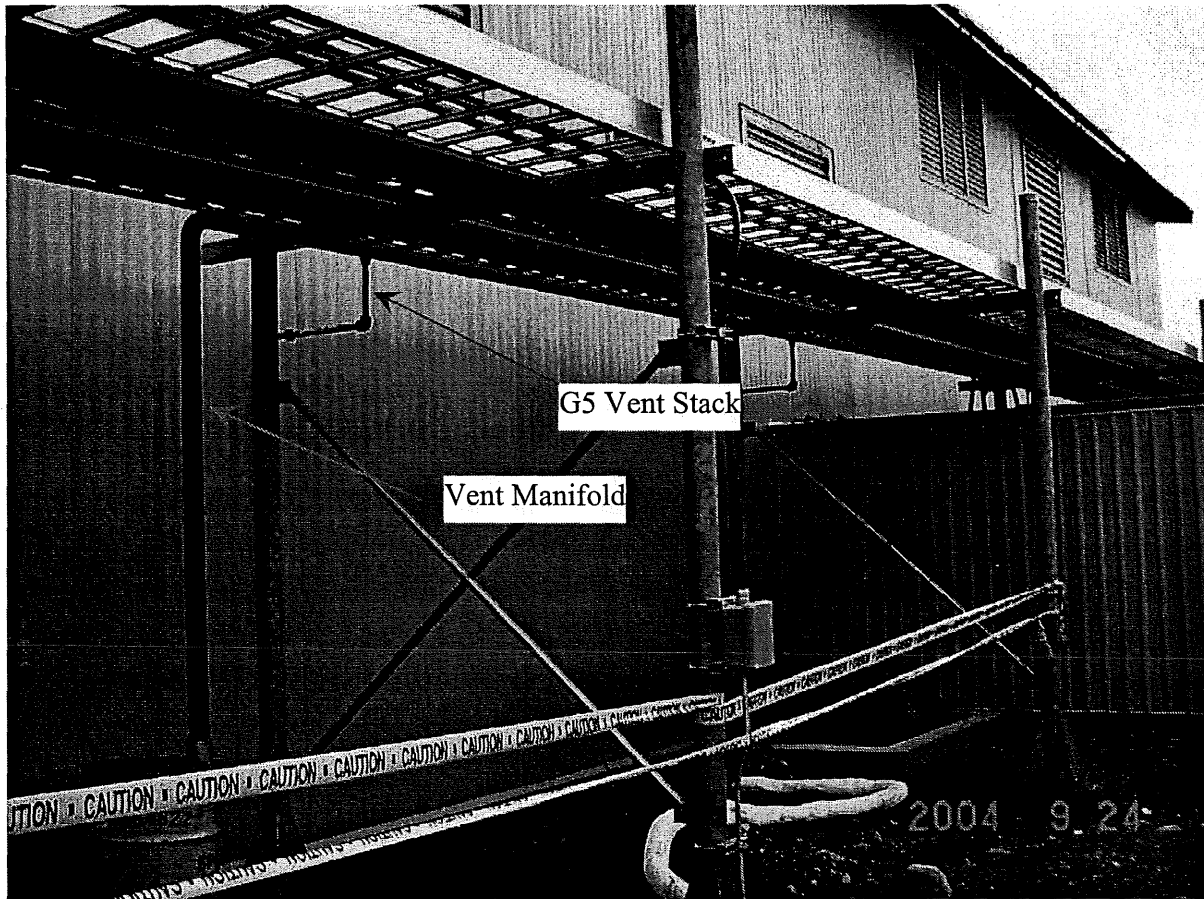
Figure 3 - EMD Plant Vent Manifold

Each day tank is fitted with a ¾" NPS vent stack, which extends upwards from the tank, then horizontally through the plant wall, and vertically into the bottom of a 3" NPS common vent manifold. The vent manifold has an elbow at the end, with a vertical section draining into a lined 45 gallon drum.

In the event of an overfill resulting in fuel in the vent manifold, fuel will spill into the 45 gallon drum as well as spill into the other day tanks.
