Jean Marie River Well Inspections

Jean Marie River, NT, July 21-23, 2014

The Office of the Regulator of Oil and Gas Operations

December 4, 2014

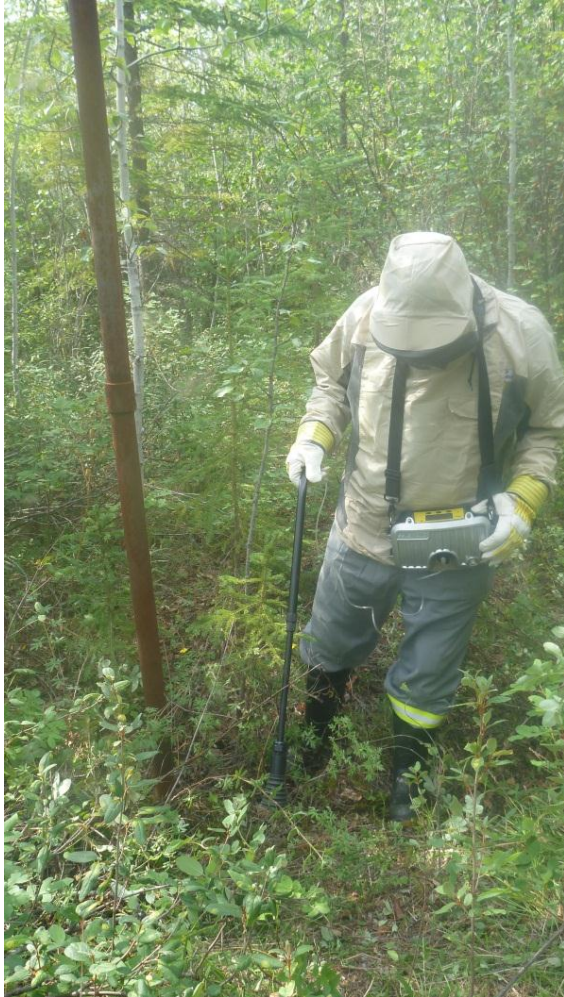
Photo 3: Jean Marie J-52 Well

The well is surrounded with secondary growth and located on solid ground (approximately 25m radius). Beyond the well site is muskeg and dense vegetation. The well site was located by local guide (Mr. Ernest Hardisty). The site was situated on solid ground at the edge of a muskeg clearing. The well was marked with a 2.5m steel pipe (5cm diameter) welded to the cap. The well site can be seen in photo 3, with additional photos in Appendix B.

Monitoring was conducted using a Portable Methane Detection unit (PMD). The ground surface was tested using the PMD wand, no methane was detected within proximity of the

wellbore. The soil was also tested for methane using monitoring cups⁵ in several locations surrounding the casing. No evidence of methane was present.

A visual inspection showed signs of healthy vegetation in all surrounding areas. There was no apparent evidence of vegetation stress. A 0.75m section of hydraulic hose was discovered approximately 15m from the well site (photos in Appendix B).

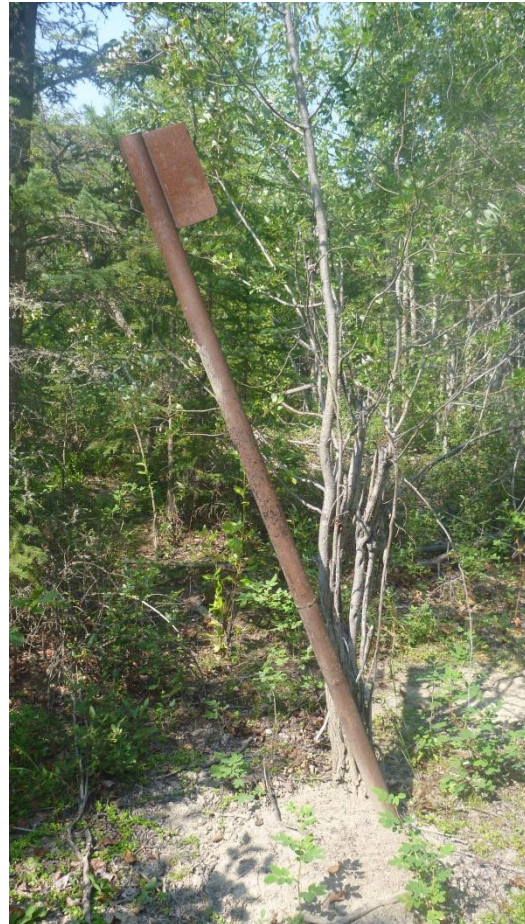
Photo 4: Jean Marie B-48 Well

From the air, the well seemed to be located in a flat open area, however, at ground level, the area was vegetated with willows and smaller shrubbery. The well marker was discovered to be surrounded by a large ant hill. The 2m steel pipe identifying the well was at a slight angle (see photo 4).

The wand was then held on top of the steel marker pipe and a peak reading of 500 ppm of methane was taken. To obtain a gas sample, the top of the pipe was taped shut for five minutes and a sample was then collected. A very small amount of gas was released when the tape was lifted, and the gas quickly dissipated. A forward looking infra-red (FLIR)⁶ camera was used to observe the gas exiting the pipe. The volume of gas released was extremely small, making it difficult to capture the release on the FLIR camera.

Gas samples from the B-48 well marker were collected and forwarded to GCHEM Ltd. for analysis, characterization and classification. High resolution compositional analysis (HRCA) of the soil gas samples indicated the presence of elevated (above expected baseline) levels of light alkane hydrocarbons⁷. This well is impacted by leaking natural gas from a thermogenic source⁸. The gas samples were highly degraded by the time they arrived at the laboratory, potentially as a result of active microbial activity. Therefore, a particular geologic formation from which the gas originated could not be determined.

be connected in a way that would allow gas to escape through the marker. It is curious as to where the gas in the steel pipe could be originating. Given the fact the marker pipe was at a slight angle, the pipe may have detached from the steel plate.

All but one of the wells tested during the subject inspections had zero readings of methane. For Jean Marie B-48, the findings on July 21 recovered a very small amount of methane gas. Given that the well is in a remote area and the volume of gas detected is extremely low, the current situation is a low risk to public safety and environmental impact. Further testing is recommended to confirm the source and determine if the rate of release of gas varies with time.

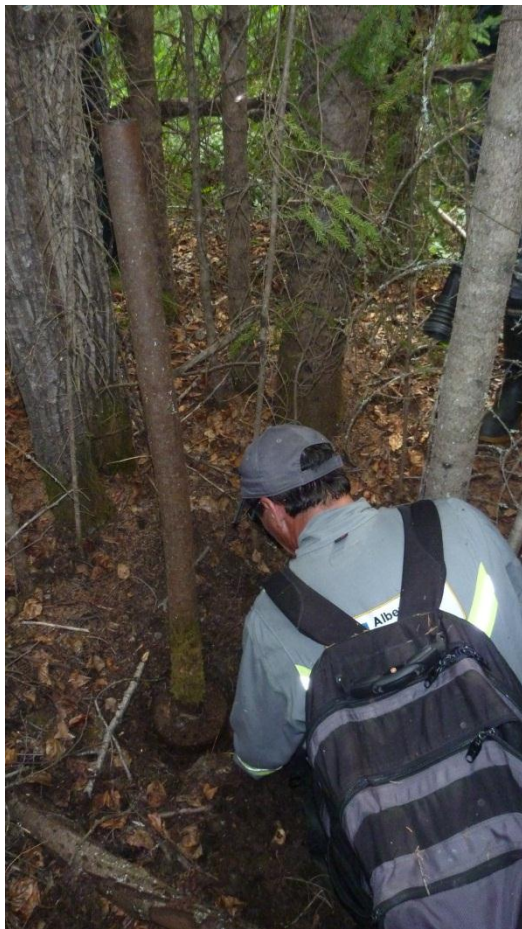
Photo 5: Jean Marie Creek No.1 Well

With the help of local guide (Mr. Angus Sanguéz), the well was discovered amongst a clump of spruce trees. A 1m steel pipe (5cm diameter) was welded to the cap of the well. The rusted steel pipe proved to be very difficult to see between trees of similar

diameter as (see photo 5).

Methane detection was conducted using a Portable Methane Detection unit (PMD). The ground surface was tested using the PMD wand, no methane was detected within proximity of the wellbore. The soil was then tested using monitoring cups in several locations surrounding the casing. No evidence of methane was present. A visual observation of the surrounding site was conducted by the team members. There were no obvious signs of vegetation stress either in the trees or low-lying shrubs. There was no other evidence of drilling activity in the area such as a drilling sump or left over materials.

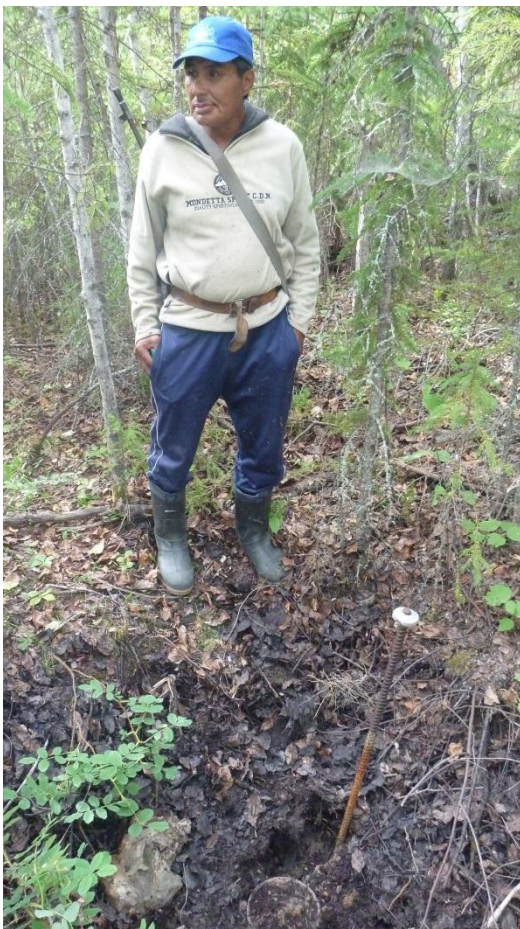
Photo 6: Westerol No. 3-A Well

The well was marked with a surveying stake, not with a steel pipe/marker as was seen on the previous wells. The wellbore was difficult to locate without a steel pipe to stand out among the thick brush (photo 6).

was tested using the PMD wand, no methane was detected within proximity of the wellbore. The soil was then tested using monitoring cups in several locations surrounding the casing. No evidence of methane was present. A visual inspection showed signs of healthy vegetation in all surrounding areas. There was no apparent evidence of vegetation stress. Some corroded metal cans were discovered 15m from the well site (photos in Appendix B).

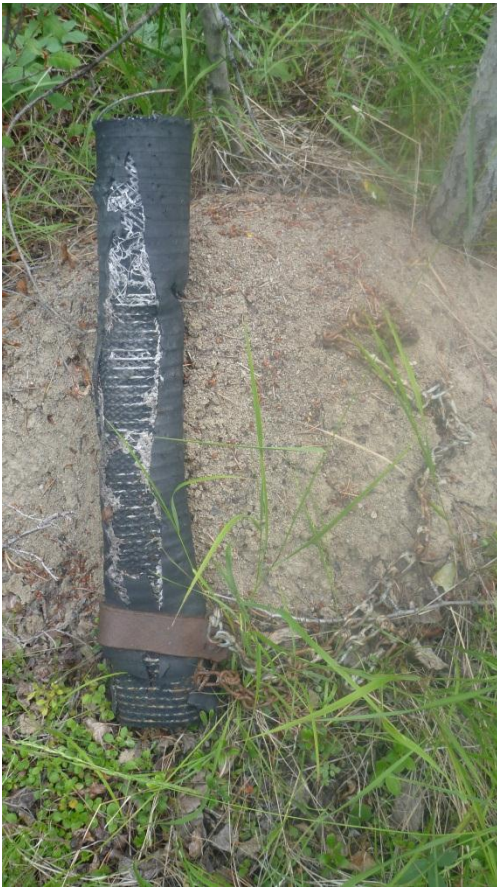
J52 Well: Hydraulic hose found near well

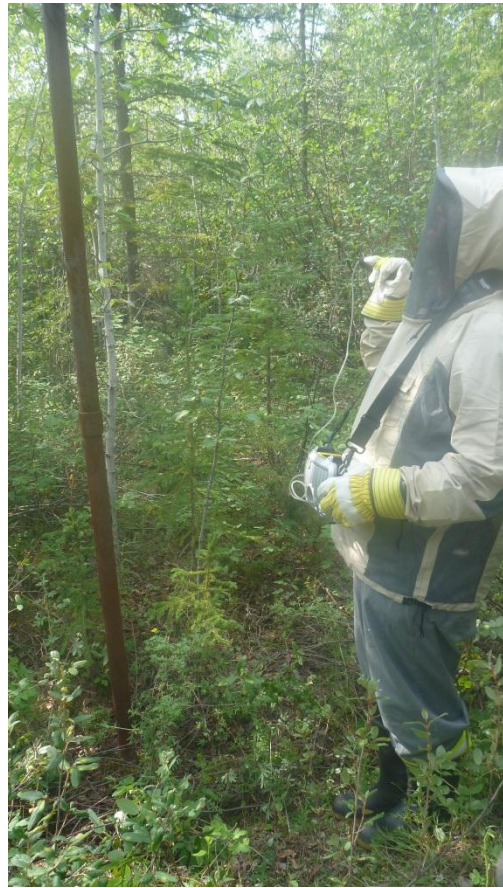
J52 Well: Methane detection

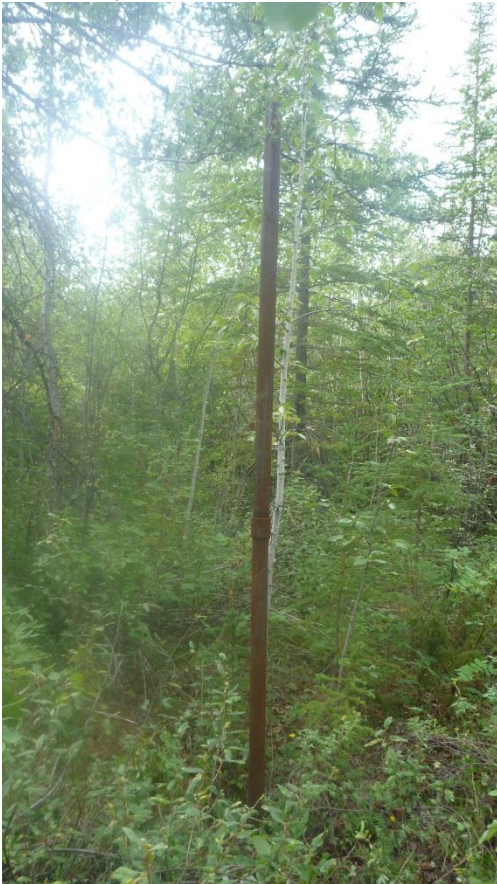
J52 Well: Well-site vegetation

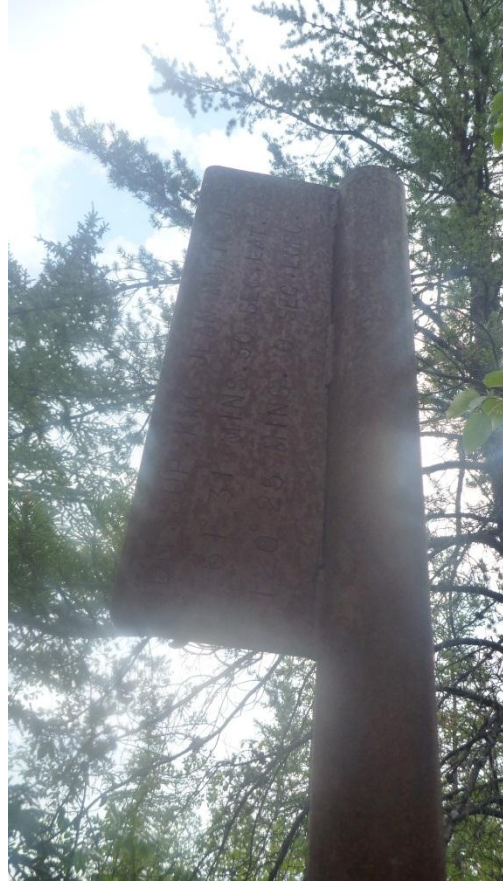
J52 Well: Wellhead marker pipe

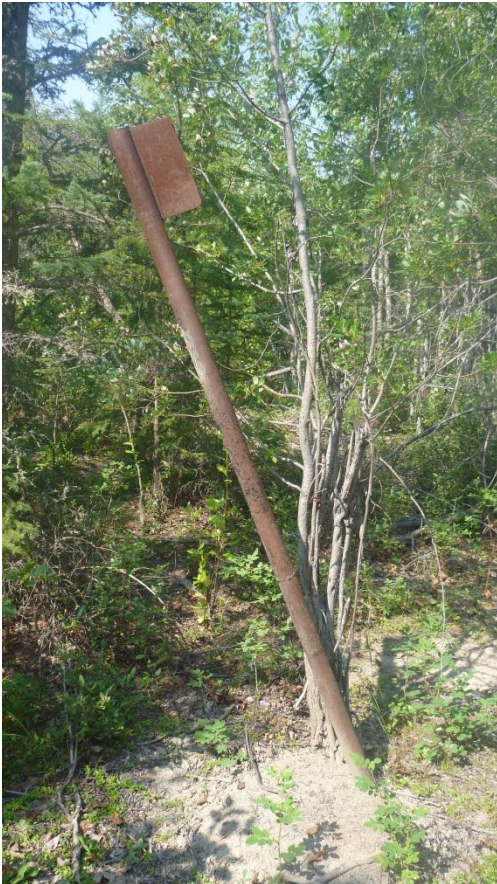
B-48 Well: Wellbore marker

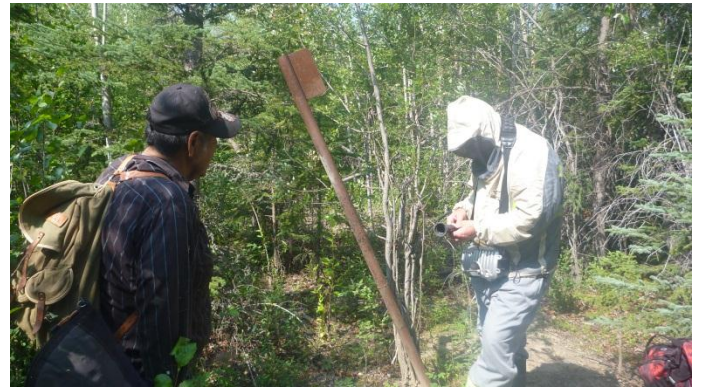
B48 Well: Methane monitoring

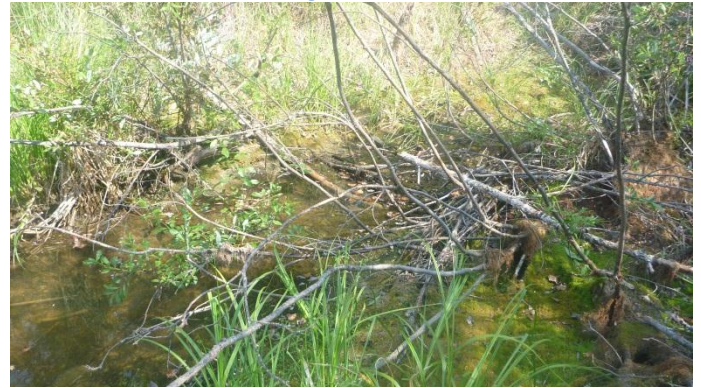
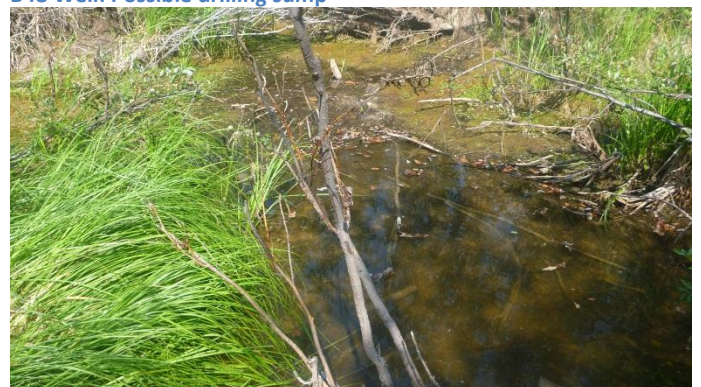
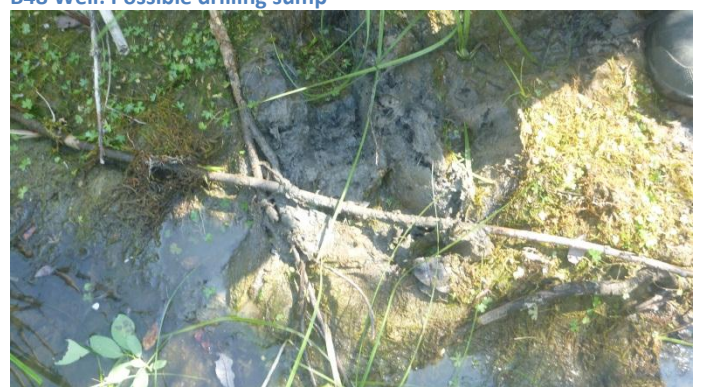
Aerial reconnaissance showed a low-lying area near the wellbore which could be the remnants of a drilling sump used when drilling the subject well. The low-lying area identified from the air, located approximately 15m from the well, was found to have abundant vegetation. There were no signs of hydrocarbons and no sheen present on the surface of the water.

B48 Well: Possible drilling sump

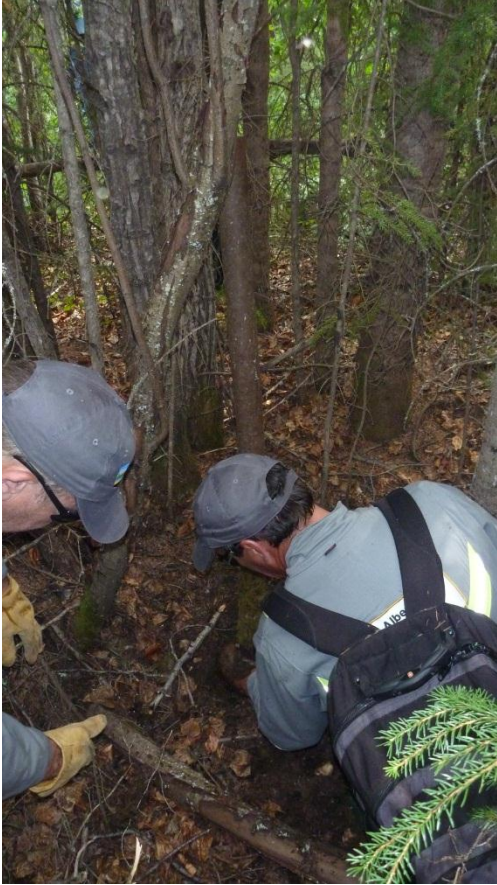
JMR No. 1 Well: Uncovering wellhead and cap

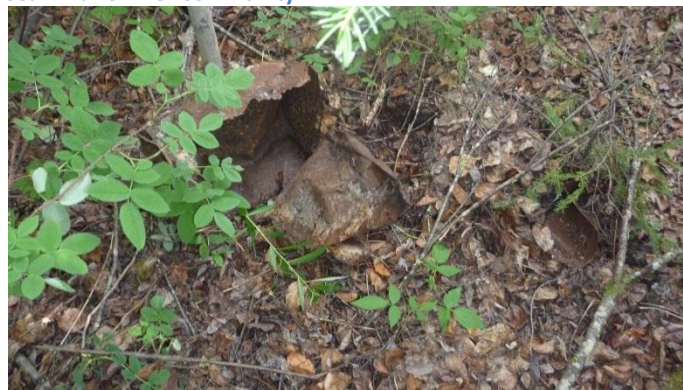
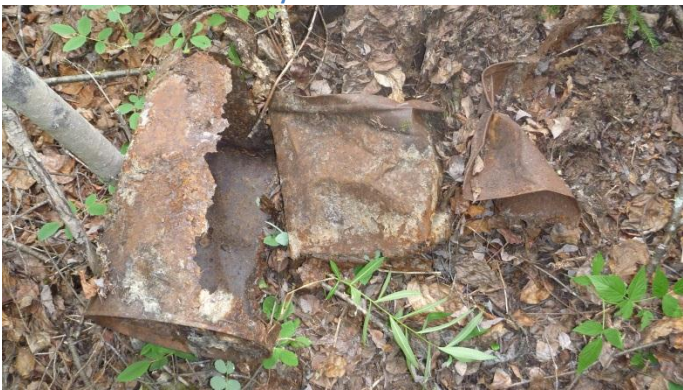
Old rusted drums found near Westerosl 3A site

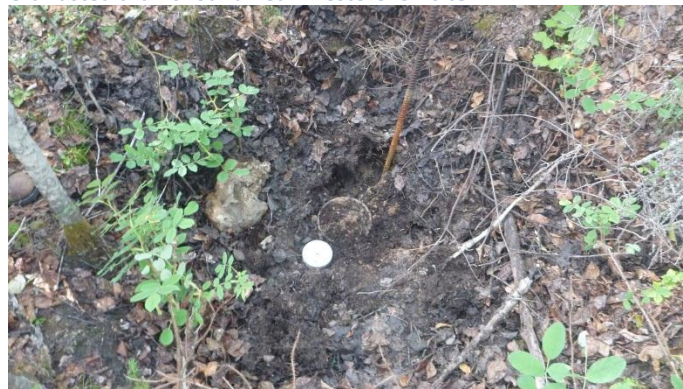
Westerol 3A Well: Uncovered wellbore cap

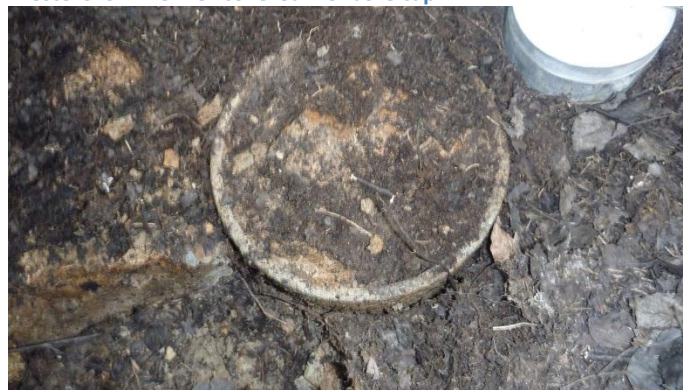
Westerol 3A Well: Unearthed wellbore cap
