Follow up to Oral Question 503-18(2) Northern Frontier Visitors Centre

J.
Williams Engineering NFVC
Structural Assessment

File No. 35826.00

May 19, 2017

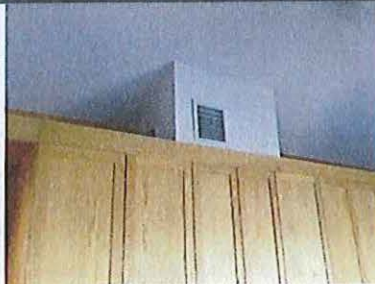
Ventilation grilles in the second floor board room
M10.1

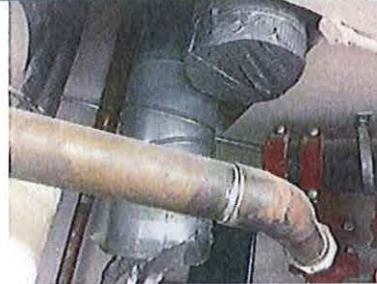
Capped ductwork from the second floor ventilation grilles
M10.2

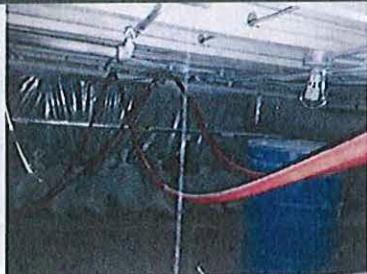
Painted sprinkler head
M11.1

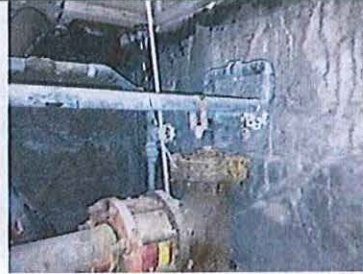
Water service entrance
M13.1

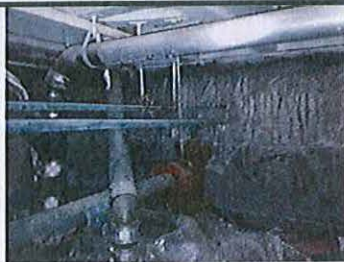
Water service entrance
M13.2

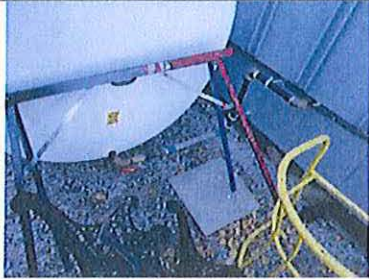
Storage in and around fuel oil tank
N8.1
