Government of the Northwest Territories

Bridge Inspection Form

Struct. ID	03B004
-------------------	--------

Structure Name	Frank Channel Bridge		
Structure Location	HWY003-KM00243.8		
Road Number	3	On <input checked="" type="checkbox"/>	Under <input type="checkbox"/>
Road Name	Yellowknife Highway		
Watercourse Name	Frank Channel		
Crossing Type:	Road <input type="checkbox"/>	Rail <input type="checkbox"/>	Water <input checked="" type="checkbox"/> Navigable waterway <input type="checkbox"/>
	River <input type="checkbox"/>	Other <input type="checkbox"/>	Creek <input type="checkbox"/> Pedestrian <input type="checkbox"/>
Hwy Direction	3-SOUTH/NORTH		
Owner Category			
Maint.Resp.		Northing	62.7841667
Region	North Slave	Easting	-115.94639
District		National Highway System	
Municipality		Highway Designation	
Township		Hwy Functional Classification	
Structure Category	Bridge	AADT	890
Main Struct. Subcateg.	Truss	Trucks (%)	3
Main Struct. Type	Through Truss	District Bridge Engineer	002
Deck Length (Total)	207.15 (m)	Road Authority

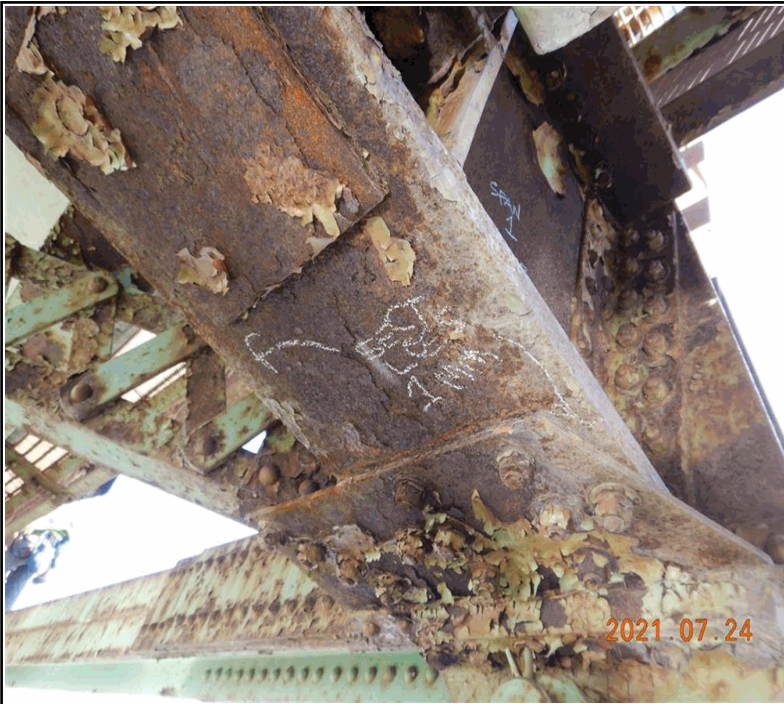
File Name DSCN2206 (Medium).JPG

Description Vertical L7U7, Span 4, D/S	
Elem Grp/Class	Trusses/Arches/Verticals/diagonal
Elem Type	
Sub Element	
Material Type	Steel
Locator	
Defect Descript1	
Defect Descript2	
Defect	
Other

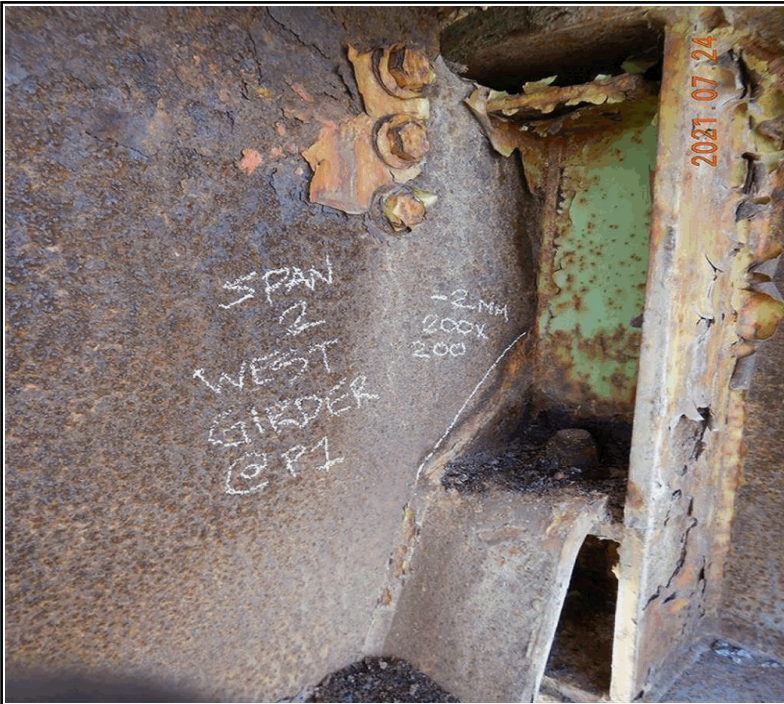
Description
Span 2, Girder 4 at Pier 1, section loss 2mm, area 200x200mm

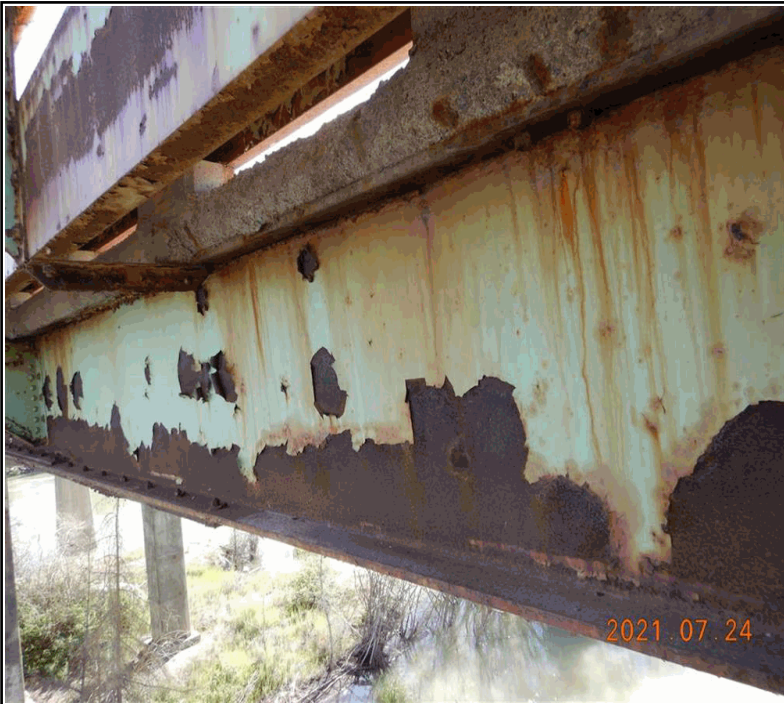
File Name DSCN2211 (Medium).JPG

Description Exterior girder at Span 2, typical	
Elem Grp/Class	Beams/MLE's/Girders
Elem Type	I type
Sub Element	End
Material Type	Steel
Locator	
Defect Descript1	
Defect Descript2	
Defect	
Other

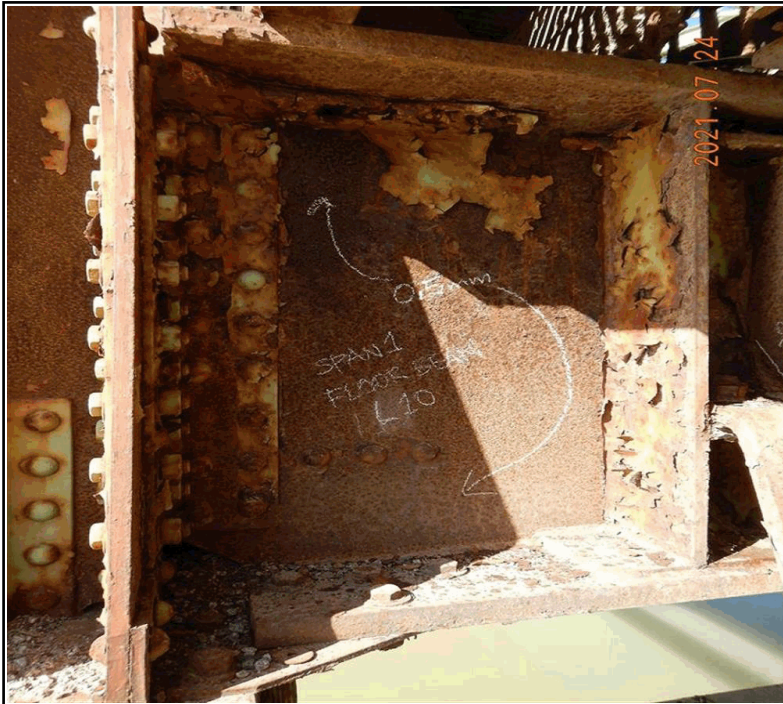
File Name DSCN2218 (Medium).JPG

Description Floor Beam at Span 1, L10 (Pier 1) coat peeled, section loss 0.5mm on web	
Elem Grp/Class	Beams/MLE's/Floor Beams
Elem Type	I type
Sub Element	Intermediate
Material Type	Steel
Locator	
Defect Descript1	
Defect Descript2	
Defect	
Other

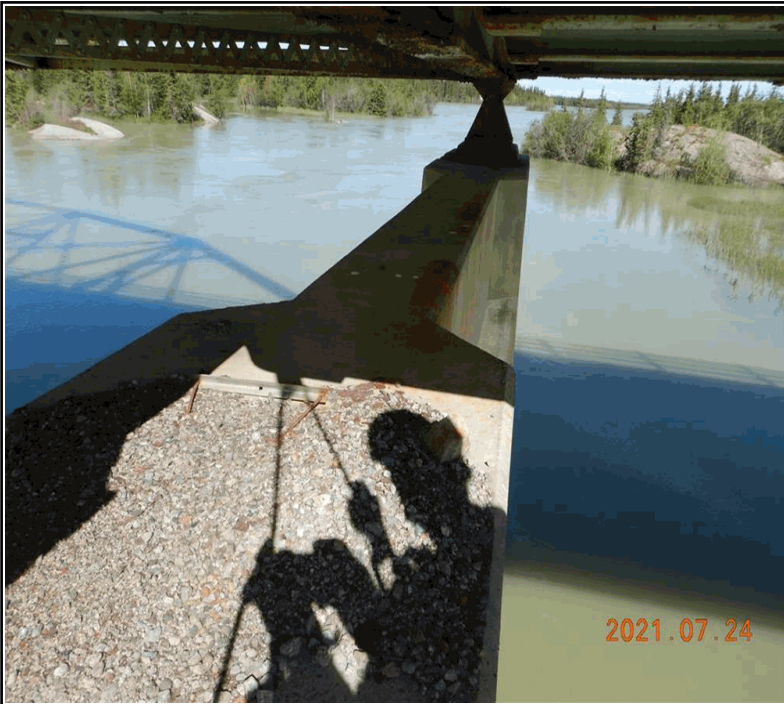
File Name DSCN2223 (Medium).JPG

Description Debris on top of Pier 1	
Elem Grp/Class	Piers/Caps
Elem Type	
Sub Element	
Material Type	Cast-in-place concrete
Locator	
Defect Descript1	
Defect Descript2	
Defect	
Other

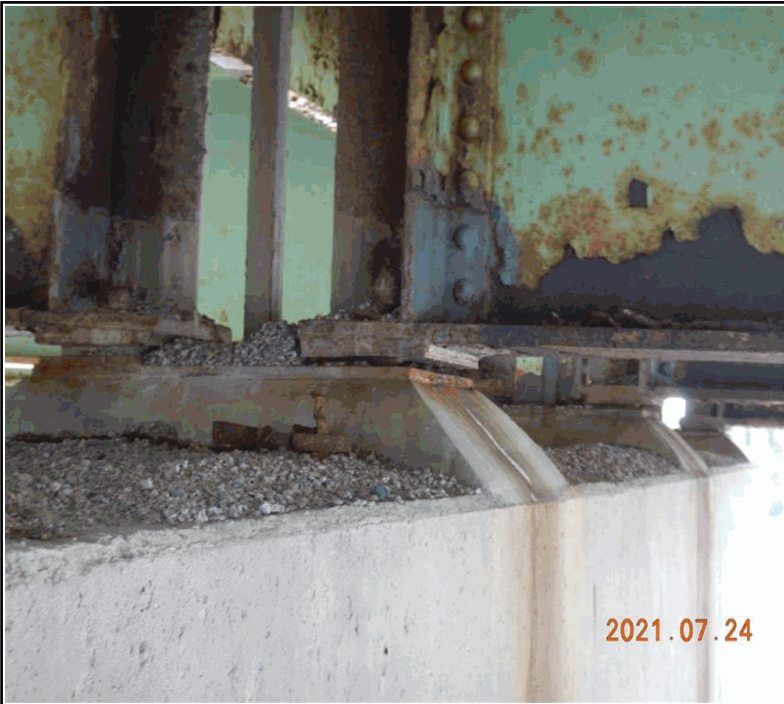
File Name DSCN2231 (Medium).JPG

Description FloAnchor bolts of the girder bearings at Pier 3 are sheared off	
Elem Grp/Class	Piers/Bearings
Elem Type	Plate
Sub Element	
Material Type	
Locator	
Defect Descript1	
Defect Descript2	
Defect	
Other

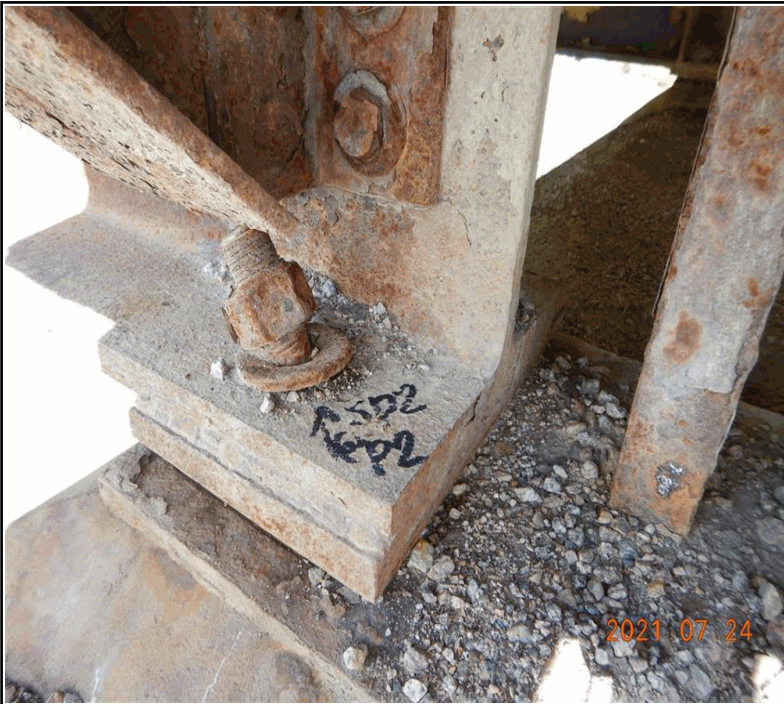
File Name DSCN2240 (Medium).JPG

Description Anchor bolt at Girder 1, Span 2at Pier2, sheared off	
Elem Grp/Class	Piers/Bearings
Elem Type	Plate
Sub Element	
Material Type	
Locator	
Defect Descript1	
Defect Descript2	
Defect	
Other

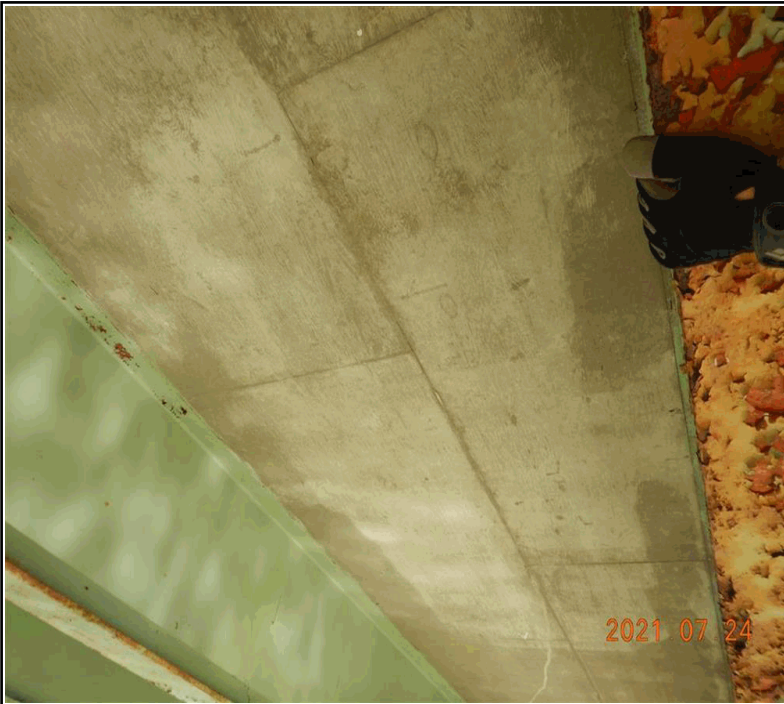
File Name DSCN2248 (Medium).JPG

Description Deck soffit of the truss span, typical in good condition	
Elem Grp/Class	Decks/Soffit - Thin Slab
Elem Type	
Sub Element	Exterior
Material Type	Cast-in-place concrete
Locator	
Defect Descript1	
Defect Descript2	
Defect	
Other

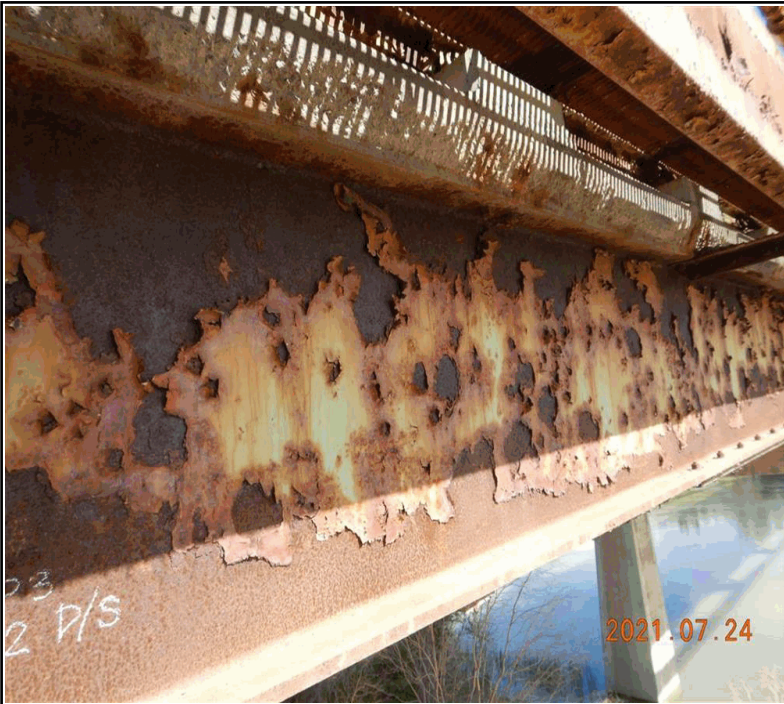
Description
Coat peeled and light corrosion of the girders at span 3, no section loss

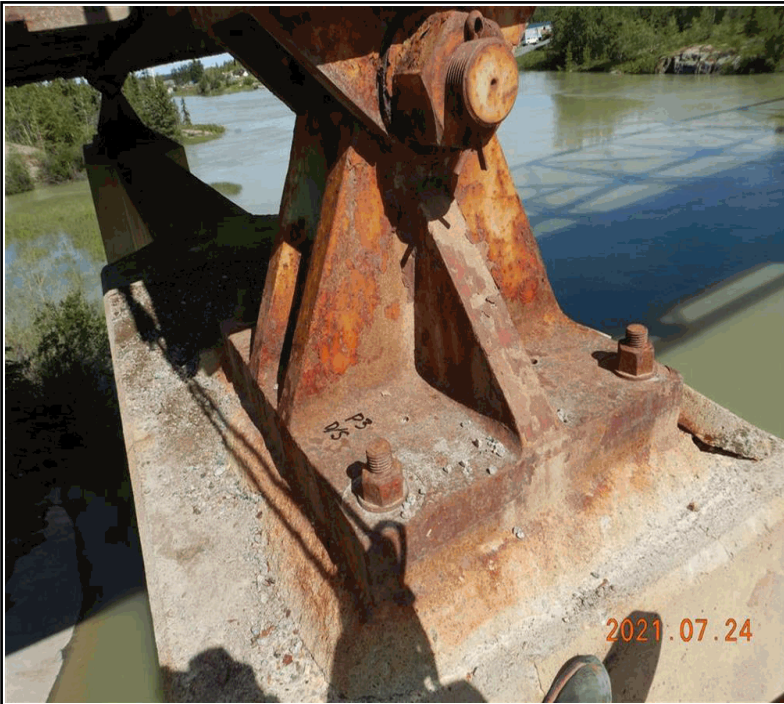
File Name DSCN2260 (Medium).JPG

Description light corrosion of the rock bearing at Pier 3 (D/S)	
Elem Grp/Class	Piers/Bearings
Elem Type	Hinge
Sub Element	
Material Type	
Locator	
Defect Descript1	
Defect Descript2	
Defect	
Other

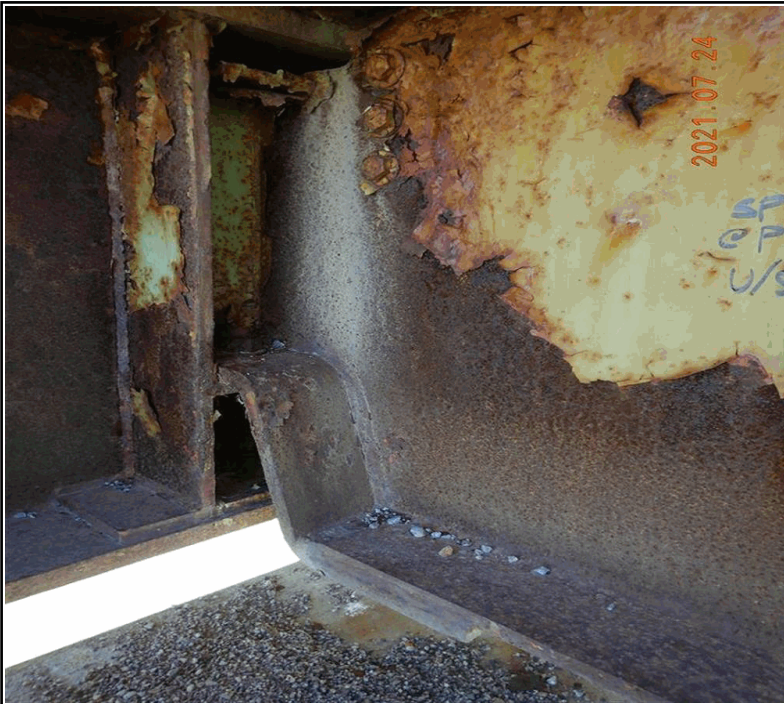
File Name DSCN2270 (Medium).JPG

Description Girder1# (U/S) end support on end floor beam on P3	
Elem Grp/Class	Beams/MLE's/Girders
Elem Type	I type
Sub Element	End
Material Type	Steel
Locator	
Defect Descript1	
Defect Descript2	
Defect	
Other

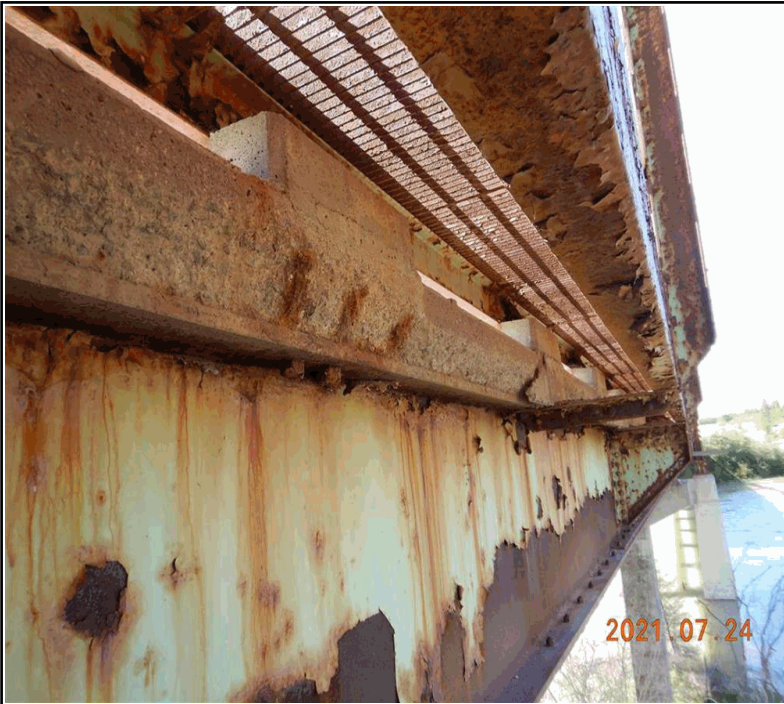
File Name DSCN2272 (Medium).JPG

Description Underside of the sidewalk grating, typical light section loss	
Elem Grp/Class	Sidewalks/curbs/Curbs
Elem Type	
Sub Element	
Material Type	Other
Locator	
Defect Descript1	
Defect Descript2	
Defect	
Other

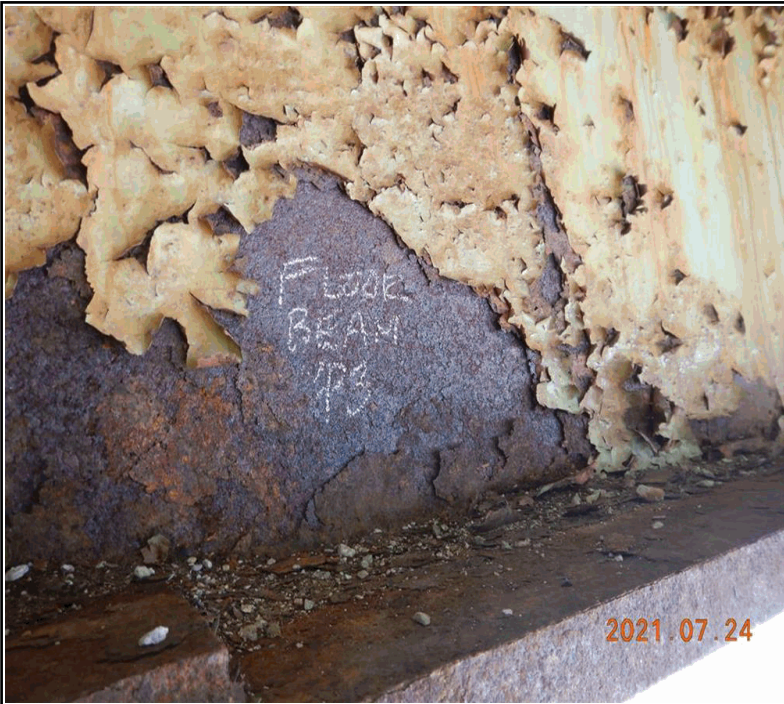
File Name DSCN2278 (Medium).JPG

Description End floor beam at Pier 3 has section loss of up to 1 mm on the web, 100mm height	
Elem Grp/Class	Beams/MLE's/Floor Beams
Elem Type	I type
Sub Element	End
Material Type	Steel
Locator	
Defect Descript1	
Defect Descript2	
Defect	
Other

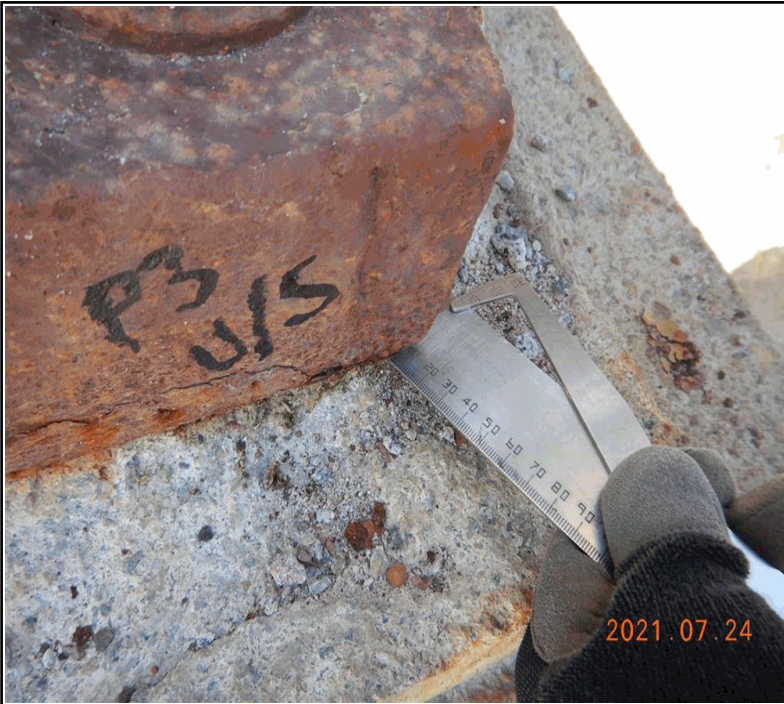
File Name DSCN2285 (Medium).JPG

Description Medium section loss at the bottom plate of Bearing at P3, U/S, concrete grout spalled	
Elem Grp/Class	Piers/Bearings
Elem Type	Hinge
Sub Element	
Material Type	
Locator	
Defect Descript1	
Defect Descript2	
Defect	
Other

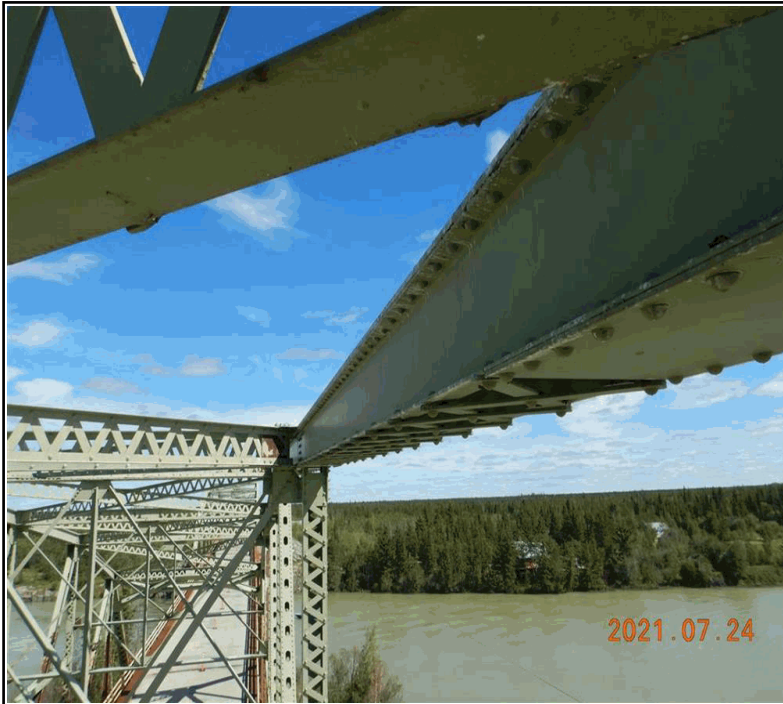
File Name DSCN2293 (Medium).JPG

Description Top chord at Span 1	
Elem Grp/Class	Trusses/Arches/Top chords
Elem Type	
Sub Element	
Material Type	Steel
Locator	
Defect Descript1	
Defect Descript2	
Defect	
Other

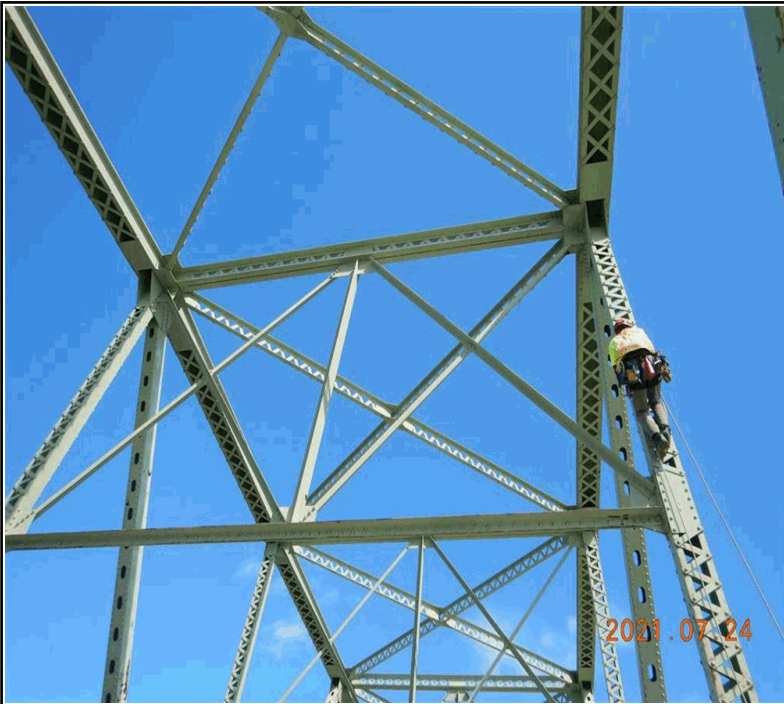
File Name DSCN2298 (Medium).JPG

Description Inspection of verticals, in good conditions	
Elem Grp/Class	Trusses/Arches/Verticals/diagonals
Elem Type	
Sub Element	
Material Type	Steel
Locator	
Defect Descript1	
Defect Descript2	
Defect	
Other

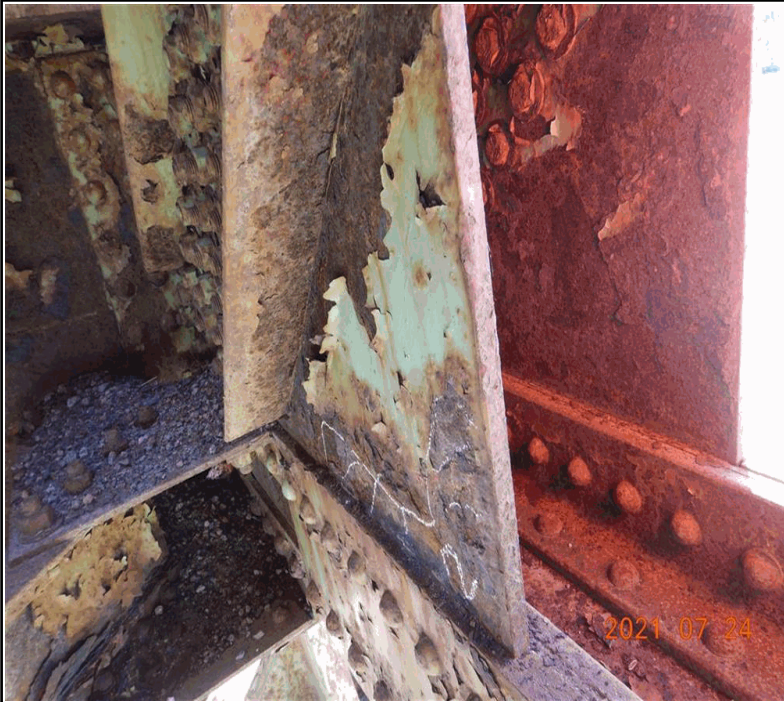
File Name DSCN4778 (Medium).JPG

Description Minor section loss on the gusset plates at Pier 1#, U/S	
Elem Grp/Class	Trusses/Arches/Connections
Elem Type	
Sub Element	
Material Type	Steel
Locator	
Defect Descript1	
Defect Descript2	
Defect	
Other

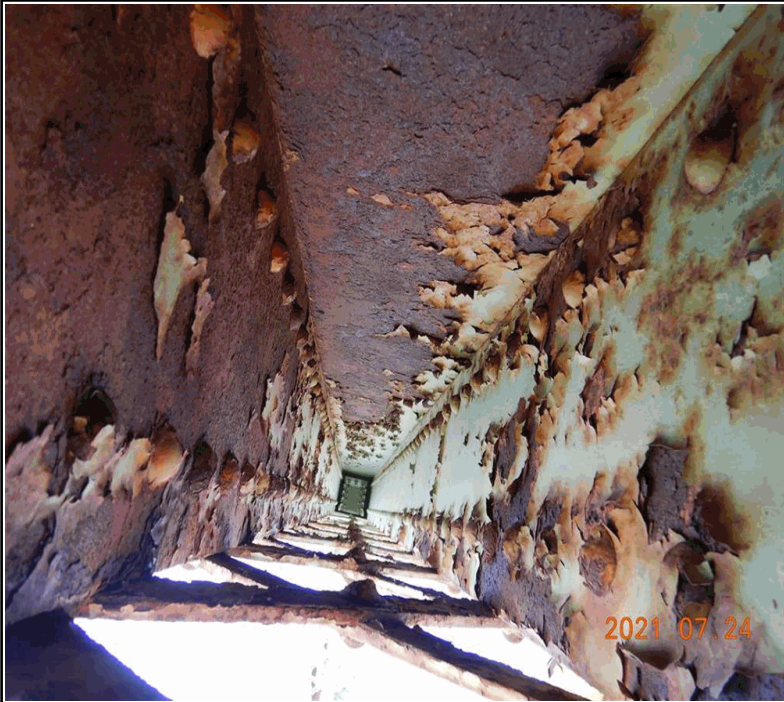
File Name DSCN4781 (Medium).JPG

Description	
Verticals looking inside, typical, coat failure at splash zone, minor section loss	
Elem Grp/Class	Trusses/Arches/Verticals/diagonal:
Elem Type	
Sub Element	
Material Type	Steel
Locator	
Defect Descript1	
Defect Descript2	
Defect	
Other

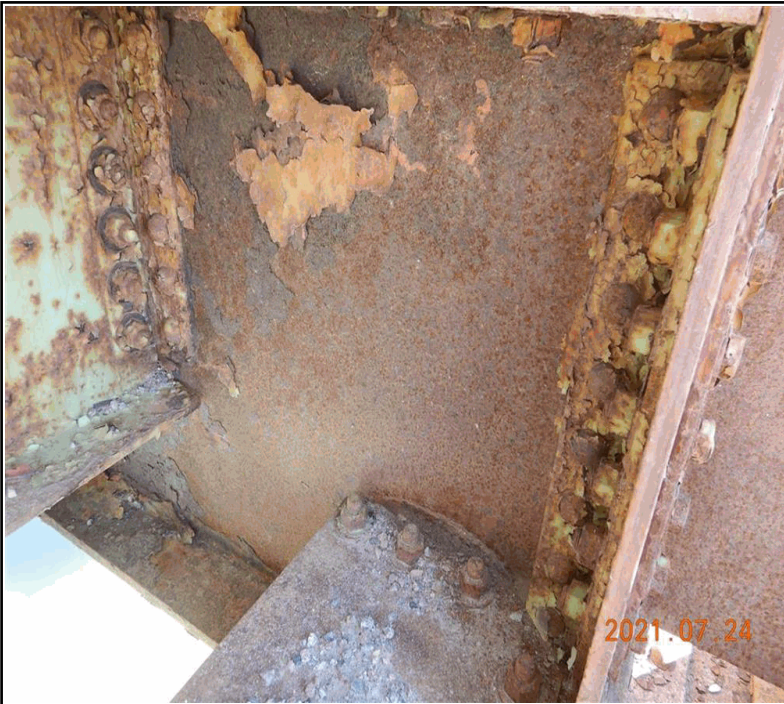
File Name DSCN4789 (Medium).JPG

Description Floor beam typical, coat peeled, minor section loss	
Elem Grp/Class	Beams/MLE's/Floor Beams
Elem Type	I type
Sub Element	Intermediate
Material Type	Steel
Locator	
Defect Descript1	
Defect Descript2	
Defect	
Other

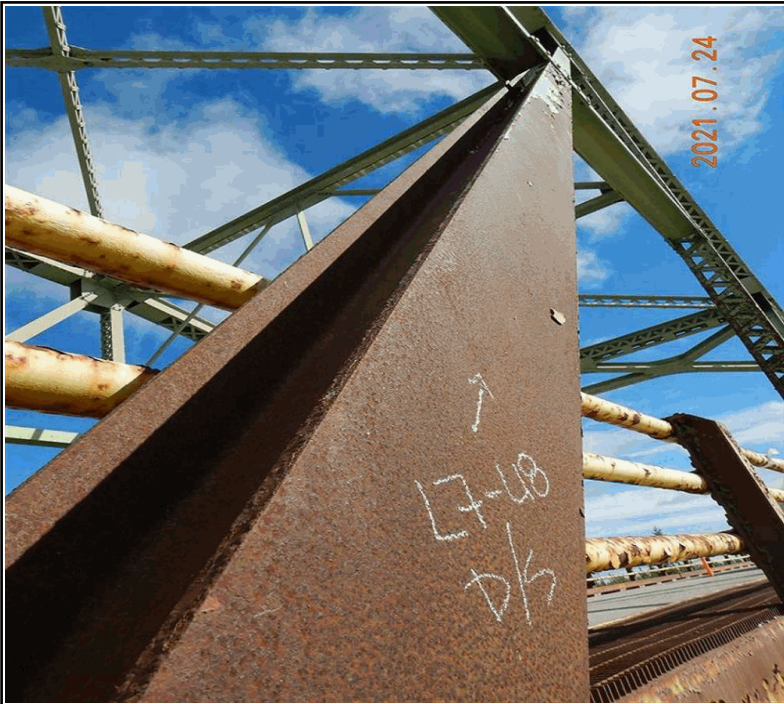
Description
Diagonal (L7U8) D/S, coating fail at splash zone, minor section loss

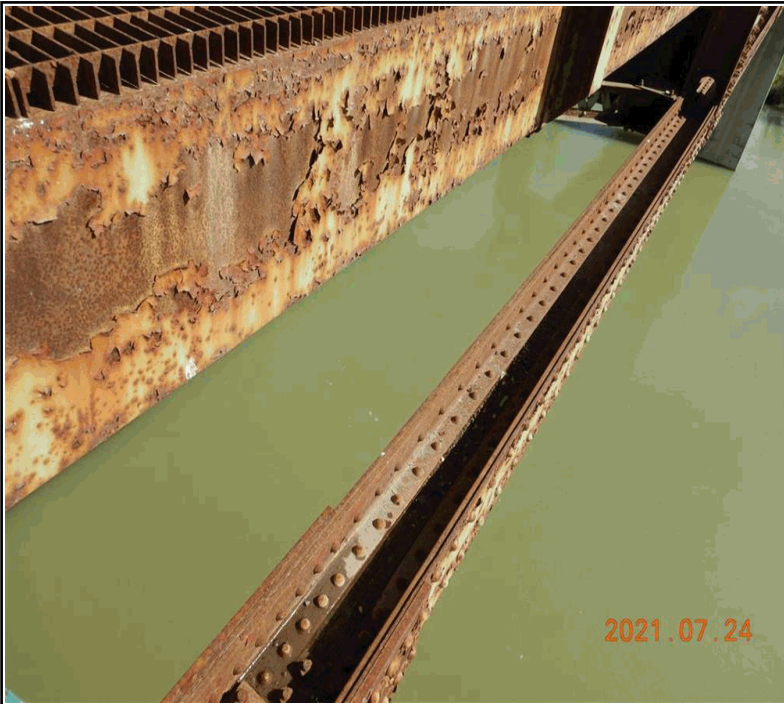
File Name DSCN4814 (Medium).JPG

Description	
Bottom chord, Span 1, D/S, debris has been cleaned.	
Elem Grp/Class	Trusses/Arches/Bottom chords
Elem Type	
Sub Element	
Material Type	Steel
Locator	
Defect Descript1	
Defect Descript2	
Defect	
Other

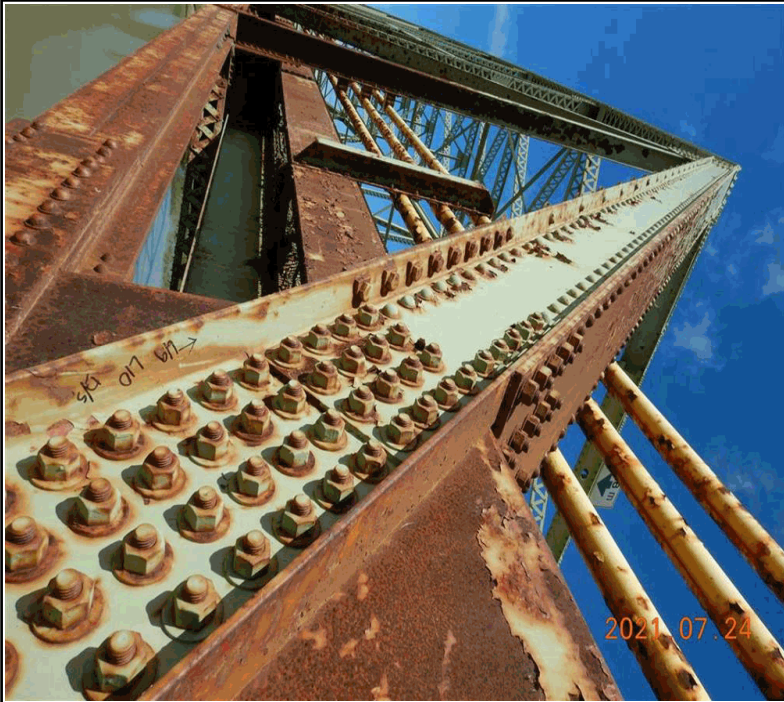
File Name DSCN4840 (Medium).JPG

Description Diagonal L10U9, Span 1, D/S	
Elem Grp/Class	Trusses/Arches/Verticals/diagonal
Elem Type	
Sub Element	
Material Type	Steel
Locator	
Defect Descript1	
Defect Descript2	
Defect	
Other

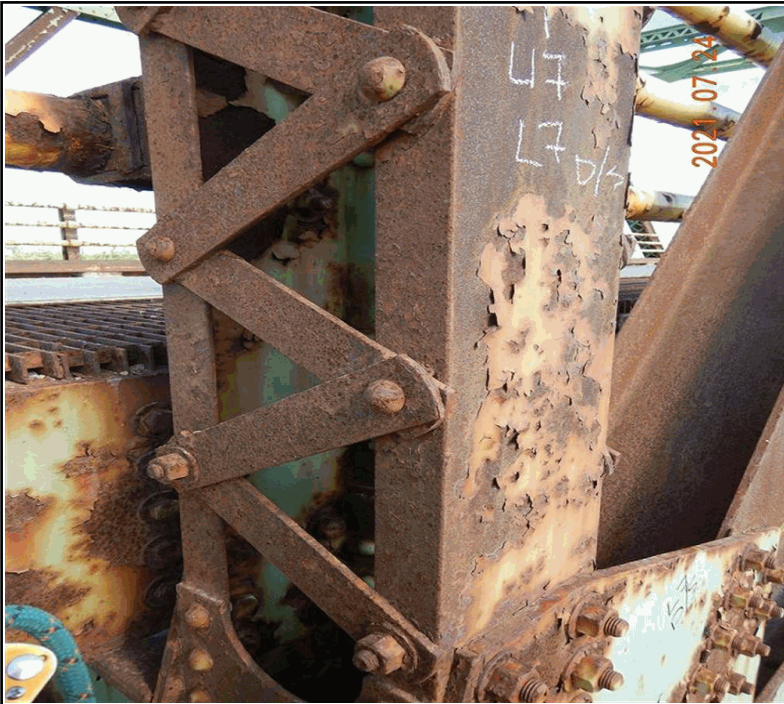
File Name DSCN4870 (Medium).JPG

Description Vertical U7L7, Span 2, D/S	
Elem Grp/Class	Trusses/Arches/Verticals/diagonal:
Elem Type	
Sub Element	
Material Type	Steel
Locator	
Defect Descript1	
Defect Descript2	
Defect	
Other

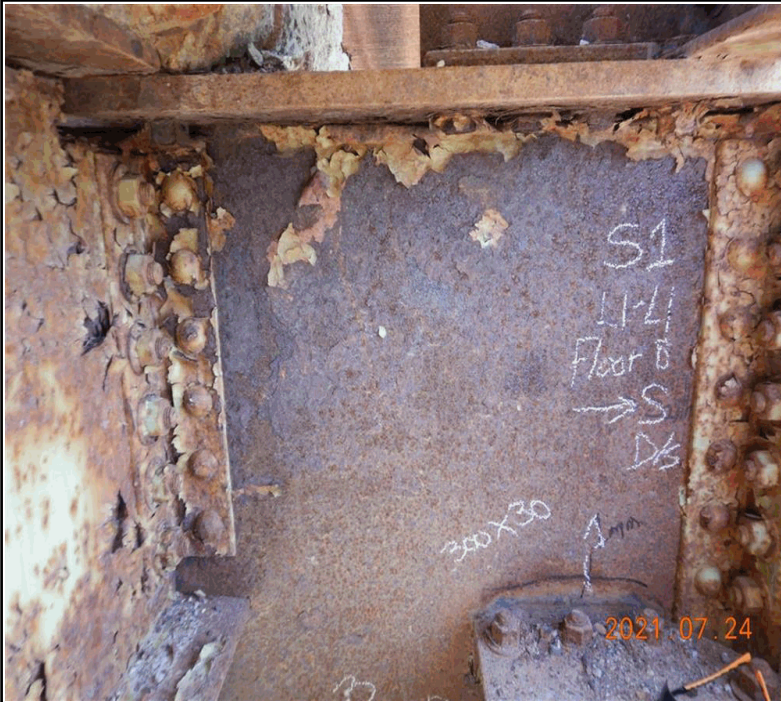
Span 1, Floor beam at L1U1, D/S, section loss 1mm, area 300x30mm

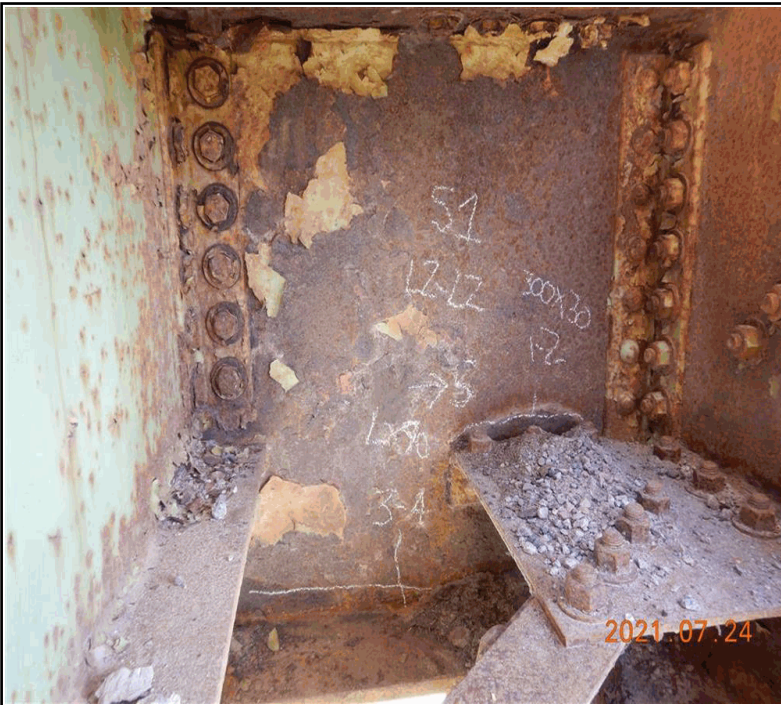
Span 1, Floor beam at L2U2, D/S, section loss 3-4mm, area 1000x90mm, bottom of the web

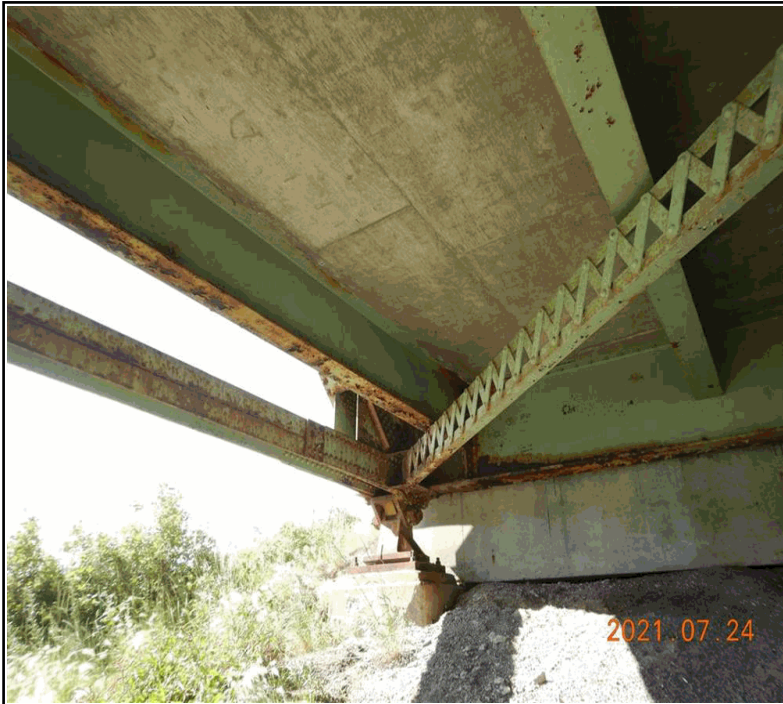
File Name DSCN9204 (Medium).JPG

Description
Elements near bearing (U/S) at abutment 1#, looking Southeast

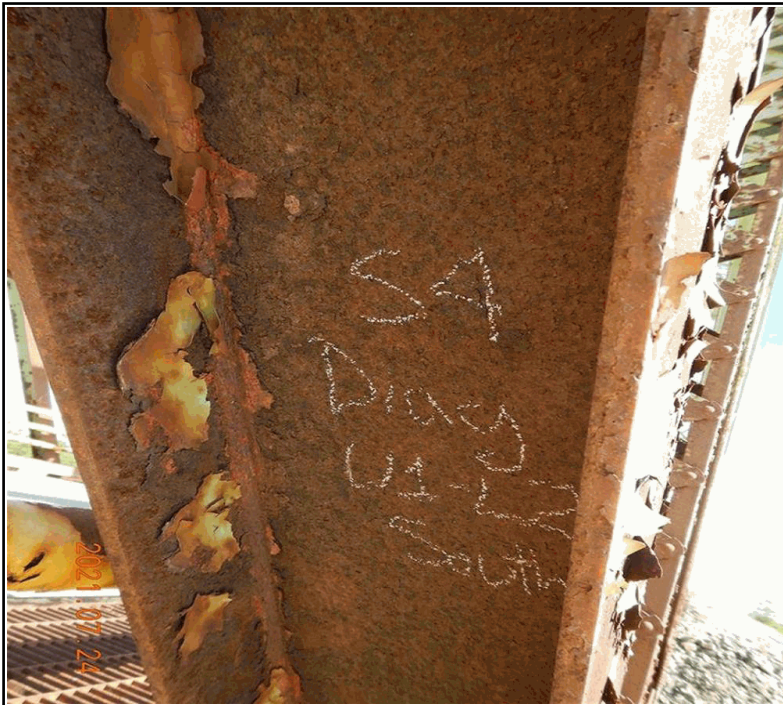
Description
Diagonal, U1U2 at Span 4, U/S

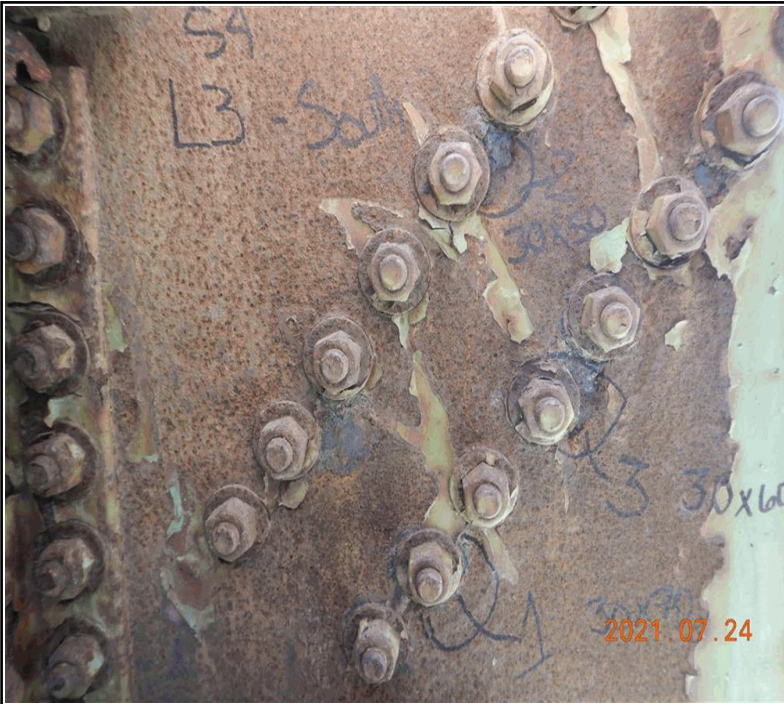
File Name DSCN9214 (Medium).JPG

Description Gusset plat at Span 4, L3, U/S section loss at bolt locations	
Elem Grp/Class	Trusses/Arches/Connections
Elem Type	
Sub Element	
Material Type	Steel
Locator	
Defect Descript1	
Defect Descript2	
Defect	
Other

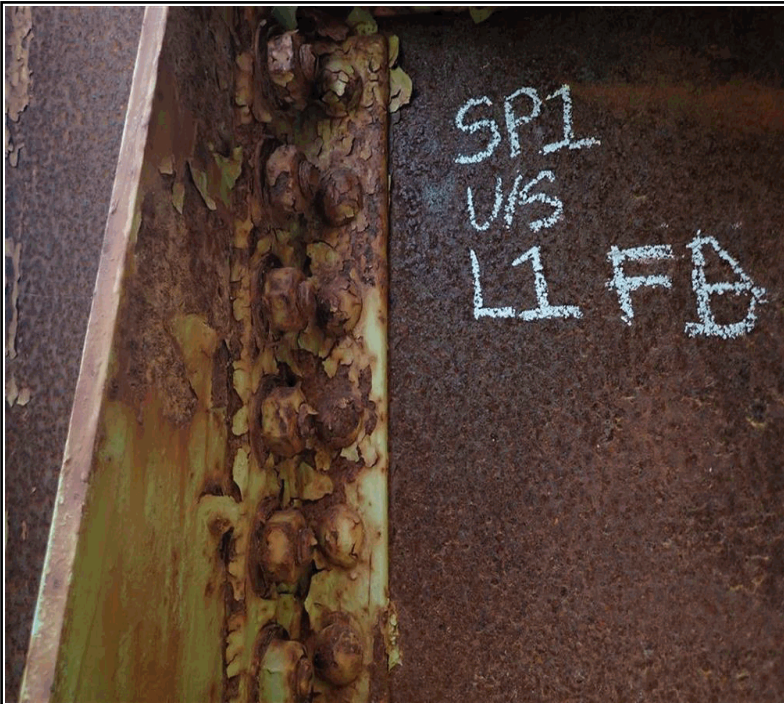
File Name frank_channel_ert_005 (Medium).JPG

Description Floor beam at Span 1, L1, U/S	
Elem Grp/Class	Beams/MLE's/Floor Beams
Elem Type	I type
Sub Element	Intermediate
Material Type	Steel
Locator	
Defect Descript1	
Defect Descript2	
Defect	
Other

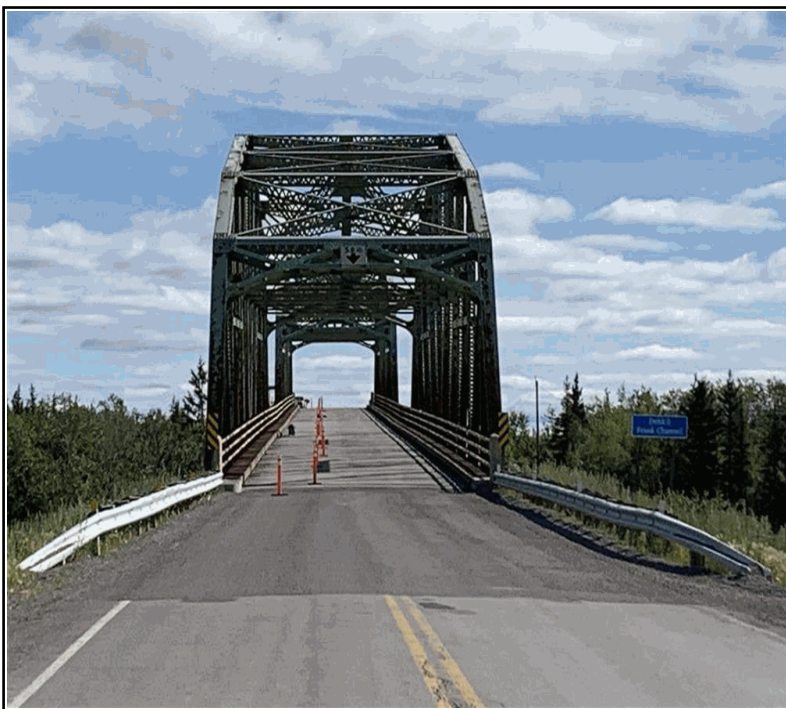
File Name IMG_4072 (Medium).JPG

Description General view looking east	
Elem Grp/Class	Approaches/Wearing surface
Elem Type	
Sub Element	
Material Type	Cast-in-place concrete
Locator	
Defect Descript1	
Defect Descript2	
Defect	
Other

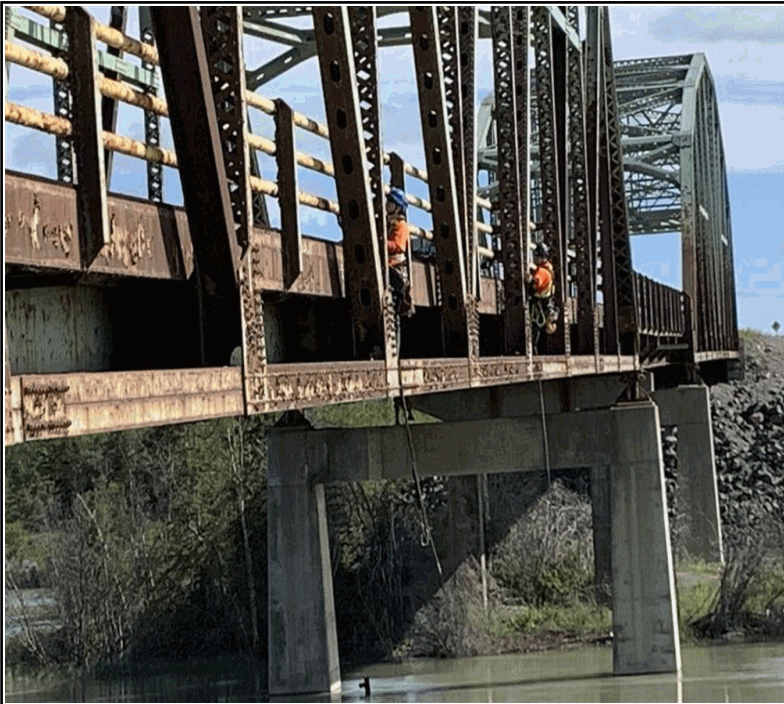
Description
Inspection of truss elements, U/S

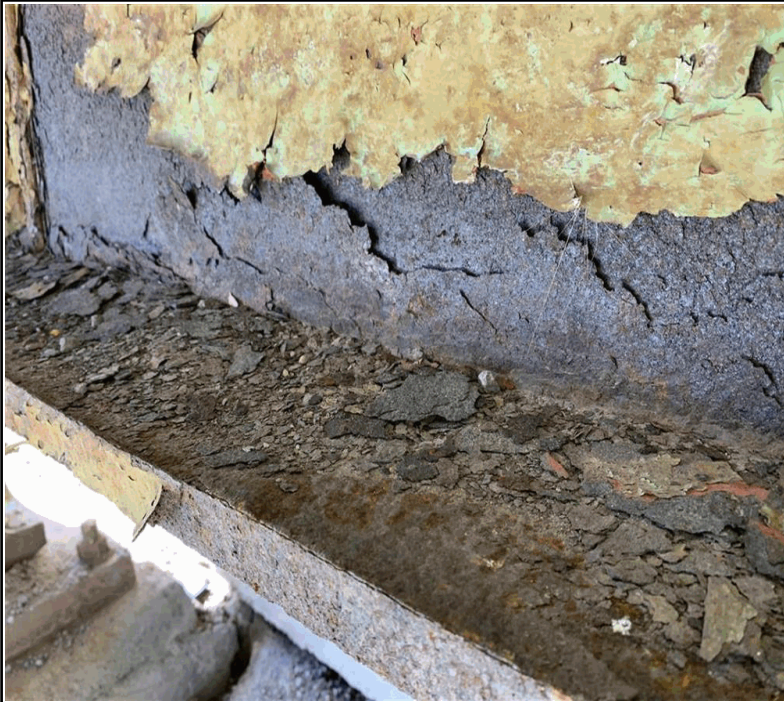
File Name IMG_4118 (Medium).JPG

Description End floor beams at abutment 1 has section loss of 1 -2mm on the web.	
Elem Grp/Class	Beams/MLE's/Floor Beams
Elem Type	I type
Sub Element	End
Material Type	Steel
Locator	
Defect Descript1	
Defect Descript2	
Defect	
Other

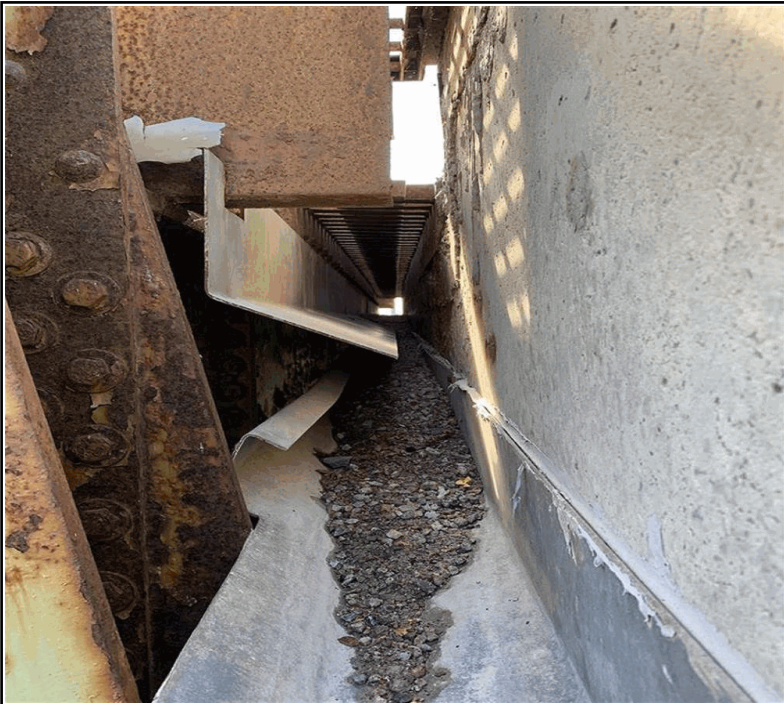
File Name IMG_4129 (Medium).JPG

Description Debris/gravel on the drain trough, Abut 1	
Elem Grp/Class	Joints/Armoring/retaining devices
Elem Type	
Sub Element	
Material Type	Steel
Locator	
Defect Descript1	
Defect Descript2	
Defect	
Other

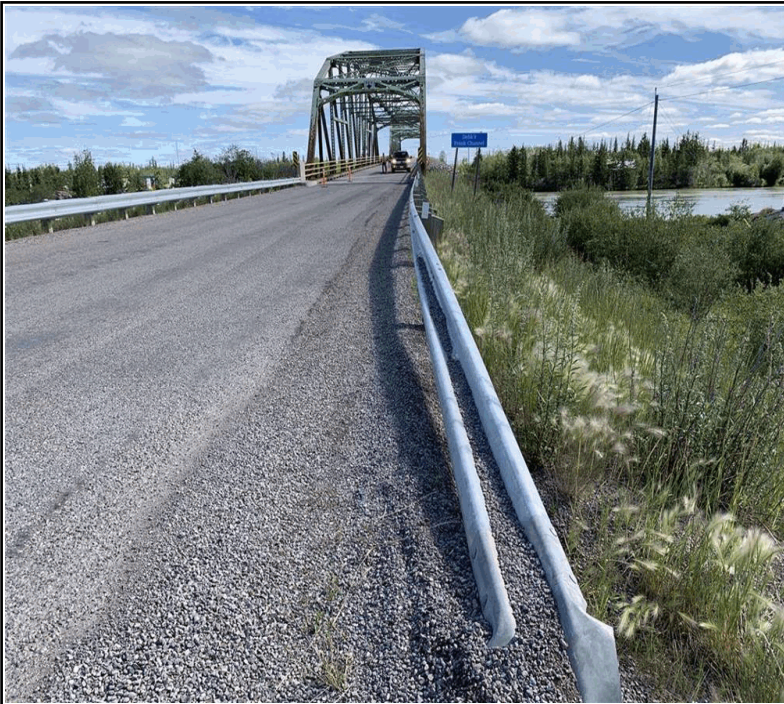
File Name IMG_4140 (Medium).JPG

Description Turndown end treatment W-Beam guardrail at Southeast	
Elem Grp/Class	Approaches/Sidewalk/Curb
Elem Type	Cast-in-place concrete
Sub Element	
Material Type	
Locator	
Defect Descript1	
Defect Descript2	
Defect	
Other

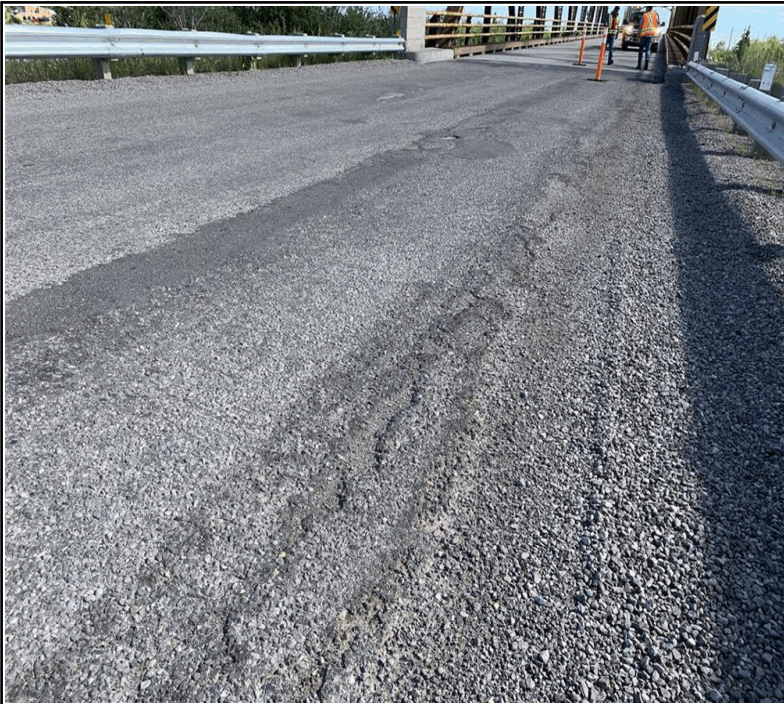
File Name IMG_4143 (Medium).JPG

Description Chip seal wearing surface at Southeast	
Elem Grp/Class	Approaches/Wearing surface
Elem Type	
Sub Element	
Material Type	Cast-in-place concrete
Locator	
Defect Descript1	
Defect Descript2	
Defect	
Other

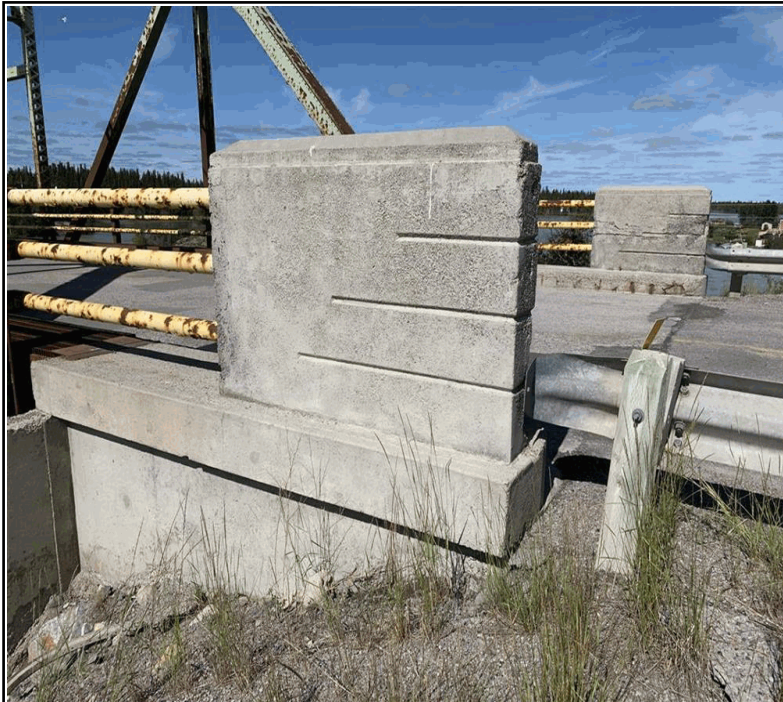
IMG_4149 (Medium).JPG

Wingwall and parapet at Northwest, Abutment 1, typical

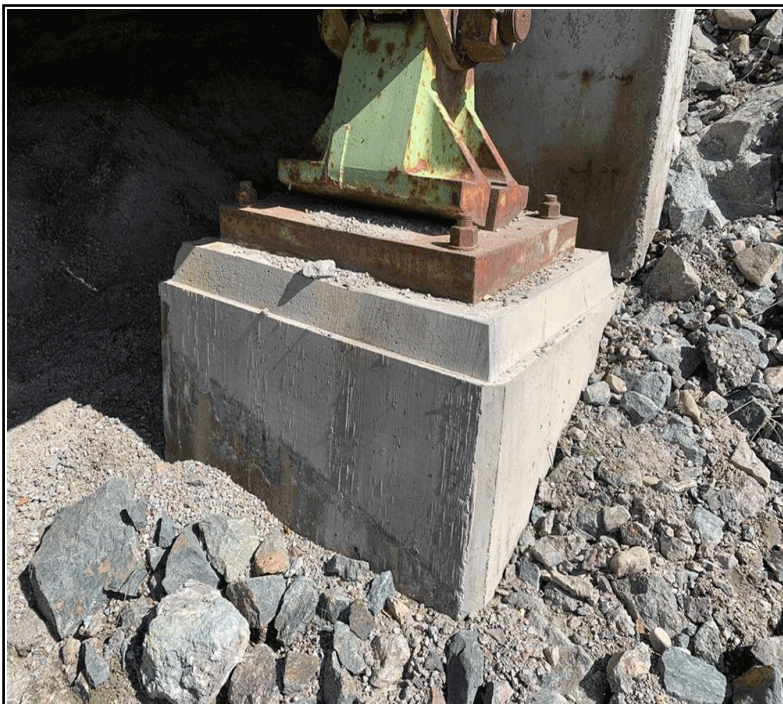
Concrete spall at bearing seat, Abutment 2, Southeast has been repaired
