Government of the Northwest Territories

Bridge Inspection Form

Struct. ID	03B004
-------------------	--------

Structure Name	Frank Channel Bridge		
Structure Location	HWY003-KM00243.8		
Road Number	3	On <input checked="" type="checkbox"/>	Under <input type="checkbox"/>
Road Name	Yellowknife Highway		
Watercourse Name	Frank Channel		
Crossing Type:	Road <input type="checkbox"/>	Rail <input type="checkbox"/>	Water <input checked="" type="checkbox"/> Navigable waterway <input type="checkbox"/>
	River <input type="checkbox"/>	Other <input type="checkbox"/>	Creek <input type="checkbox"/> Pedestrian <input type="checkbox"/>
Hwy Direction	3-SOUTH/NORTH		
Owner Category			
Maint.Resp.		Northing	62.7841667
Region	North Slave	Easting	-115.94639
District		National Highway System	
Municipality		Highway Designation	
Township		Hwy Functional Classification	
Structure Category	Bridge	AADT	890
Main Struct. Subcateg.	Truss	Trucks (%)	3
Main Struct. Type	Through Truss	District Bridge Engineer	002
Deck Length (Total)	207.15 (m)	Road Authority

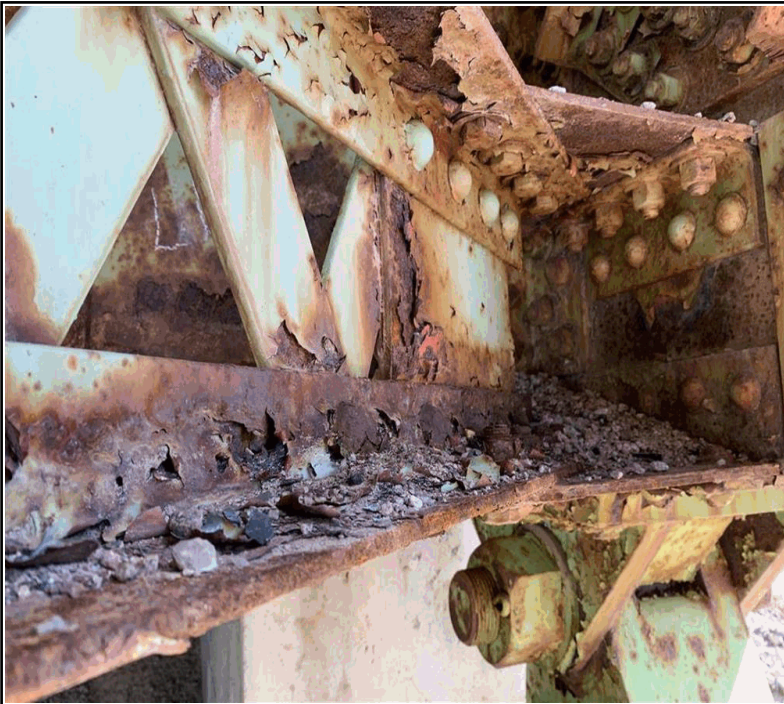
File Name IMG_4153 (Medium).JPG

Description Rust pack at Abutment 1, D/S	
Elem Grp/Class	Bracing/Bracing
Elem Type	
Sub Element	End
Material Type	Steel
Locator	
Defect Descript1	
Defect Descript2	
Defect	
Other

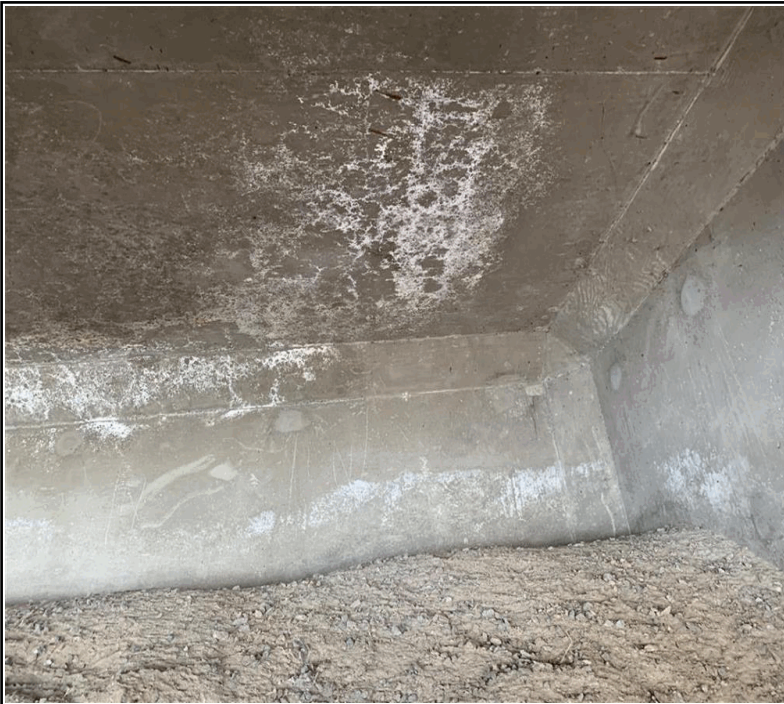
File Name IMG_4156 (Medium).JPG

Description efflorescence on the underside of roof slab at Abutment 2	
Elem Grp/Class	Approaches/Approach slabs
Elem Type	
Sub Element	
Material Type	Cast-in-place concrete
Locator	
Defect Descript1	
Defect Descript2	
Defect	
Other

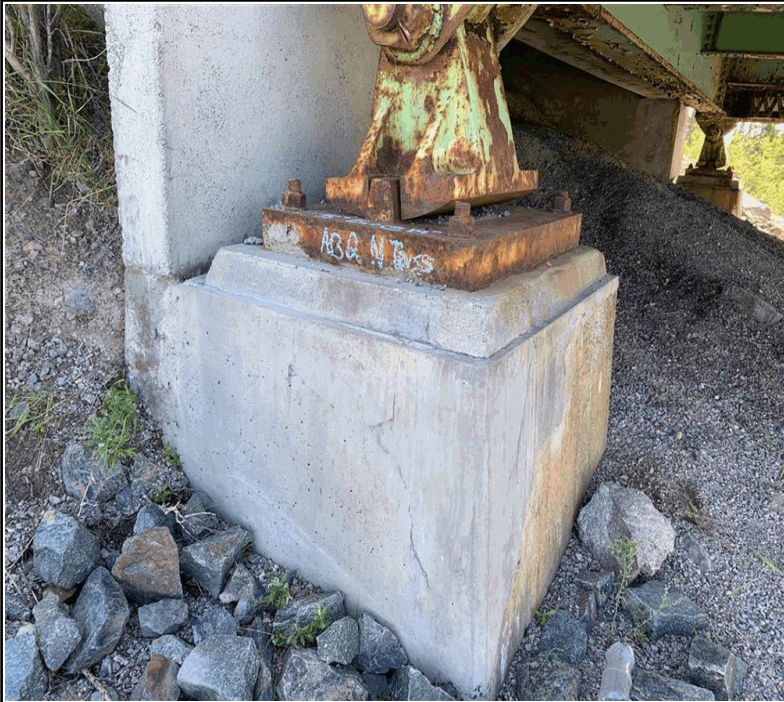
File Name IMG_4158 (Medium).JPG

Description Rock bearing at Abut 2, D/S, rotated toward abutment	
Elem Grp/Class	Abutments/Bearings
Elem Type	Rocker
Sub Element	
Material Type	
Locator	
Defect Descript1	
Defect Descript2	
Defect	
Other

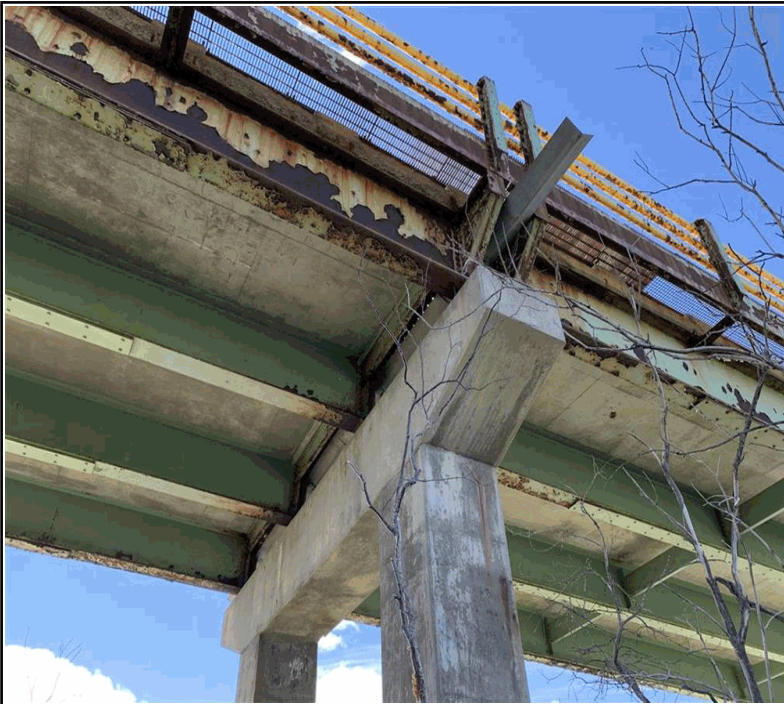
File Name IMG_4176 (Medium).JPG

Description Pier 2, fair condition	
Elem Grp/Class Elem Type Sub Element Material Type Locator Defect Descript1 Defect Descript2 Defect Other	Piers/Caps Cast-in-place concrete

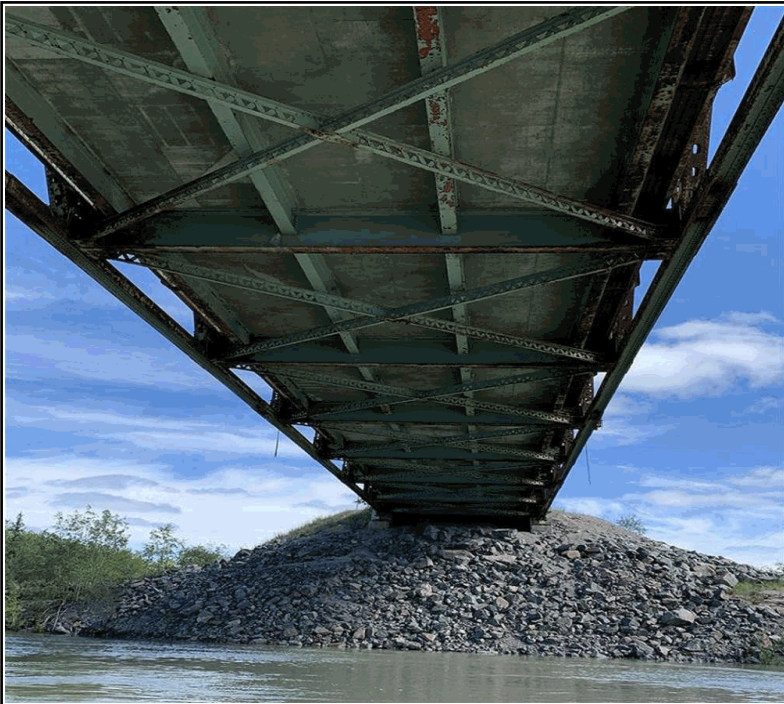
File Name IMG_4187 (Medium).JPG

Description
Abutment 2, head slope protection and deck soffit of the Span 4, looking east

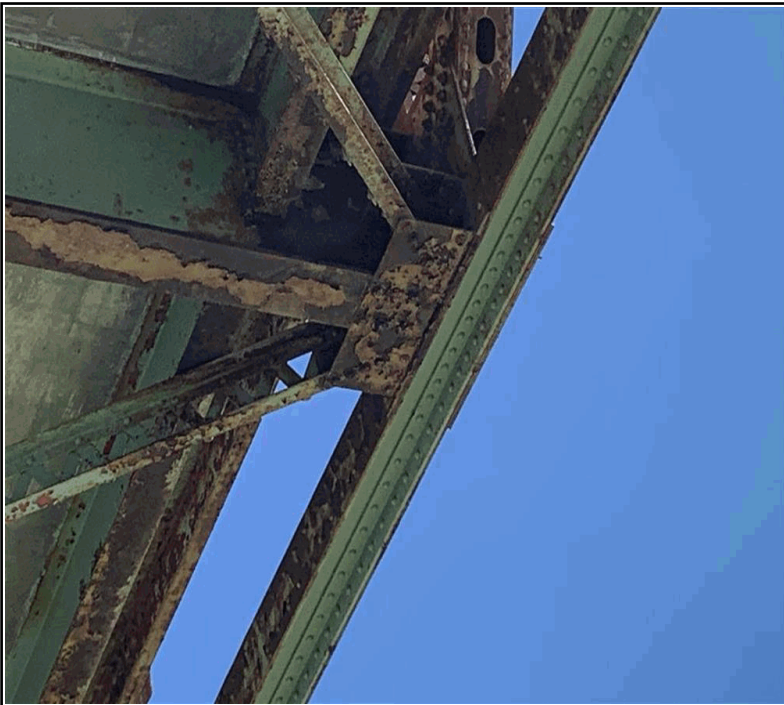
Description
Connection of the bottom chord/floor beam and braces, light corrosion typical

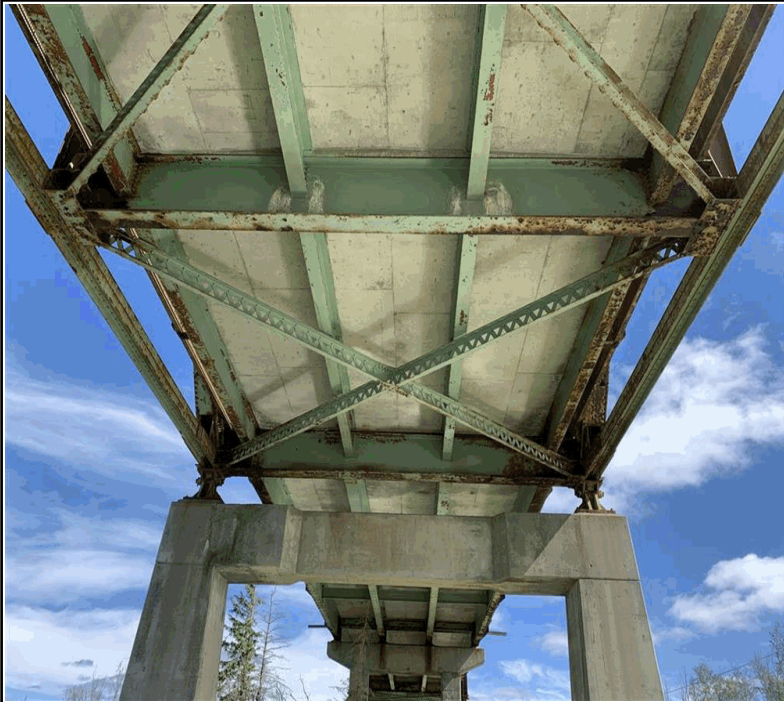
File Name IMG_4205 (Medium).JPG

Description Deck soffit at Near Pier 1, good condition	
Elem Grp/Class	Decks/Soffit - Thin Slab
Elem Type	End
Sub Element	Cast-in-place concrete
Material Type	
Locator	
Defect Descript1	
Defect Descript2	
Defect	
Other

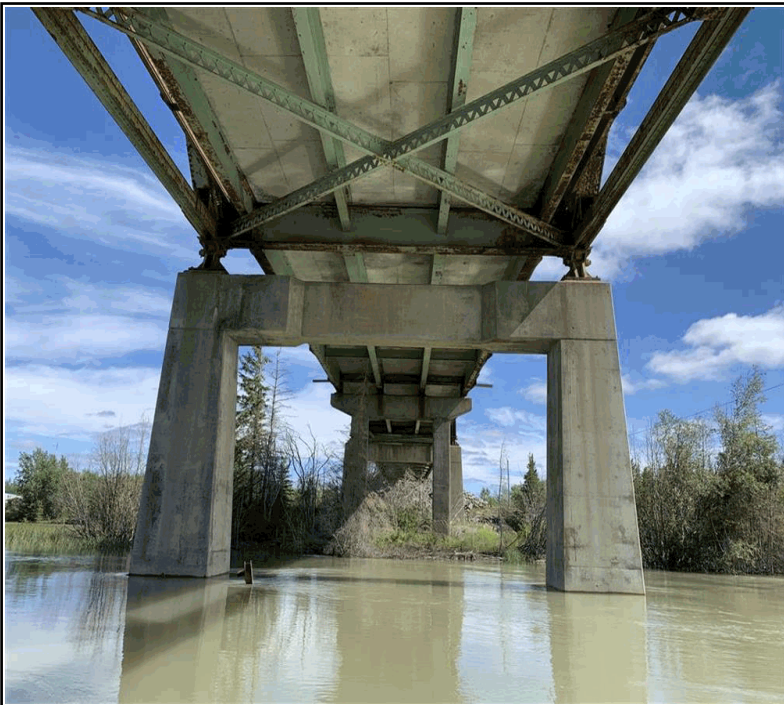
File Name IMG_4206 (Medium).JPG

Description Pier 1	
Elem Grp/Class	Piers/Caps
Elem Type	
Sub Element	Cast-in-place concrete
Material Type	
Locator	
Defect Descript1	
Defect Descript2	
Defect	
Other

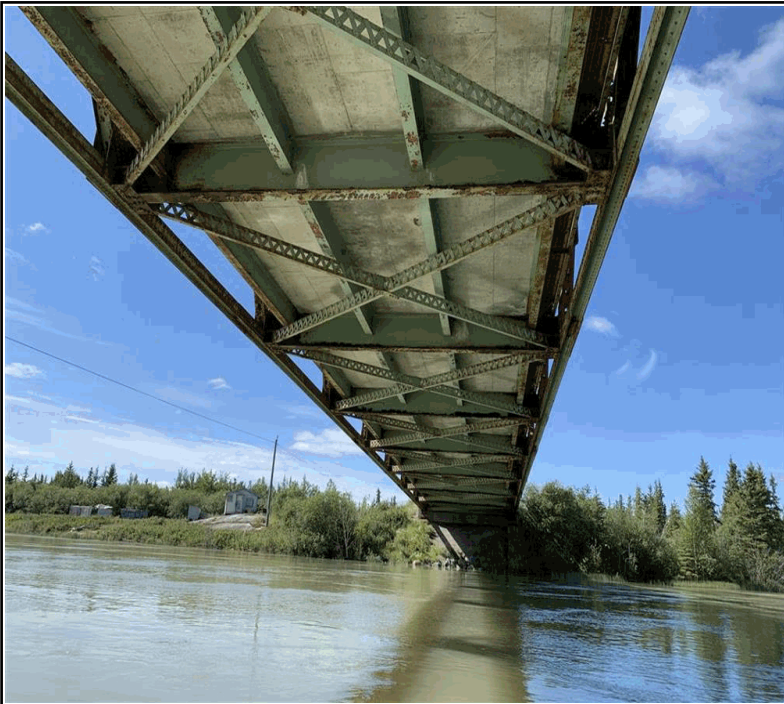
File Name IMG_4207 (Medium).JPG

Description Underside of the Span1, looking west	
Elem Grp/Class	Beams/MLE's/Stringers
Elem Type	I type
Sub Element	Intermediate
Material Type	Steel
Locator	
Defect Descript1	
Defect Descript2	
Defect	
Other

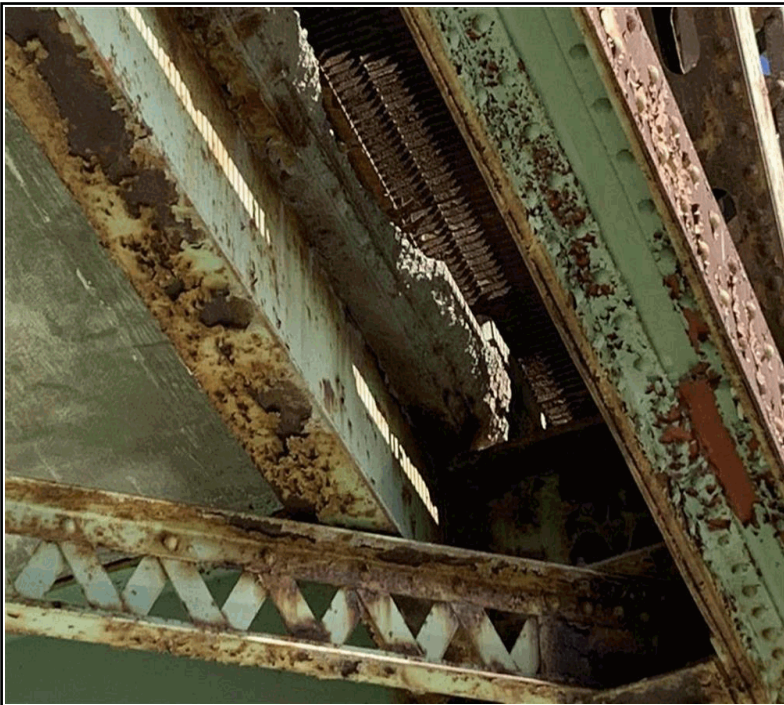
File Name IMG_4218 (Medium).JPG

Description Concrete in the exterior soffits had severe spalls and scaling with exposed corroded reinforcement throughout.	
Elem Grp/Class	Decks/Soffit - Thin Slab
Elem Type	
Sub Element	Exterior
Material Type	Cast-in-place concrete
Locator	
Defect Descript1	
Defect Descript2	
Defect	
Other

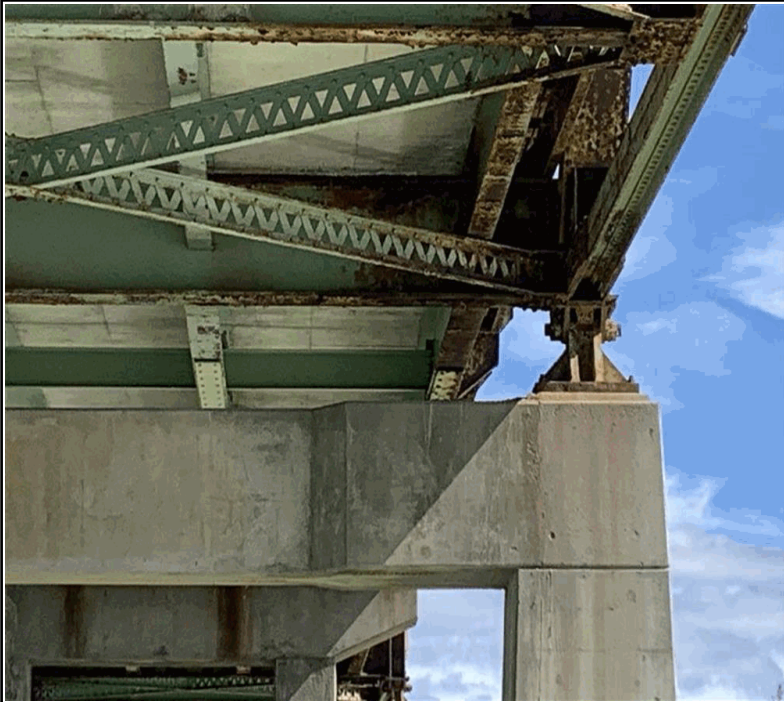
File Name IMG_4228 (Medium).JPG

Description
Pier cap at Pier 3, concrete spalls at U/S

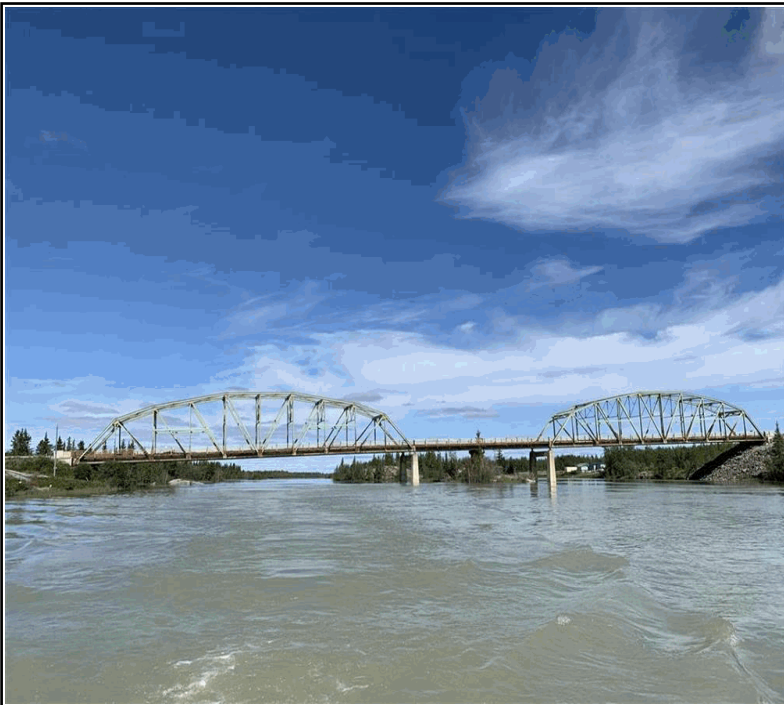
Description
General view looking north

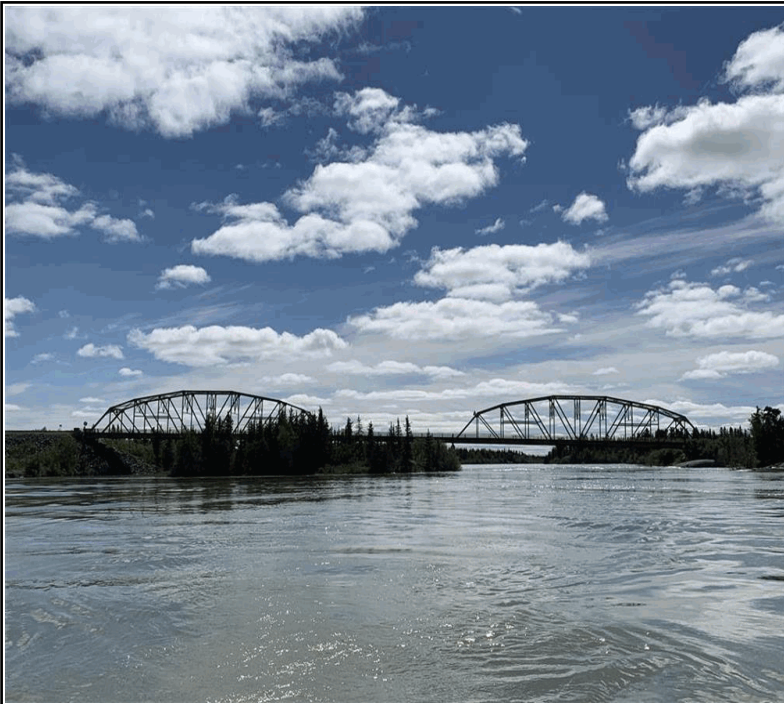
File Name IMG_4243 (Medium).JPG

Description General view looking south	
Elem Grp/Class	Trusses/Arches/Top chords
Elem Type	
Sub Element	
Material Type	Steel
Locator	
Defect Descript1	
Defect Descript2	
Defect	
Other

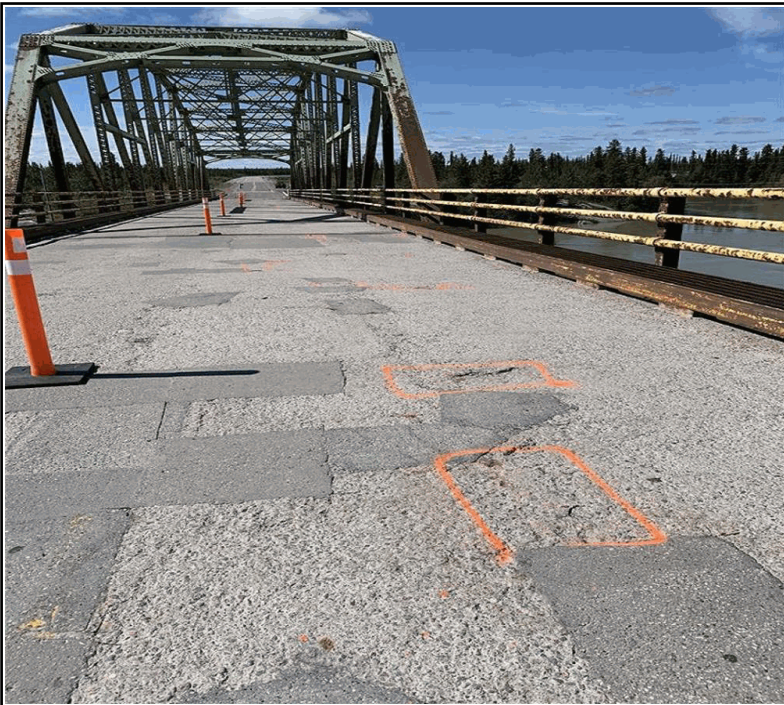
File Name IMG_4246 (Medium).JPG

Description Patching area and delamination area at Span 2	
Elem Grp/Class	Decks/Deck top
Elem Type	Cast-in-place concrete on supports
Sub Element	Middle
Material Type	Cast-in-place concrete
Locator	
Defect Descript1	
Defect Descript2	
Defect	
Other

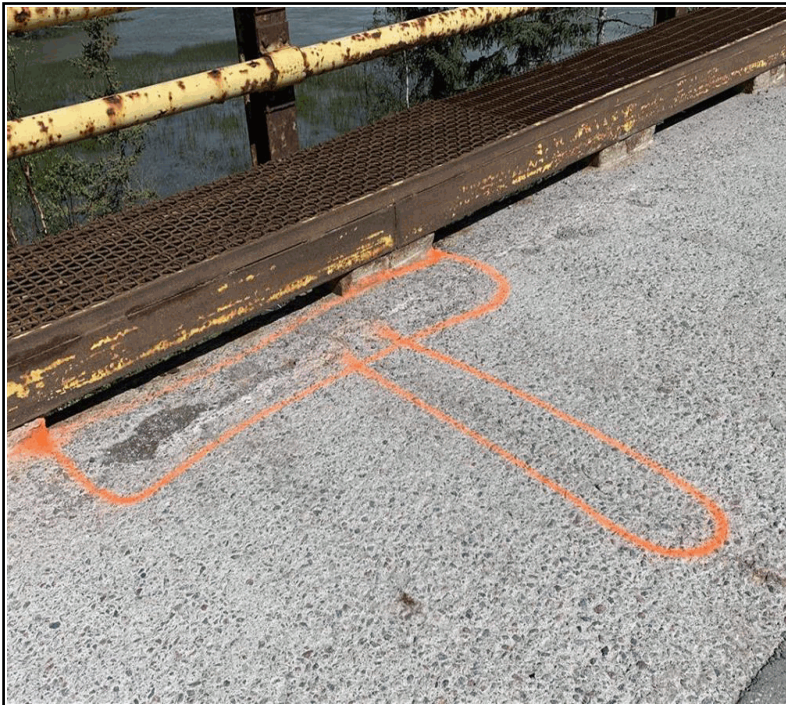
Description
Concrete spall at Span 1, U/S

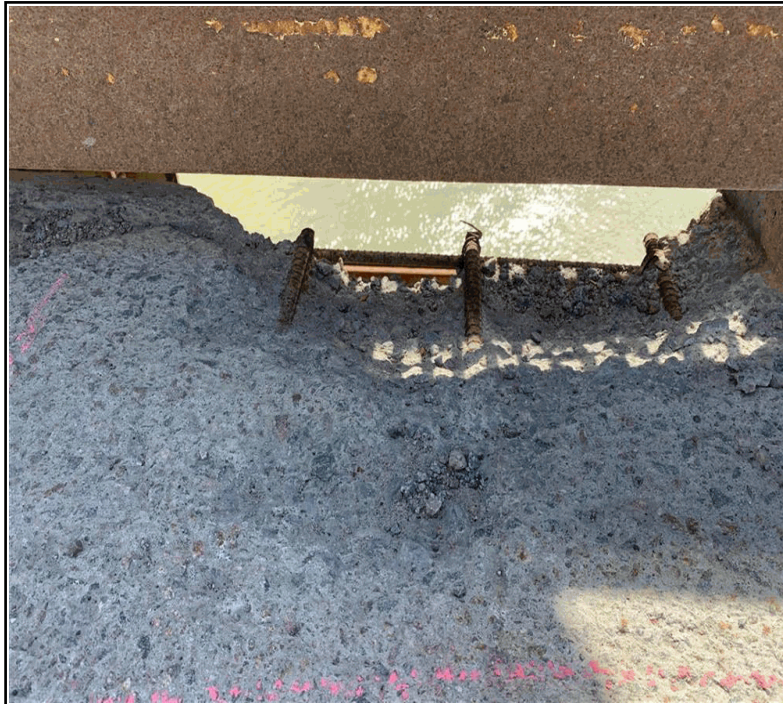
Concrete in the exterior soffits had severe spalls and scaling with exposed corroded reinforcement throughout

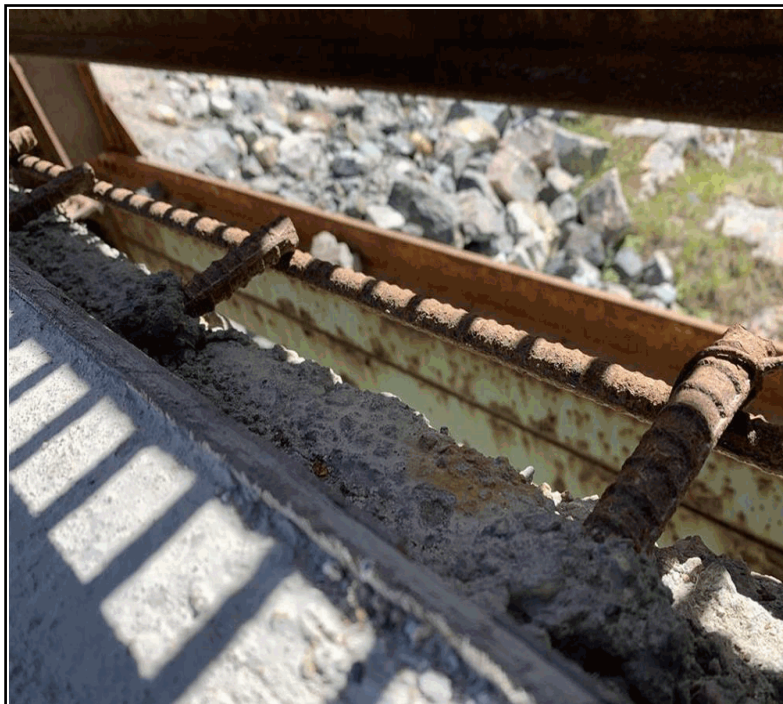
IMG_4258 (Medium).JPG

Concrete in the exterior soffits had severe spalls and scaling with exposed corroded reinforcement throughout

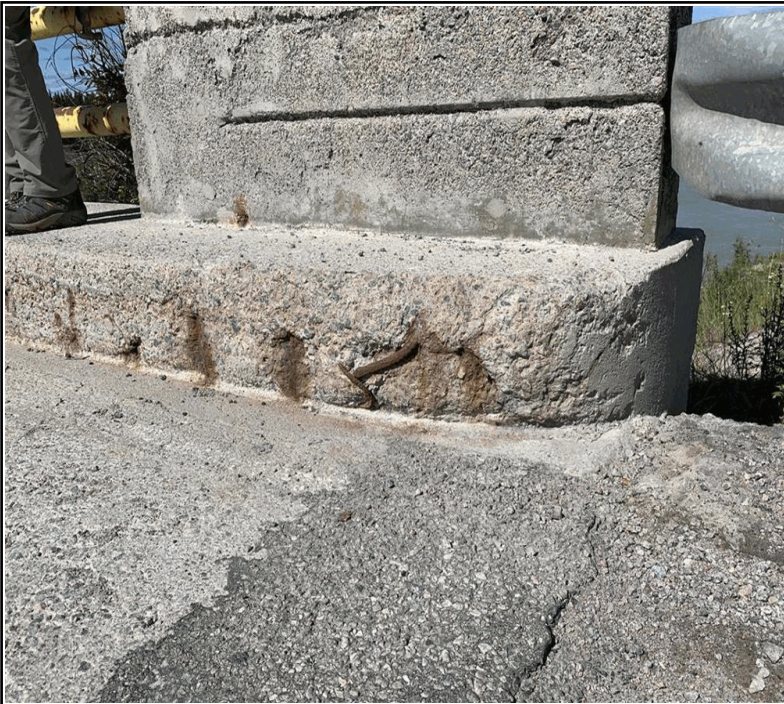
File Name IMG_4263 (Medium).JPG

Description Concrete spall with exposed rebar at Abutment 2, U/S	
Elem Grp/Class	Barriers/Posts
Elem Type	Cast-in-place concrete
Sub Element	
Material Type	
Locator	
Defect Descript1	
Defect Descript2	
Defect	
Other

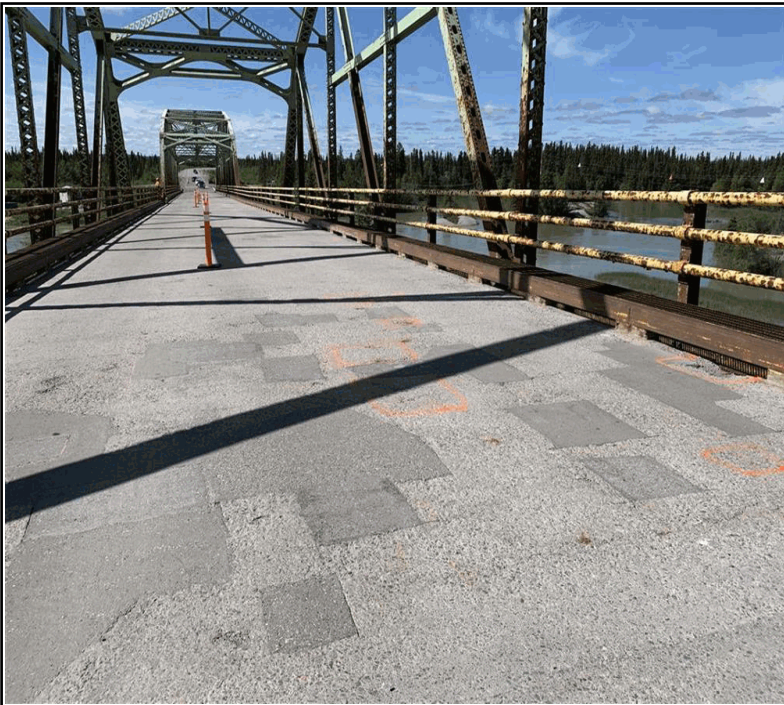
File Name IMG_4270 (Medium).JPG

Description Patching area and delamination area at Span 4	
Elem Grp/Class	Decks/Deck top
Elem Type	Cast-in-place concrete on supports
Sub Element	Middle
Material Type	Cast-in-place concrete
Locator	
Defect Descript1	
Defect Descript2	
Defect	
Other

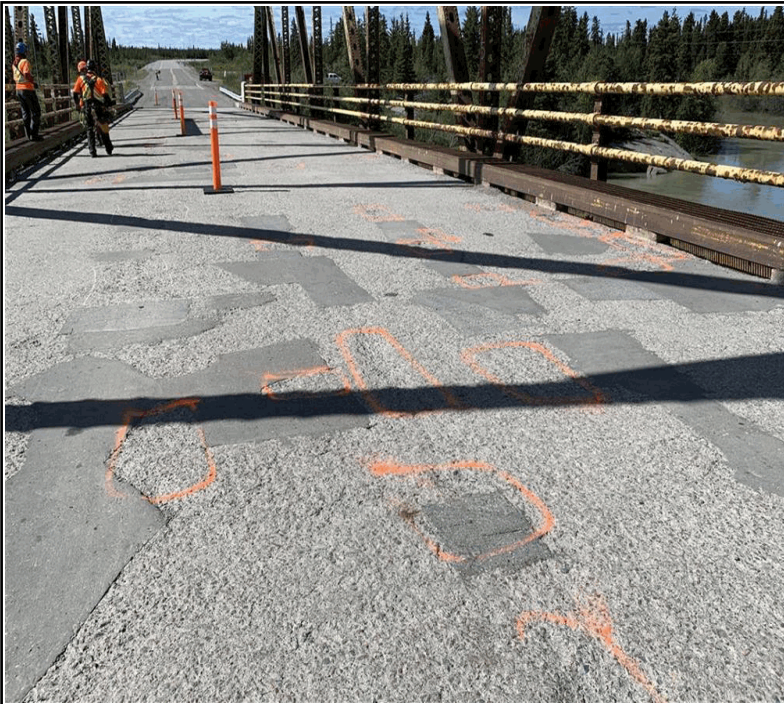
File Name IMG_4282 (Medium).JPG

Description Concrete wearing surface at Span 1, looking west	
Elem Grp/Class	Decks/Deck top
Elem Type	Cast-in-place concrete on supports
Sub Element	Middle
Material Type	Cast-in-place concrete
Locator	
Defect Descript1	
Defect Descript2	
Defect	
Other

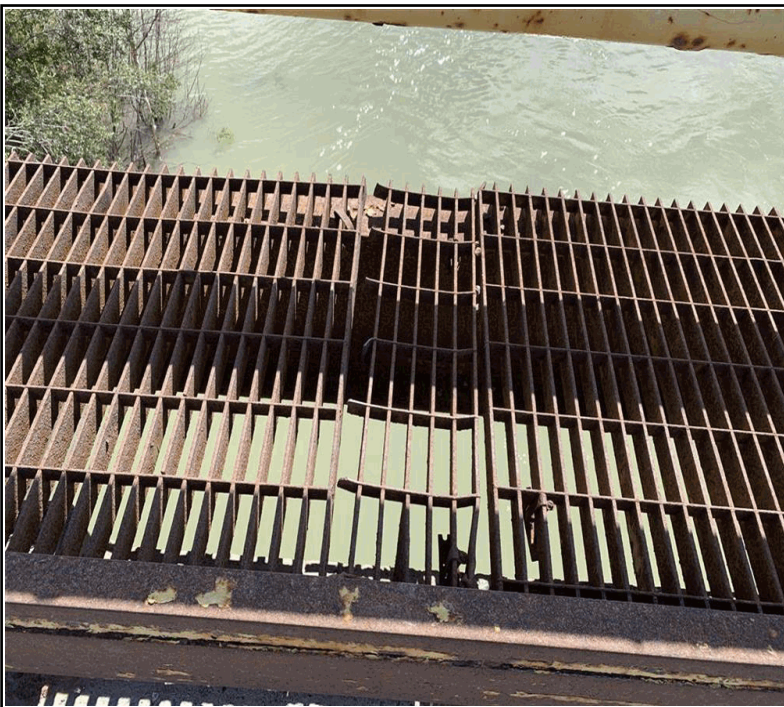
File Name IMG_4284 (Medium).JPG

Description Steel grating sidewalk, light corrosion	
Elem Grp/Class	Sidewalks/curbs/Curbs
Elem Type	
Sub Element	
Material Type	Other
Locator	
Defect Descript1	
Defect Descript2	
Defect	
Other

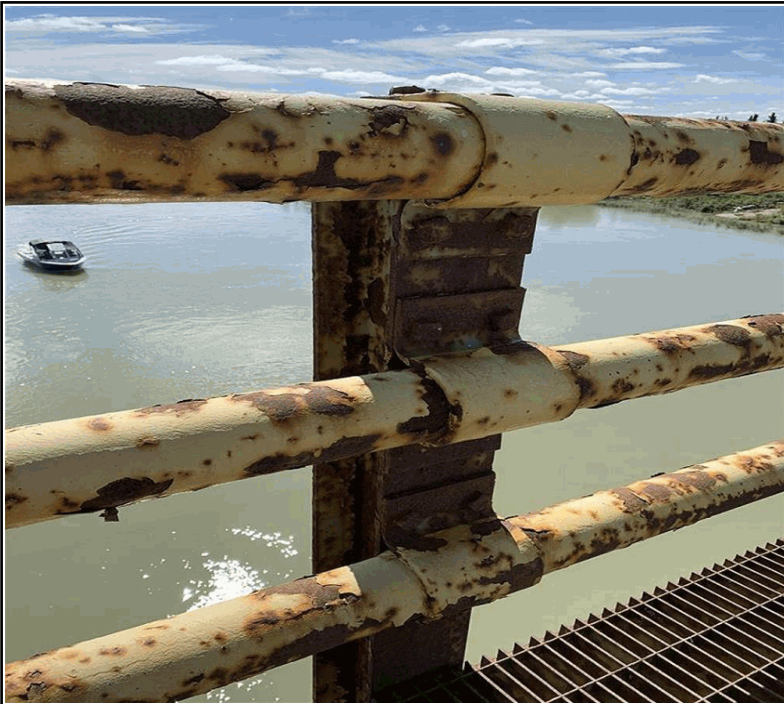
File Name IMG_4290 (Medium).JPG

Description Typical bridge rail post, typical	
Elem Grp/Class	Barriers/Posts
Elem Type	
Sub Element	
Material Type	Cast-in-place concrete
Locator	
Defect Descript1	
Defect Descript2	
Defect	
Other

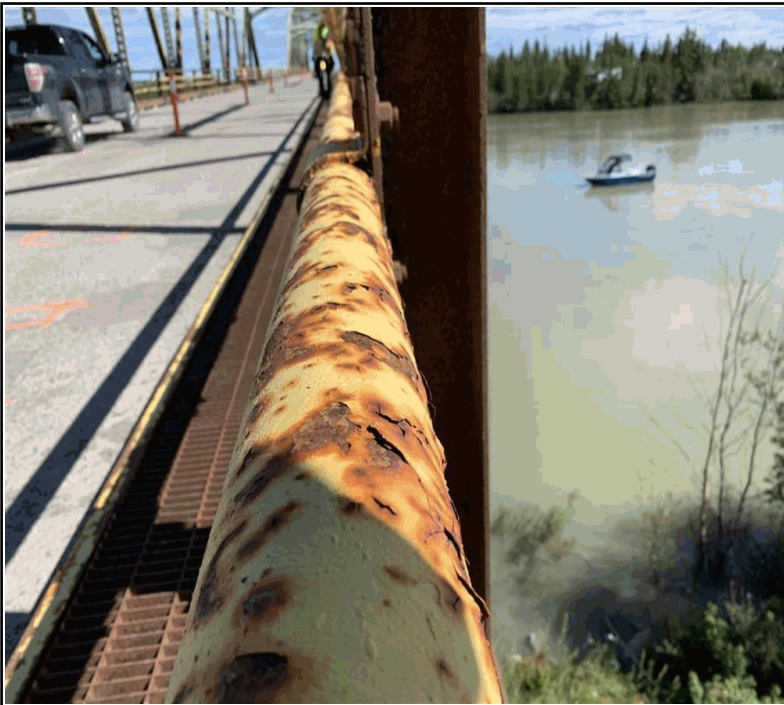
File Name IMG_4300 (Medium).JPG

Description coat peeled on the railing system and posts, typical. 8. Barrier post 4 on south side of bridge in span 4 is bent to the west.	
Elem Grp/Class	Barriers/Railing Systems
Elem Type	3 Rail Metal Railing - Steel
Sub Element	
Material Type	Steel
Locator	
Defect Descript1	
Defect Descript2	
Defect	
Other

Description Top railing, coat peeled, light corrosion, no section loss	
Elem Grp/Class	Barriers/Railing Systems
Elem Type	3 Rail Metal Railing - Steel
Sub Element	
Material Type	Steel
Locator	
Defect Descript1	
Defect Descript2	
Defect	
Other

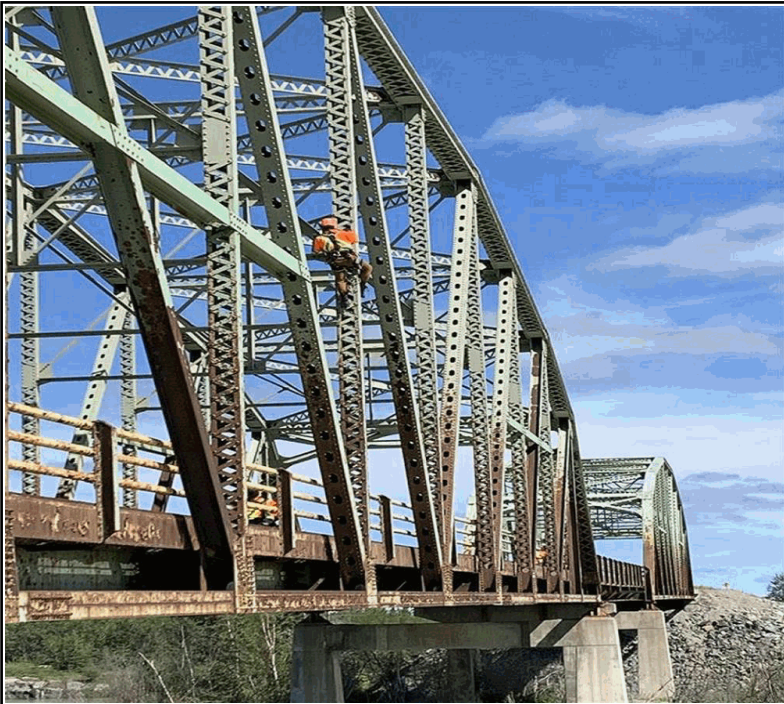
File Name IMG_4308 (Medium).JPG

Description Inspection of the truss elements, span 1, U/S	
Elem Grp/Class	Trusses/Arches/Verticals/diagonals
Elem Type	
Sub Element	
Material Type	Steel
Locator	
Defect Descript1	
Defect Descript2	
Defect	
Other

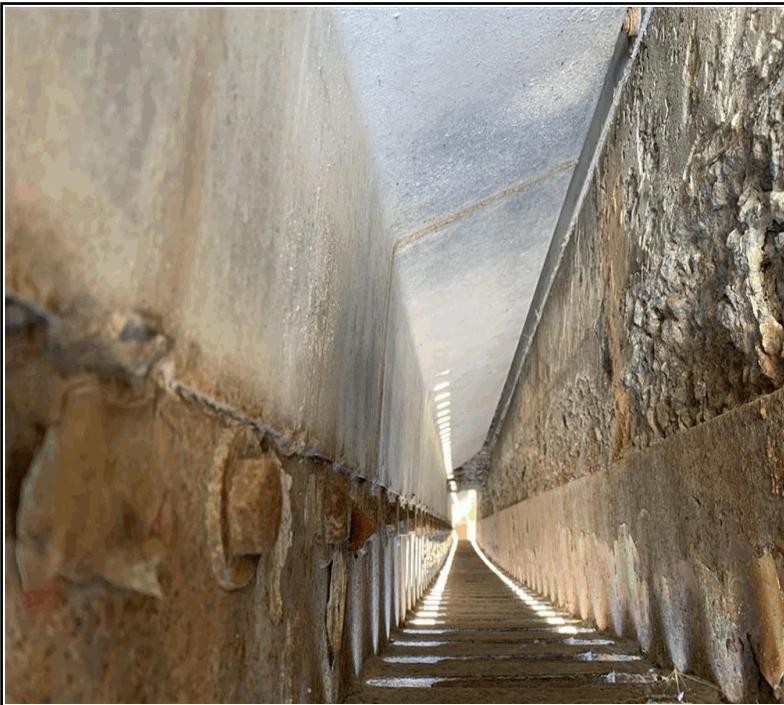
File Name IMG_4311 (Medium).JPG

Description Deck joint drain trough at Abut 2	
Elem Grp/Class	Joints/Armoring/retaining devices
Elem Type	
Sub Element	
Material Type	Steel
Locator	
Defect Descript1	
Defect Descript2	
Defect	
Other

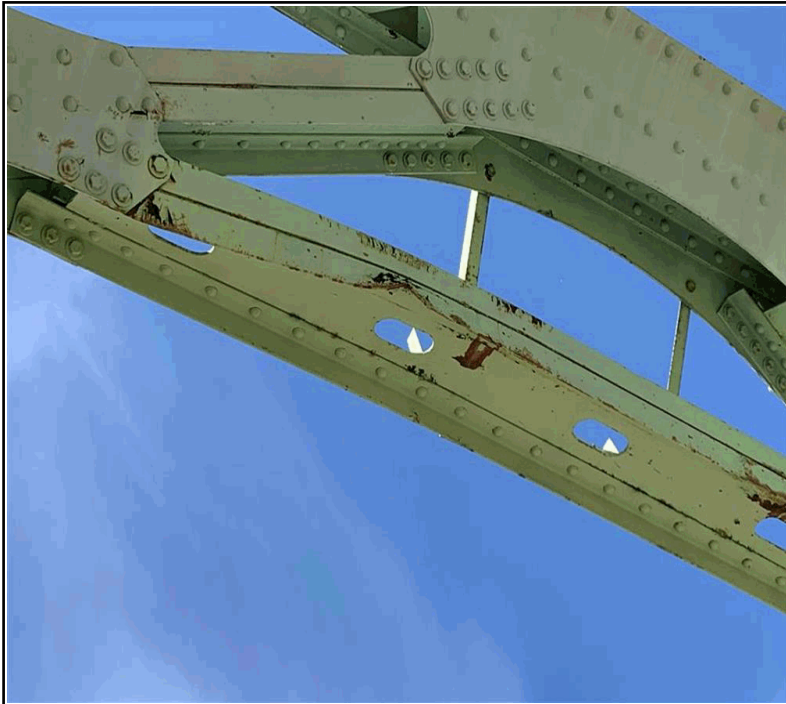
File Name IMG_4312 (Medium).JPG

Description
Span 1 @ U1 portal frame has impact damage

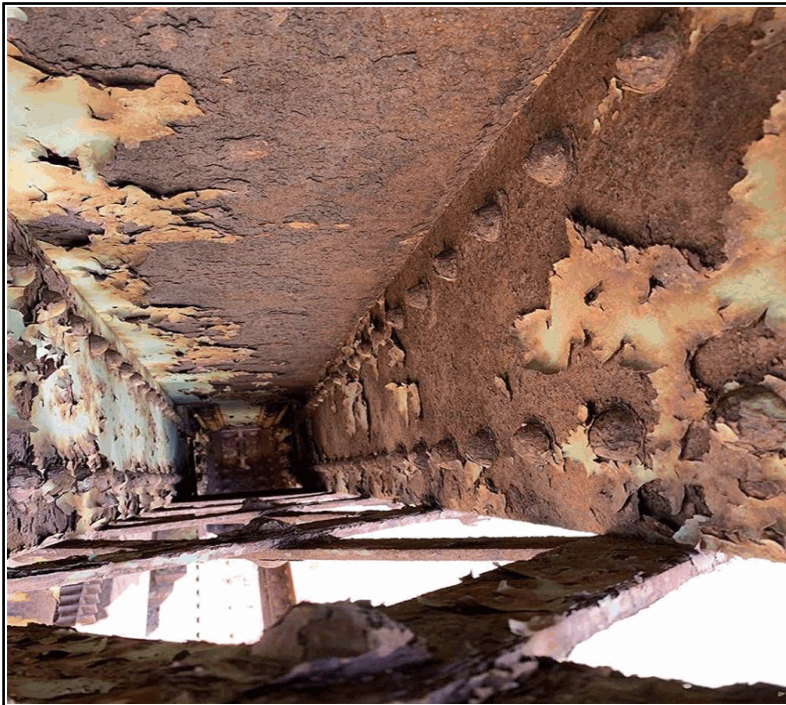
Description
Underside of diagonals have light to medium corrosion throughout at splash zone

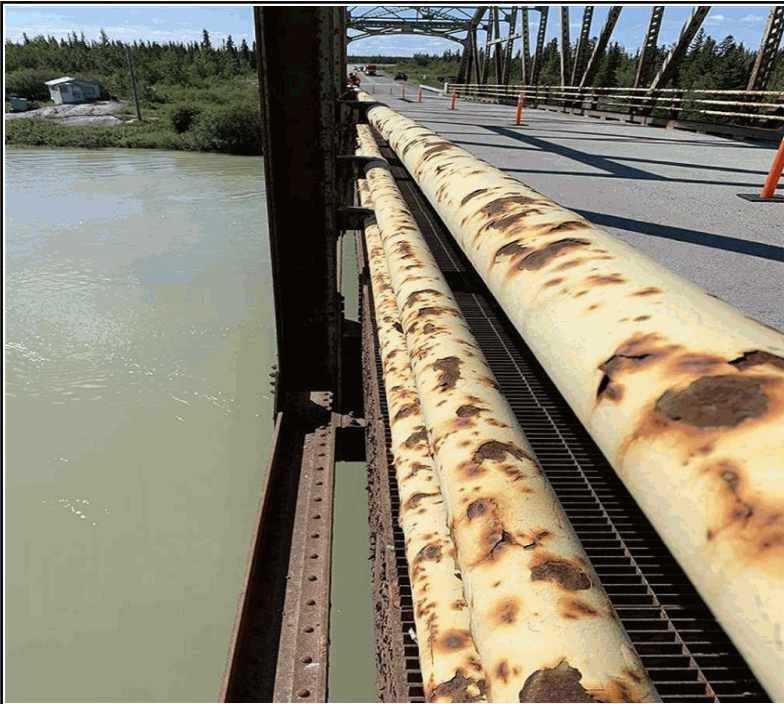
File Name IMG_4326 (Medium).JPG

Description Coat peeled and failed	
Elem Grp/Class	Coatings/Railing Systems / Hand F
Elem Type	Unknown
Sub Element	
Material Type	
Locator	
Defect Descript1	
Defect Descript2	
Defect	
Other

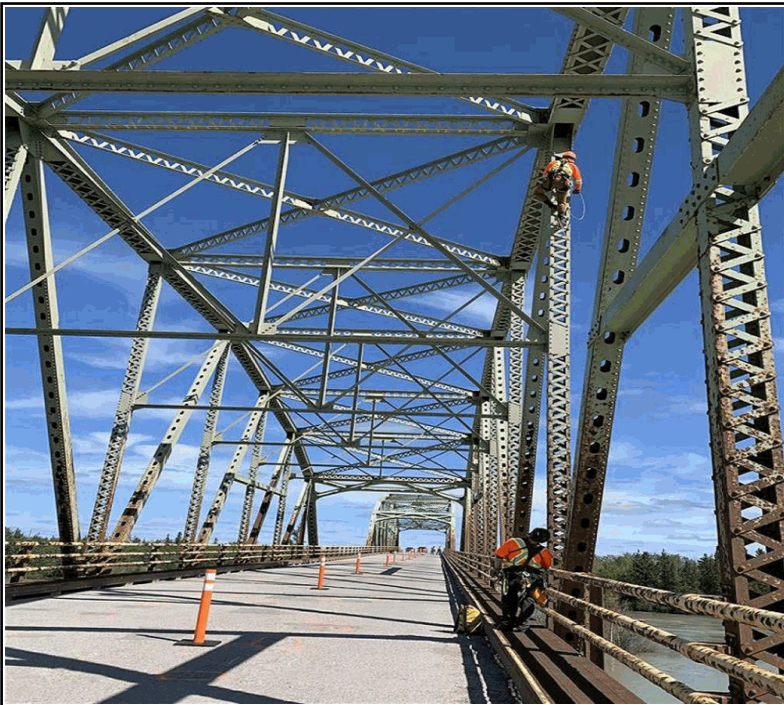
File Name IMG_4337 (Medium).JPG

Description Inspection of the truss elements, top portion of the truss elements are in excellent condition	
Elem Grp/Class	Trusses/Arches/Top chords
Elem Type	
Sub Element	
Material Type	Steel
Locator	
Defect Descript1	
Defect Descript2	
Defect	
Other

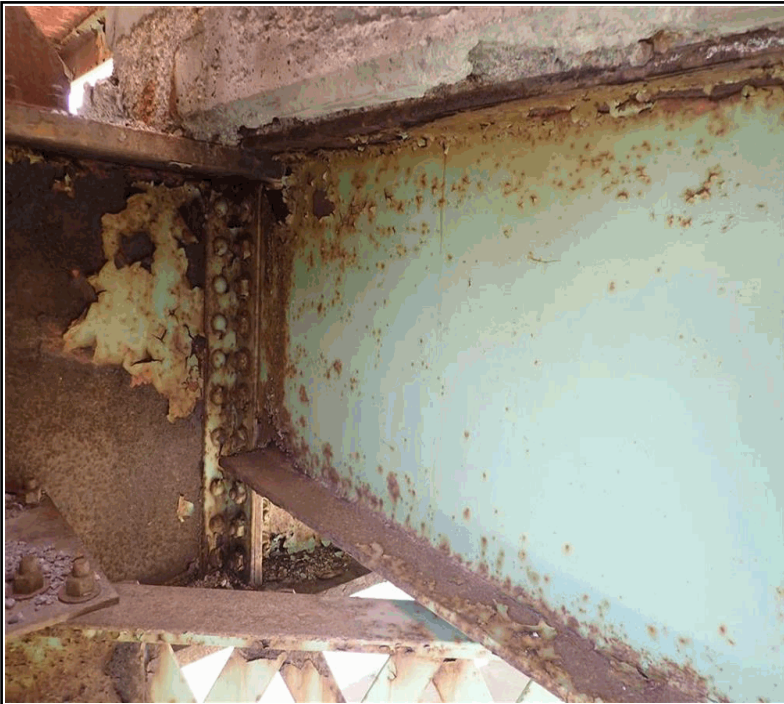
File Name JD001955 (Medium).JPG

Description
Typical stringers and connection to the floor beam

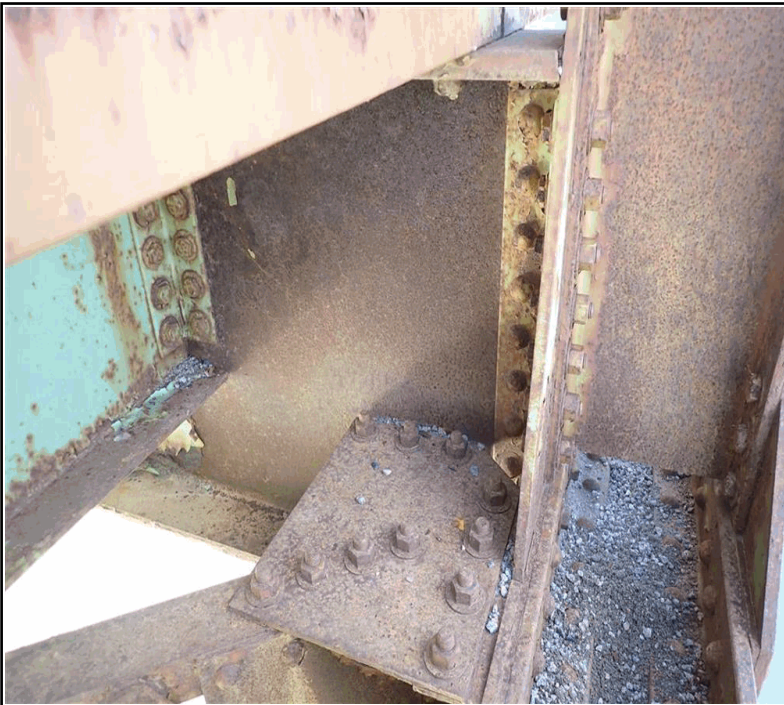
Description
Debris/gravel at bottom chord

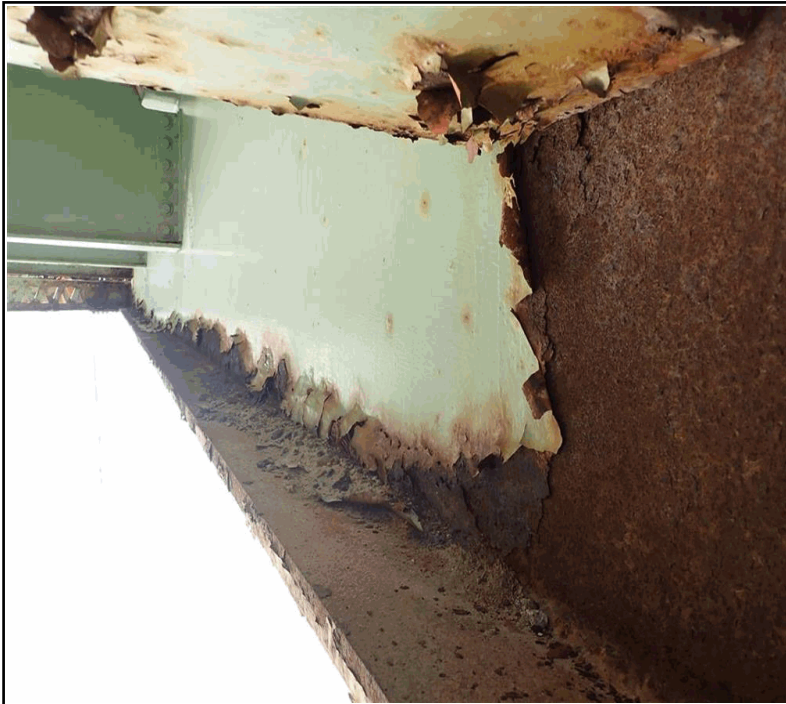
Description Intermediate Floor Beams, on one face, have severe corrosion on the bottom of the web directly above the bottom flange. Section loss is 2-4 mm	
Elem Grp/Class	Beams/ML'E's/Floor Beams
Elem Type	I type
Sub Element	Intermediate
Material Type	Steel
Locator	
Defect Descript1	
Defect Descript2	
Defect	
Other

Description
Severe corrosion on the bottom of the web directly above the bottom flange. Section loss is 2-4 mm

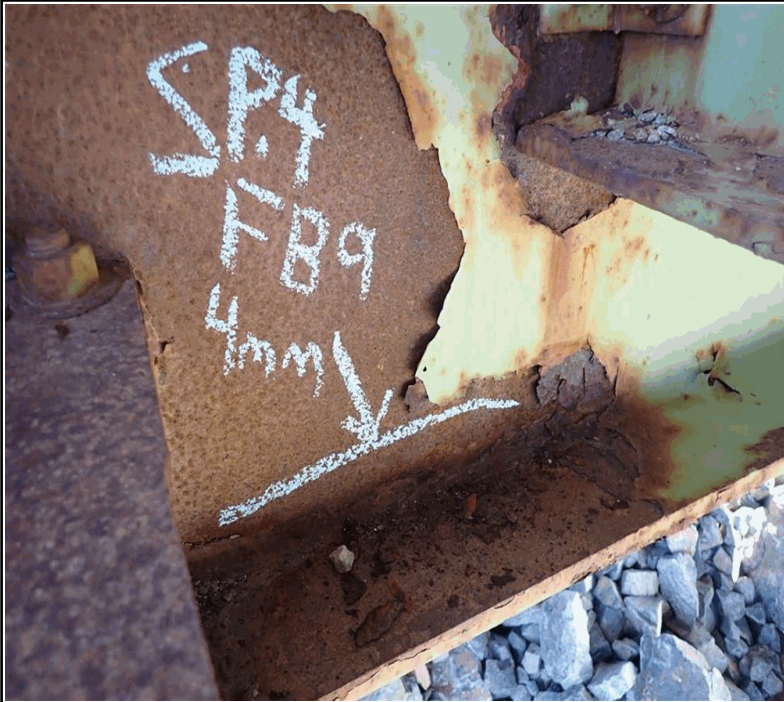
File Name JD001982 (Medium).JPG

Description Floor beam at Span 4, 4mm section loss at bottom of web	
Elem Grp/Class	Beams/MLE's/Floor Beams
Elem Type	I type
Sub Element	Intermediate
Material Type	Steel
Locator	
Defect Descript1	
Defect Descript2	
Defect	
Other

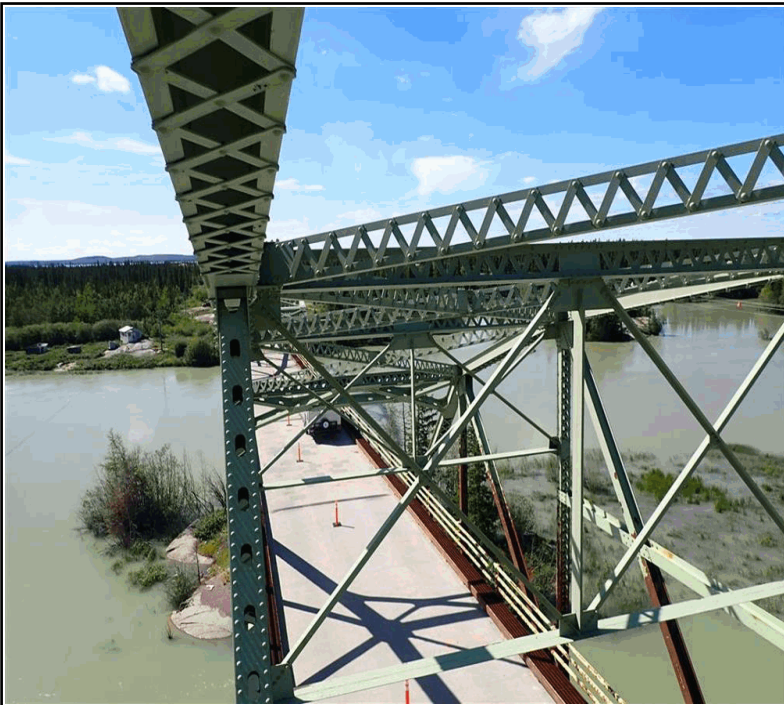
File Name JD001986 (Medium).JPG

Description Elements on top portion of the truss (Span 1) are in excellent condition	
Elem Grp/Class	Bracing/Bracing
Elem Type	
Sub Element	Intermediate
Material Type	Steel
Locator	
Defect Descript1	
Defect Descript2	
Defect	
Other

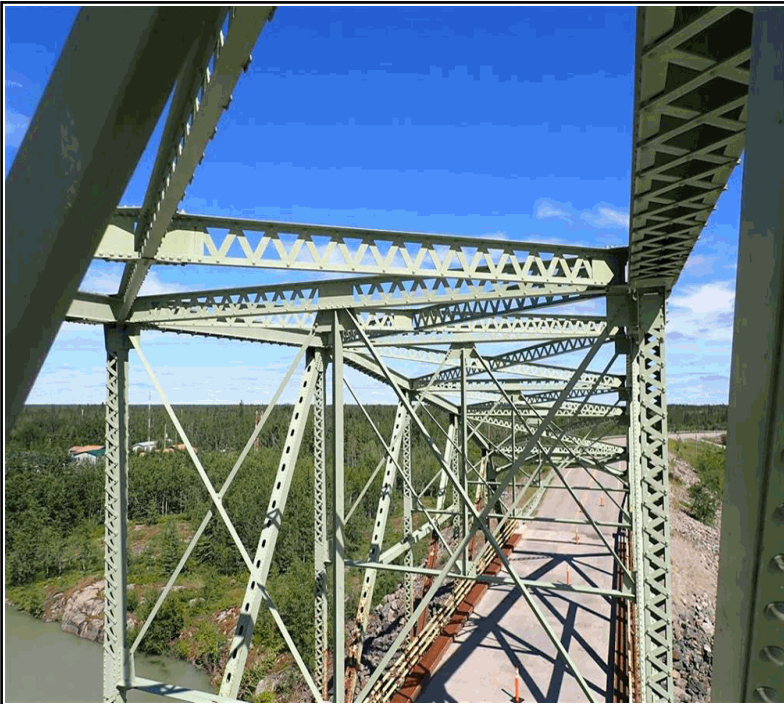
File Name JD001992 (Medium).JPG

Description Elements on top portion of the truss (Span 4) are in excellent condition	
Elem Grp/Class	Bracing/Bracing
Elem Type	
Sub Element	Intermediate
Material Type	Steel
Locator	
Defect Descript1	
Defect Descript2	
Defect	
Other

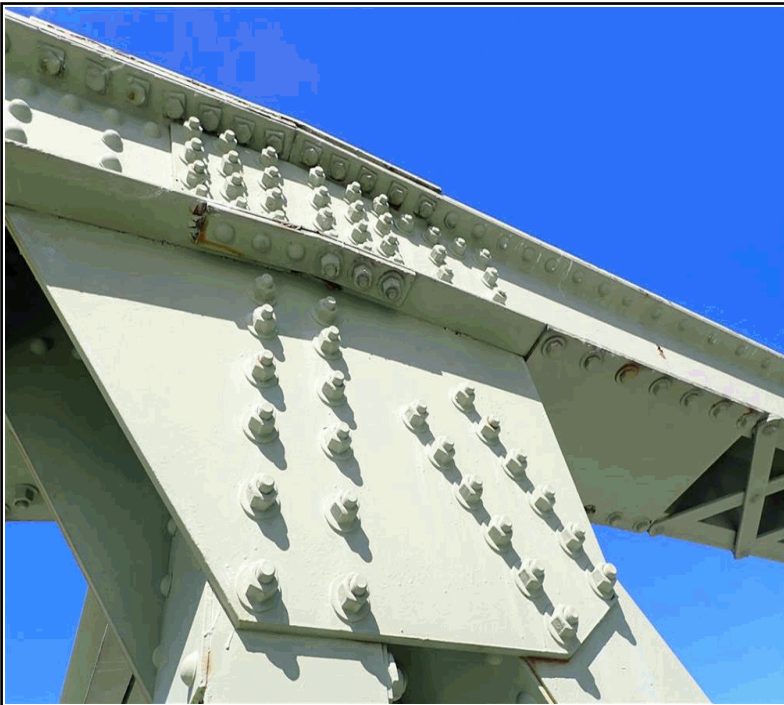
File Name JD001994 (Medium).JPG

Description Connection of top chords, verticals and diagonals, excellent condition	
Elem Grp/Class	Trusses/Arches/Connections
Elem Type	
Sub Element	
Material Type	Steel
Locator	
Defect Descript1	
Defect Descript2	
Defect	
Other

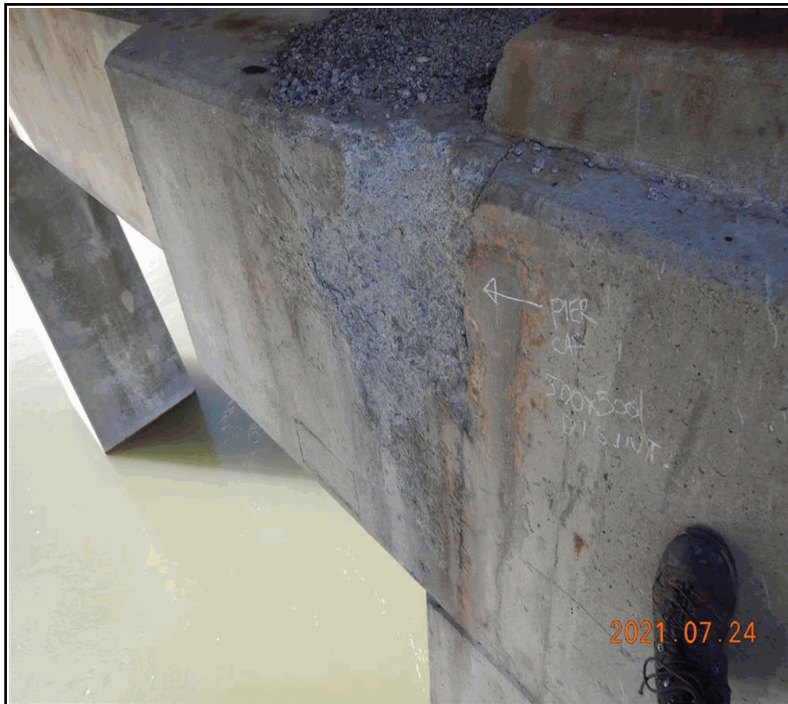
File Name DSCN2203 (Medium).JPG

Description Pier 1, concrete spall 0.5x 0.5 sqm	
Elem Grp/Class	Piers/Caps
Elem Type	
Sub Element	
Material Type	Cast-in-place concrete
Locator	
Defect Descript1	
Defect Descript2	
Defect	
Other
