Government of the Northwest Territories

Bridge Inspection Form

Struct. ID	03B004
-------------------	--------

Structure Name	Frank Channel Bridge		
Structure Location	HWY003-KM00243.8		
Road Number	3	On <input checked="" type="checkbox"/>	Under <input type="checkbox"/>
Road Name	Yellowknife Highway		
Watercourse Name	Frank Channel		
Crossing Type:	Road <input type="checkbox"/>	Rail <input type="checkbox"/>	Water <input checked="" type="checkbox"/> Navigable waterway <input type="checkbox"/>
	River <input type="checkbox"/>	Other <input type="checkbox"/>	Creek <input type="checkbox"/> Pedestrian <input type="checkbox"/>
Hwy Direction	3-SOUTH/NORTH		
Owner Category			
Maint.Resp.		Northing	62.7841667
Region	North Slave	Easting	-115.94639
District		National Highway System	
Municipality		Highway Designation	
Township		Hwy Functional Classification	
Structure Category	Bridge	AADT	890
Main Struct. Subcateg.	Truss	Trucks (%)	3
Main Struct. Type	Through Truss	District Bridge Engineer	002
Deck Length (Total)	207.15 (m)	Road Authority

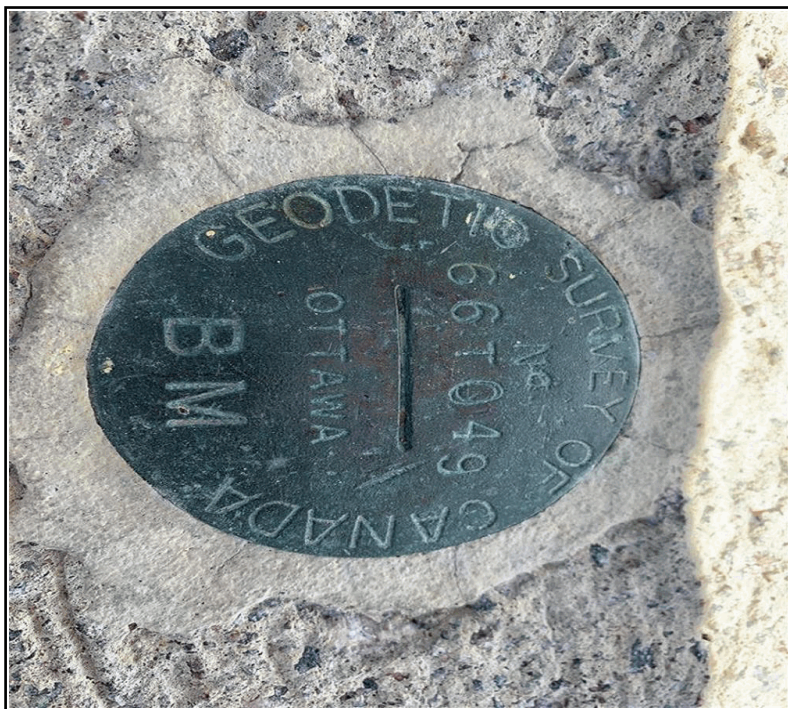
File Name IMG_4301 (Medium).JPG

Description Survey benchmark on the curb (U?S) Span 1	
Elem Grp/Class	Sidewalks/curbs/Curbs
Elem Type	
Sub Element	
Material Type	Other
Locator	
Defect Descript1	
Defect Descript2	
Defect	
Other
