UPGRADING AND REPLACEMENT OF SEWER AND WATER SYSTEM CITY OF YELLOWKNIFE EXECUTIVE SUMMARY

> PREPARED FOR: THE CITY OF YELLOWKNIFE

PREPARED BY: THE GCG ENGINEERING PARTNERSHIP 17420 STONY PLAIN ROAD EDMONTON, ALBERTA T55 1K6

AUGUST, 1984

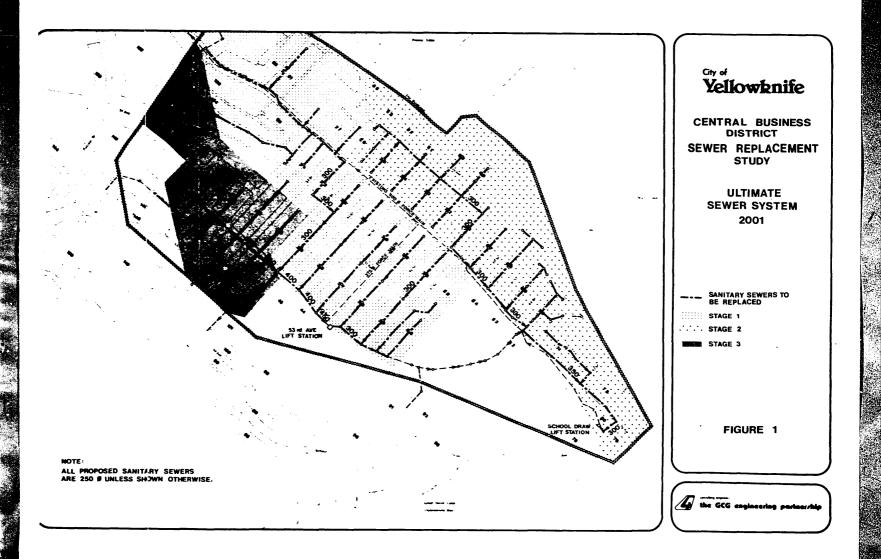
Having considered all of the above factors it was determined that a three stage program appeared to offer the best overall arrangement with the work being broken down into three distinct areas as shown on Figure 1.
