Follow up to Oral Question 503-18(2) Northern Frontier Visitors Centre

J.
Williams Engineering NFVC
Structural Assessment

File No. 35826.00

May 19, 2017

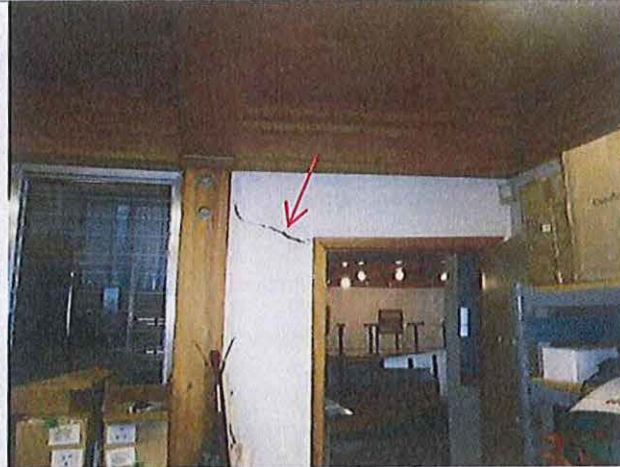
Photo 28

Condition:

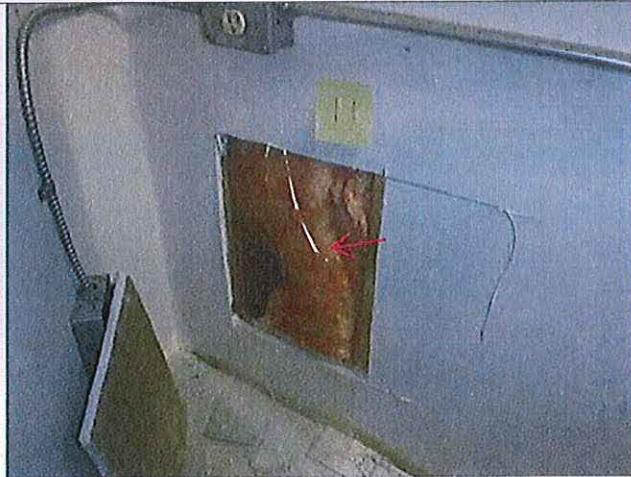
Photo 31

Condition:
Sections of the floor and walls were opened to daylight structure for review.

Recommendations:
For information.

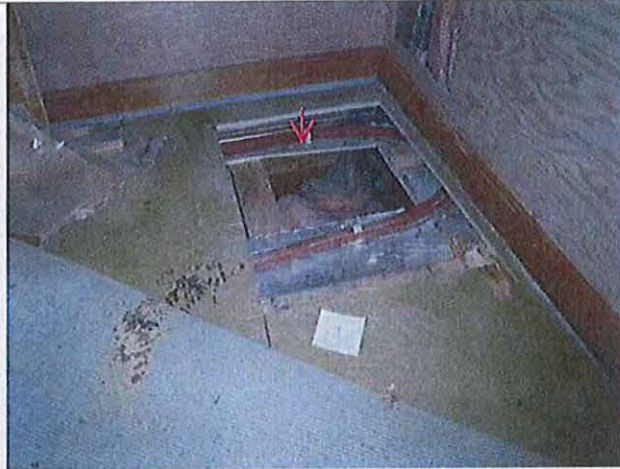
Photo 32

Condition:
In all locations that we opened up floor structure, the joists and hangers were in fair condition and performing as per their original design intent.

Recommendations:
For information.

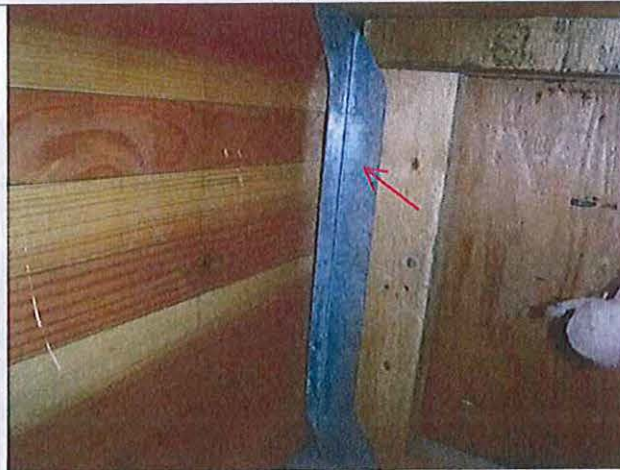
Photo 33

<p>Condition: Typical exterior beam supporting wood I-Joist floor.</p> <p>Recommendations: For information.</p>

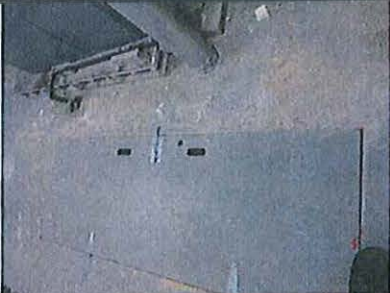
<p>Crawls space access hatch</p> <p>N2.1</p>

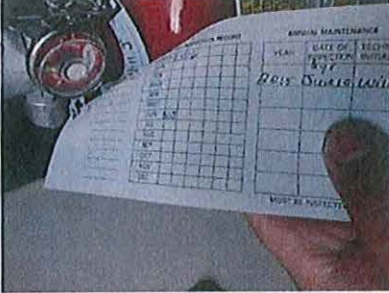
<p>Fire extinguisher checks</p> <p>N3.1</p>

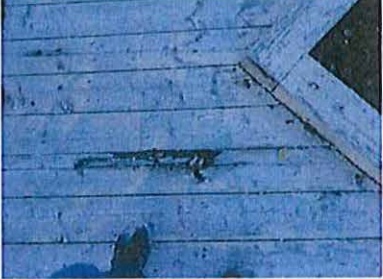
<p>Rotten deck timbers</p> <p>N7.1</p>
